SIGAR 14-62 Inspection Report

Baghlan Prison: Severe Damage to \$11.3 Million Facility Requires Extensive Remedial Action

мау 2014

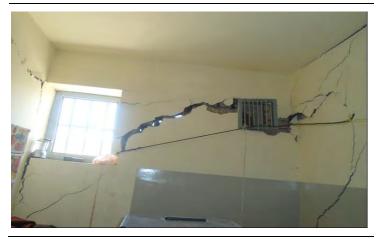
Internal View of Damage to Building 17

After construction of the Baghlan prison was completed in November 2012, building settlement occurred, which led to serious structural damage including wide cracks to three buildings. As a result, one building was demolished. Two other buildings also have collapsing walls and cracked structural beams and columns and will likely need to be rebuilt. The Department of State's Bureau of International Narcotics and Law Enforcement (INL) and its contractor, Omran Holding Group (OHG), an Afghan firm, do not agree on the cause of the building settlement and remain in negotiation regarding OHG's responsibility for repairing the facilities and assuming the cost of those repairs. Nonetheless, both parties agree that OHG did not fully comply with all contract requirements. For example, OHG failed to construct a required stormwater management system and substituted lower-grade plumbing materials that had been prohibited by INL. OHG also failed to deduct 10 percent from its billed invoices to create a retainage fund as required by the contract. This led to an \$807,254 shortfall in funds, which should have been retained for INL's protection in the event of a contract dispute.

Source: INL Technical Project Evaluation Report, dated August 18, 2013 supports of the structures, which violates the International Building Code (IBC) standards called for in the contract. American Concrete Institute manuals, referenced by the IBC, do not allow building unreinforced walls in a seismic zone. According to U.S. Geological Survey data, Baghlan prison is located in the second highest earthquake hazard zone in Afghanistan.

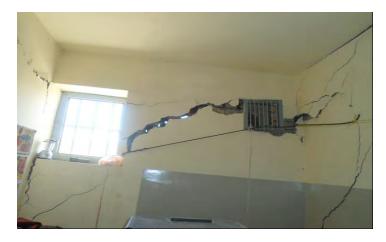
Photo 1 provides an aerial view of the prison with the three most seriously damaged buildings marked. Photo 2 shows an example of damage to the interior of building 17, which was demolished due to safety concerns.

Buildings 18 and 19 also have collapsing walls and cracked structural beams and columns. Photo 3 shows the flooding conditions in April 2012.

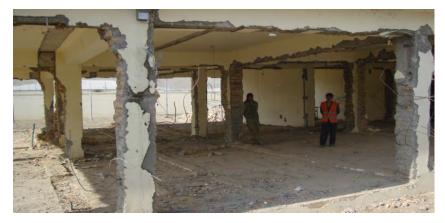
Photo 5 - Building 17 under Demolition Showing Brick Walls with a Small Amount of Reinforcing Steel

OHG's contract, provide minimum reinforcement requirements for masonry walls. The remnants of the walls shown in photos 4 and 5 have small diameter plain wire horizontal reinforcing, spaced at approximately 28-inches oncenter, and have no vertical steel. These two deficiencies alone indicate that the walls do not meet the requirements for reinforced masonry walls and, in fact, do not even comply with the minimum reinforcing steel needed to be referred to as "unreinforced" masonry walls.9

Alarmingly, the photos INL provided indicate that the reinforced concrete columns were improperly constructed and that the method of demolition of building 17 was unsafe. Specifically, the heavy concrete roof was left in place, while portions of the brick walls that help support the roof were removed. Although the brick walls contribute very little lateral load resistance, removing them entirely and

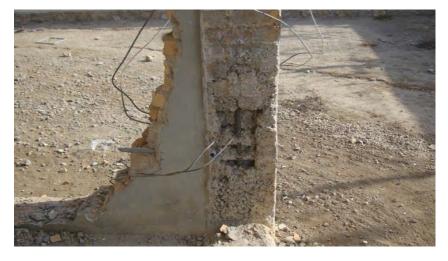
Photo 6 - Concrete Column with Voids and Exposed Reinforcing

allowing these improperly constructed columns to support the five-inch thick concrete roof provided for in the plans is dangerous. Carrying out demolition in a manner identified in the photos provided could put workers' safety in jeopardy. The photographs also raise additional concerns regarding the structural integrity of the columns and the risk of catastrophic failure. Photo 6 shows an example of a structurally deficient column. In particular, there is severe aggregate segregation¹⁰ throughout the column and a void in the concrete three-and–a-half bricks high that exposes the reinforcing steel, seriously compromising the column's strength.
