# SIGAR

**SIGAR 14-13 Inspection Report**

Forward Operating Base Sharana: Poor Planning  
and Construction Resulted in \$5.4 Million Spent  
for Inoperable Incinerators and Continued Use of  
Open-Air Burn Pits

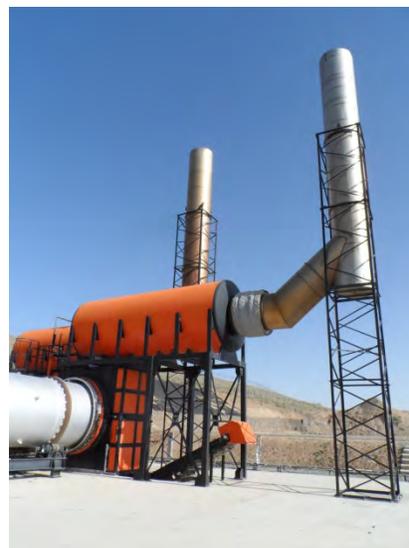
Our site inspection on May 20, 2013, found that the two incinerators installed at the site were not in operation. As a result, we could not fully assess the extent to which the facility met technical specifications. However, we were able to determine that (1) the project experienced significant construction delays; (2) the facility had electrical supply problems that could pose safety hazards; and (3) the incinerators, if made operational, could only be used by manually loading and unloading waste and would be limited to about 80 percent of the capacity called for under the original contract. Photo 1 shows the two incinerators at FOB Sharana.

**Photo 1 - Two 40-Ton Capacity Incinerators at FOB Sharana**

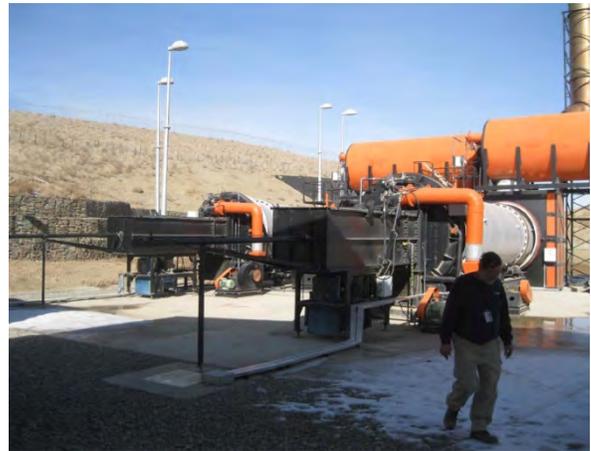
Our inspection also found that even if the electrical deficiencies were corrected, the incinerators could not be fully used. Although the contract required installing an incinerator facility with the capacity to process 24 tons of solid waste per day, two 40-ton capacity incinerators were actually installed at the facility.<sup>7</sup> Based on our observations and discussions with base personnel, we determined that the physical layout of the incinerators, as constructed, would allow them to process only 20 tons of solid

waste daily, which is about 80 percent of the capacity called for under the contract. As constructed, the incinerators also share a common loading area, which is too narrow to allow equipment, such as trash haulers and forklifts, to load the units with solid waste. As a result, solid waste would need to be manually loaded into the incinerators. In addition, the ramps to access the ash ejected from the incinerators are inaccessible to the equipment needed to load and transport the ash to a nearby pit. This design flaw means that workers would need to load wheel barrels and manually transport the ash. Photo 2 shows the narrow loading area for the two 40-ton incinerators.

**Photo 2 - Loading Area for Incinerators**

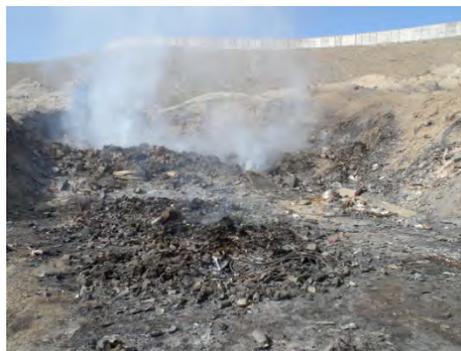
burn pits. Since the regulation's establishment in 2011, FOB Sharana had been using open-air burn pits in violation of the CENTCOM regulation. Photo 3 shows the open air burn pits and emissions at FOB Sharana.

**Photo 3 - Open-Air Burn Pit Emissions**
