SIGAR 16-56 Inspection Report

**Gardez Hospital: \$14.6 Million and Over 5
Years to Complete, Yet Construction
Deficiencies Still Need to be Addressed**

**AUGUST
2016**

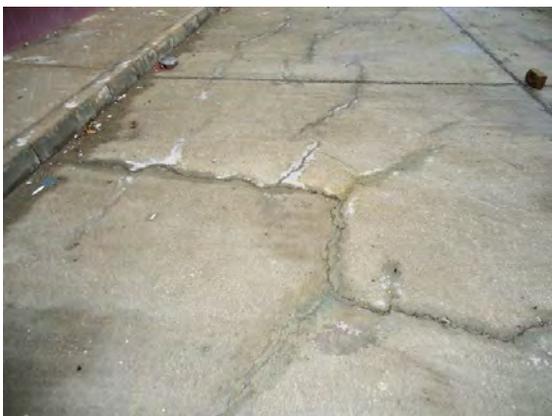
Photo 1 - Cracked Pavement

At the time of our on-site inspection in March 2015, we found numerous instances of poor workmanship that resulted in parts of the hospital and its supporting facilities experiencing deterioration and needing repair. These include significant cracks in the roadways, sidewalks, and parking areas; leaking roofs that also have standing water; crumbling concrete on the boundary wall caps; cracked exterior plaster and painting; uneven terrazzo flooring; and non-working hardware and hinges, as well as peeling paint, on the hospital’s main gate. For example, during our inspection, we observed large cracks and crumbling concrete in the roadways, sidewalks, and parking areas throughout the entire hospital grounds. Photos 1 and 2 show cracks on the roadways and crumbling sidewalk curbing. Similarly, photos 3 and 4 show cracks in the side of one building and paint peeling on the side of an outside wall. The extent of this poor workmanship raises concerns about IRD’s oversight and quality assurance services provided under its agreement with USAID for Gardez hospital.

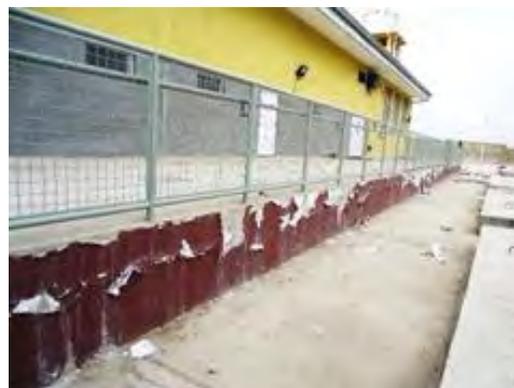
Photo 4 - Peeling Paint on Outside Wall

15	<p>Cracked Exterior Plaster and Painting</p> <p>The plaster on the walls and ramps in the loading dock and the water tower areas have cracked, and the paint is peeling. If corrective action is not taken, these defects will significantly affect the hospital's appearance.</p>	The contractor is currently taking steps to rectify the deviations.	Ongoing
16	<p>Waves on Terrazzo</p> <p>While all the terrazzo tiles are placed, there are locations where waves are visible on their surfaces. This does not conform to the technical specifications of the project and will affect the appearance of the terrazzo.</p>	The contractor is currently taking steps to rectify the deviations.	Ongoing
17	<p>Inappropriate Floor Skirting</p> <p>The skirting for the hospital floors is in place, but waves and cracks are visible on most surfaces.</p>	The contractor is aware of these deficiencies and is taking steps to correct them.	Ongoing

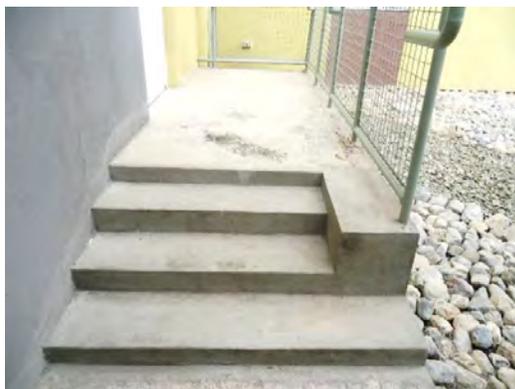
Photo 7 - Stair Rise Deviations before Repair

- the water towers' tanks, one of which had a leak, had not been tested for leaks;
- exterior stairways had not been constructed according to specifications, such as specified stair height and width;

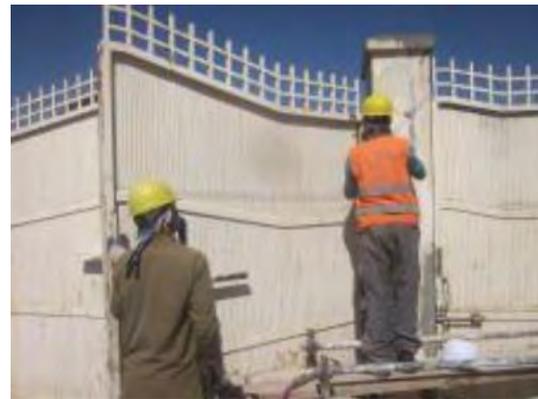
Photo 10 - Front Gate Being Repaired

6	<p>Damaged Main Gates The main gates at the primary entrance of the facility are severely damaged. Specifically, the hardware and hinges do not work properly, the painting is washed out, and the welding connections are rusting.</p>	USAID reported that IOM took steps to repair or replace the damaged/ inadequate hinges, hardware, and welding rust. However, the necessary painting is still in progress.	Ongoing
7	<p>Leaking Water Tank The construction manager stated that one of the water tanks is leaking.</p>	USAID reported that the contractor has rectified the water tank leak.	Rectified
8	<p>Gutters and Downspouts At two locations close to the loading dock area, gutters and downspouts were installed as required. However, storm water settles at the downspout openings and spreads water over the concrete surface, damaging the concrete and adjacent walls. This may be a design flaw, as the design does not require trenches or piping to carry water away from the downspout openings.</p> <p>In addition, some gutters had leaks because of poor workmanship.</p>	USAID stated that all gutters and downspouts are completed and installed according to the design and requirements.	Rectified

photographs, detailing corrective actions it was taking to address those deficiencies. Based on the information IOM provided, we determined it had rectified 13 of the 42 deficiencies we identified, was still working on 21, and had not started correcting 4.¹³ For the 4 remaining deficiencies, IOM did not agree with our assessment that corrective action was needed. Photos 5 and 6 show ongoing repairs to the hospital's roadways and sidewalk curbing; photos 7 and 8 show exterior stairs before and after repairs had been made. Photo 9 shows repairs underway at one of the guard houses to correct cracked plaster and peeling paint, and photo 10 shows repairs in progress at the front gate to correct rusted hinges and faded paint.
