Office of the Special Inspector General
for Afghanistan Reconstruction

April 2, 2014

I am writing to inform you of design and construction defects at a prison in Baghlan province built by a contractor hired by the Department of State, Bureau of International Narcotics and Law Enforcement (INL). In December 2013, we announced an inspection of the Baghlan prison. While we have been unable to conduct a physical inspection of the prison because of security concerns, our review of the contract files found serious structural damage. The structural damage resulted in at least one of the housing units being demolished. The designs indicate that this unit and other buildings at the site were built using unreinforced brick walls between concrete columns. Subsequent information provided by INL shows the facilities were built using some reinforcing steel. Although INL officials told us that any rebuilt structure(s) will use the same construction materials and methods that were previously used, we believe that INL should, for security and safety reasons, use steel reinforced masonry, such as concrete masonry units with rebar, instead.¹

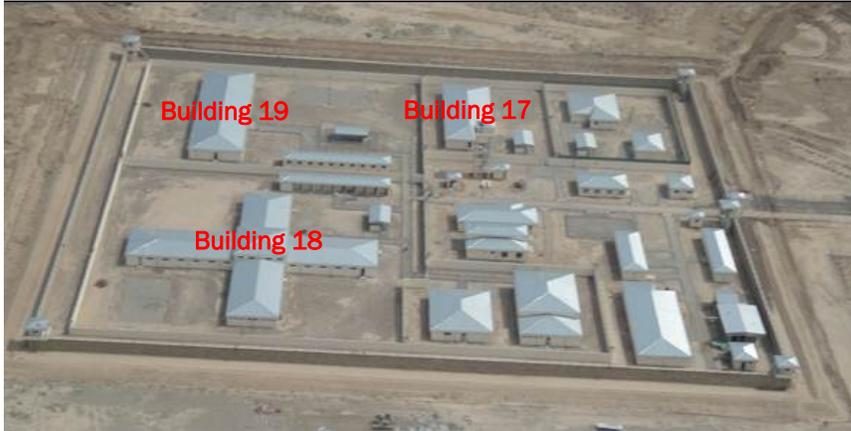
The contract files show that after the prison was transferred to the Afghan government on November 11, 2012, soil settlement occurred, which led to serious structural damage including wide cracks to buildings 17 (detention section), 18 (male section), and 19 (maximum security housing). Photos 1 and 2—obtained from INL—show an aerial view of the prison and the damage to building 17, which was subsequently demolished due to safety concerns.

Photo 1 - Buildings 17, 18, and 19 (May 2012)

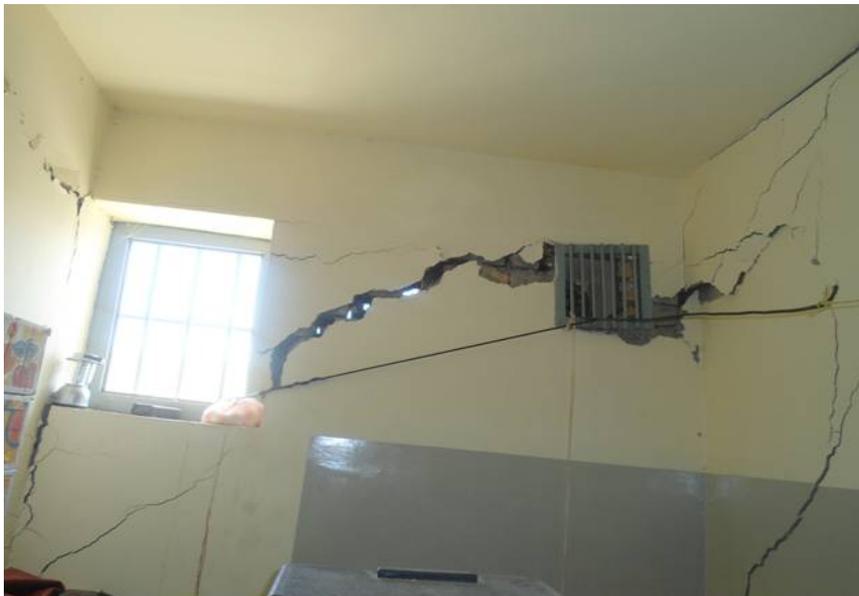
Photo 2 - Interior View of Damage to Building 17

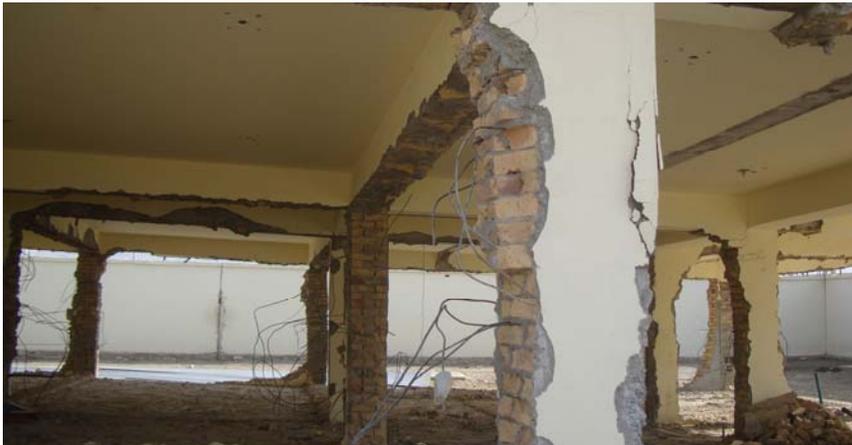
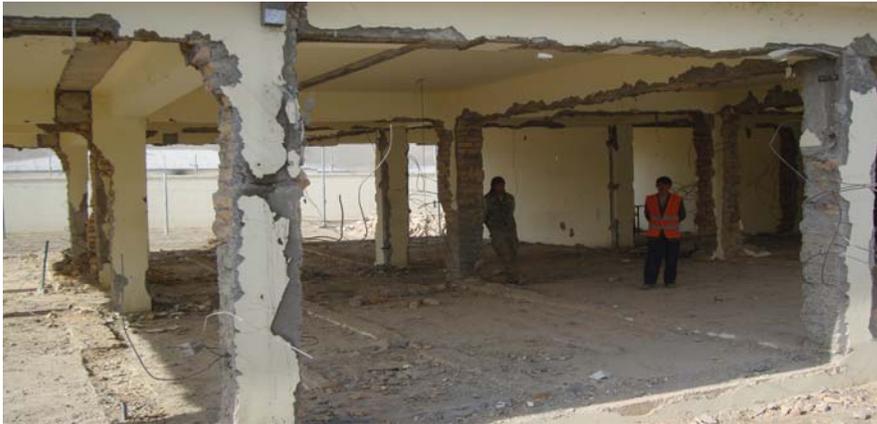
During the course of our fieldwork, we met with INL officials on three occasions in February 2014 and held an additional meeting to discuss the findings of our inspection on March 12, 2014. During these meetings, we told INL about our concerns, particularly that unreinforced brick walls between concrete columns were used in construction. At no point during any of these meetings did INL representatives dispute our assertion that the contractor inappropriately used unreinforced brick walls to construct the facilities. Nevertheless, on March 31, 2014, after we sent a draft of this letter to the State Department, U.S. Embassy Kabul, and INL, among others, we received an e-mail from INL providing two photos. According to INL's e-mail, these photos show that, contrary to the findings in our draft letter, the housing unit being demolished had actually been built using reinforced brick. See photos 3 and 4 below.

Photo 3 - Building under Demolition

Photo 4 - Building under Demolition

Although the two photos provided by INL show that some reinforcing steel had been used during construction, the photos do not show that reinforced masonry walls between concrete columns were used in compliance with the International Building Code. The American Concrete Institute (ACI) Building Code Requirements for Masonry Structures (ACI 530-05), referenced by the International Building Code and incorporated by reference into OHG's contract, provide minimum reinforcement specifications for masonry walls. The remnants of the walls shown in photos 3 and 4 have small diameter plain wire horizontal reinforcing, spaced at approximately 28-inches on-center, and have no vertical steel. These two deficiencies alone indicate that these walls do not comply with ACI requirements for *Detailed plain (unreinforced) masonry shear walls* in ACI 530-05 section 1.14.2.2.2.

More alarmingly, the photos INL provided indicate that the reinforced concrete columns were improperly constructed and that the method of demolition was unsafe. Specifically, the heavy concrete roof was left in place, while portions of the brick walls that help support the roof were removed. INL also provided additional photographs on April 1, 2014. Those photographs raise additional concerns regarding the structural integrity of the columns and the risk of catastrophic failure. Photo 5 shows an example of a structurally deficient column. In particular, there is severe aggregate segregation⁴ throughout the column and a void in the concrete three and a half bricks high that exposes the reinforcing steel, seriously compromising the column's strength.

We are concerned that additional structural damage as a result of this type of demolition and new construction using similar materials and methods could threaten employee and prisoner safety and the security of the facility. Therefore, we suggest that INL reconsider its plan and direct that the structures be rebuilt using reinforced masonry between concrete columns, as called for in the International Building Code.

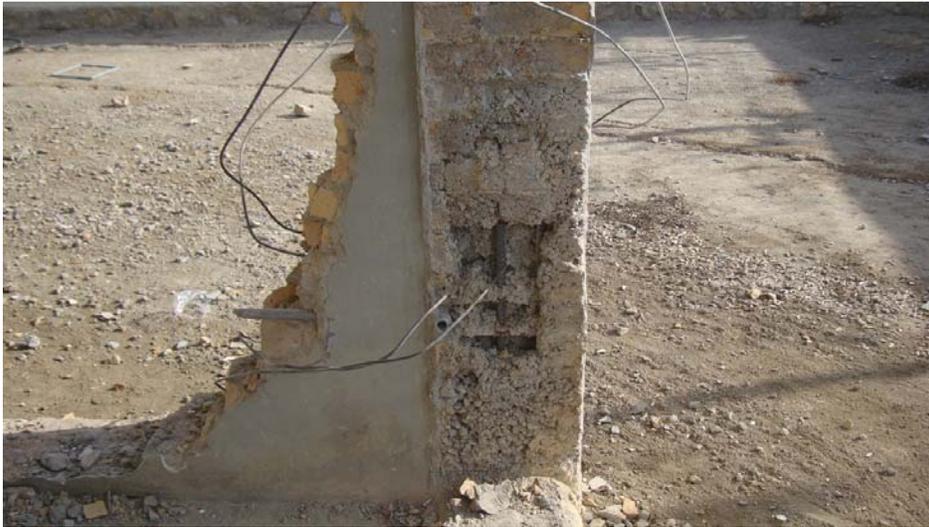
Photo 5 - Concrete Column with Voids and Exposed Reinforcing
