SIGAR Inspection – 13-1

KUNDUZ ANA GARRISON: ARMY CORPS OF ENGINEERS RELEASED DYNCORP OF ALL CONTRACTUAL OBLIGATIONS DESPITE POOR PERFORMANCE AND STRUCTURAL FAILURES

OCTOBER
2012

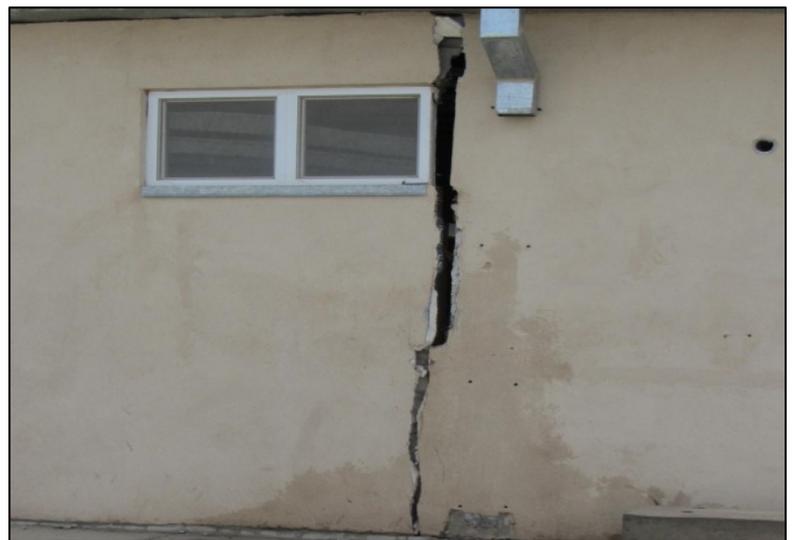
Exterior Structural Failure, Building 603 (latrine), Kunduz Army Garrison, March 2012

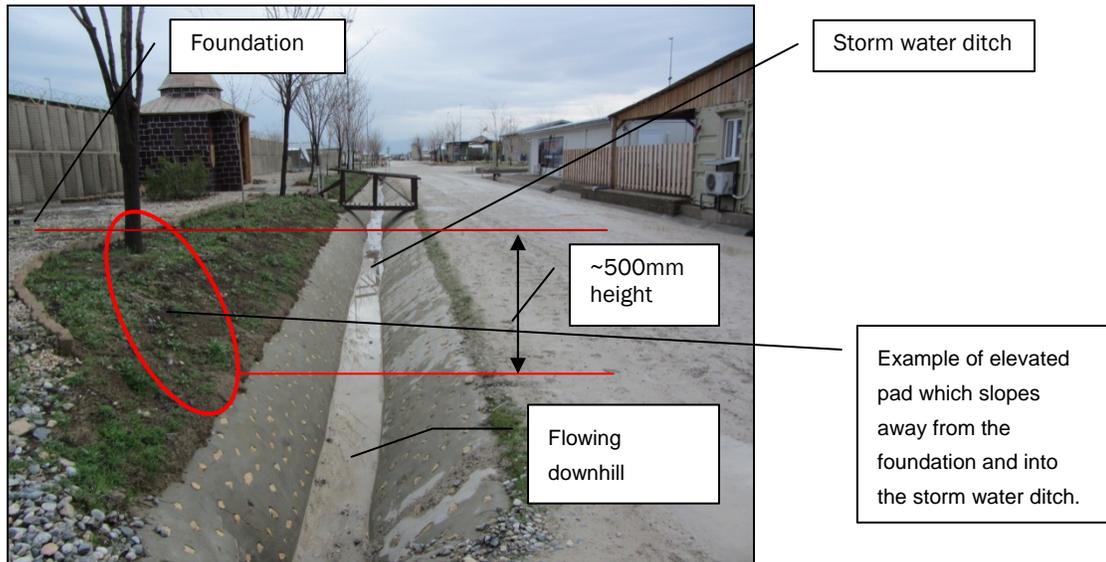
Figure 1 - Kunduz PRT March 2012 with Elevated Building Pad and Positive Drainage System

Figure 1 illustrates a typical drainage channel and elevated building pad at the Kunduz PRT.

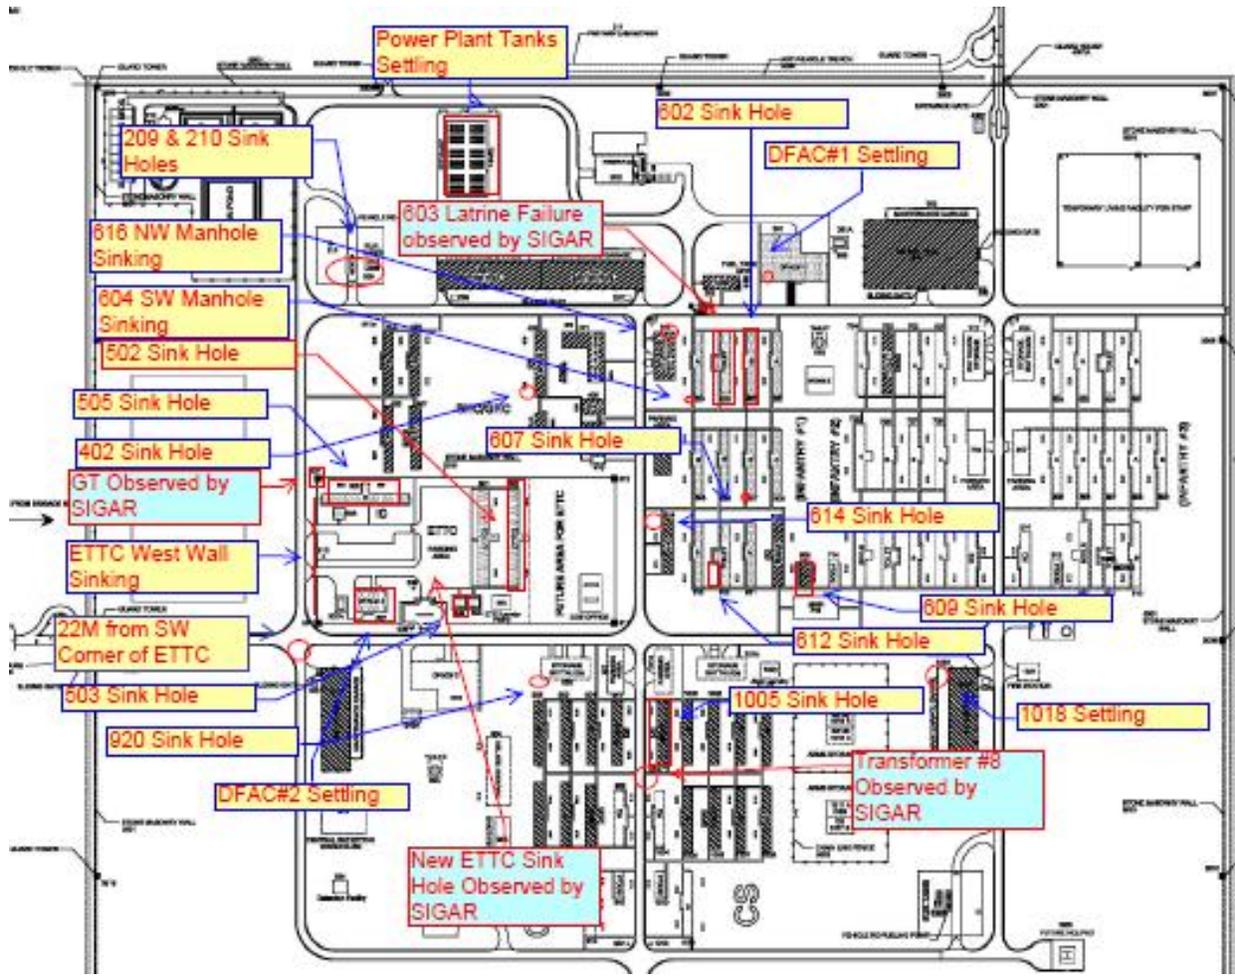
Figure 2 - SIGAR Analysis of Historical Sink Holes and Structural Failures

Soil instability continues to cause sink holes and structural failures at Camp Pamir, as can be seen in figure 2. Based on our review of data provided by USACE-TAN, we have noted sink holes and structural failures over a 2-year period, highlighted in yellow. We also noted our observations from the site visit on March 25, 2012, highlighted in blue. These included new sink holes occurring at various locations, including the ETTC. During the site visit, we also observed structural failures at transformer 8 and building 603 (latrine), and noted that building 604 (barracks) was visibly beginning to settle.

Source: USACE-TAN, Kunduz ANA-Master Plan phase II, submitted by DynCorp on September 28, 2008. Note: We highlighted sink holes and structural failures discussed in Q-01 QA Daily Reports (0033) and SIGAR Record of Site Visit to Kunduz, Camp Pamir. Yellow background callouts are sourced from historical QARs over a 2-year period. Blue background callouts indicate areas observed during the March 25, 2012 site inspection.

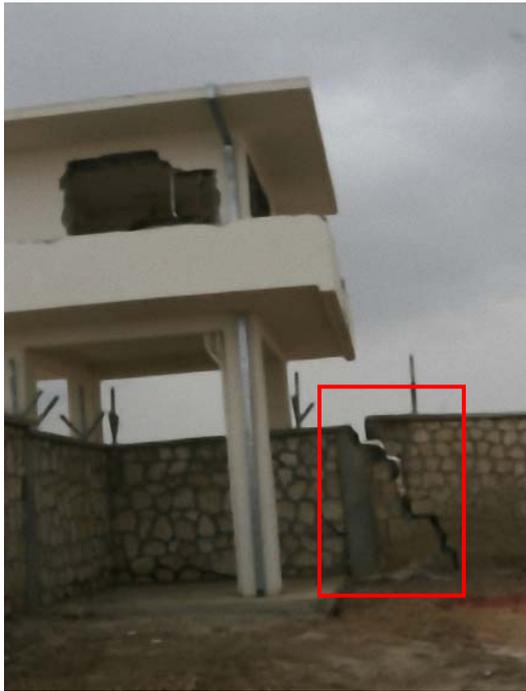
Figure 3 - Guard Tower and Wall, January 2010

In April 2010,⁸ we reported that several structures (see figure 3) had failed⁹ following a December 2009 rainfall. We also observed severe settling and improper soil grading and noted that the probable cause for the settling was lack of adequate site preparation. We reported that the soil at the site appeared to have the characteristics of collapsible soil—loose, dry, low-density materials that collapse and compact if exposed to water. According to USACE-TAN documentation and SIGAR analysis, the sinkholes appeared after DynCorp mobilized onsite and began removing a half meter of topsoil, thereby changing localized drainage patterns.

DynCorp dug piping trenches and foundation holes without providing proper grading and drainage of the site. Without proper site grading and drainage, water pooled and caused the sinkholes.

The roadbed at an intersection adjacent to these structures had also settled, and a large area appeared to be collapsing into a cavity under this roadbed. We observed similar collapses at other locations throughout the construction site. In December 2009, DynCorp indicated that as many as 48 sites in and around the garrison showed signs of collapsed soil. USACE-TAN documentation indicated that the probable cause for the severe settling was inadequate site preparation before building construction, and we reported that a future rainfall would likely cause the soil and additional areas to collapse, jeopardizing other structures. Improper grading also failed to allow rainwater to run off the site, further exacerbating the soil issues.

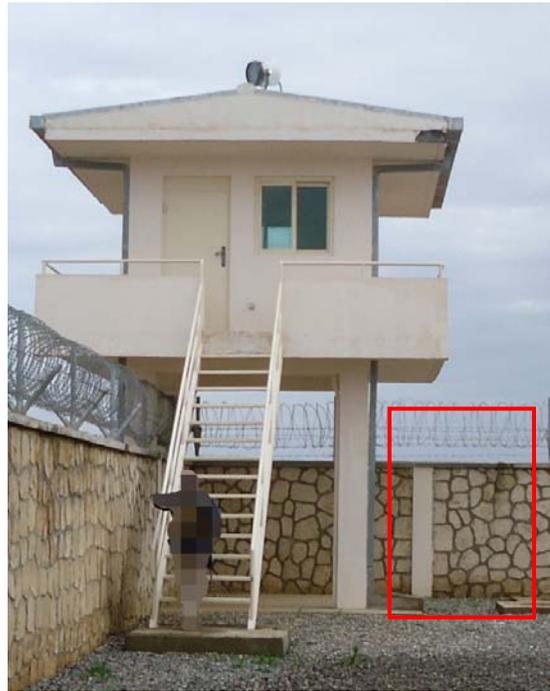
Figure 4 - Guard Tower and Wall, March 2012

The embedded training team compound (ETTC) is a separate compound within Camp Pamir and consists of an entry control point, barracks, perimeter wall, guard towers, and a dining facility. During our site visit on March 25, 2012, we noted that USACE-TAN had repaired the failing guard tower and the perimeter wall. Figure 3 shows the tower and perimeter wall during the site visit in January 2010, and figure 4 shows the result of the repairs in March 2012. Although we identified no additional structural failures within the compound, we did identify new sink holes,¹⁷ which are noted in figure 2. We also observed that, with the exception of the entry control point, none of the ETTC facilities were being used by the ANA.¹⁸ Although the compound was designed and constructed to be used by German army trainers, it did not meet their security requirements and, therefore, had not been occupied as planned. The dining facility was being used as billeting by a group of training contractors.

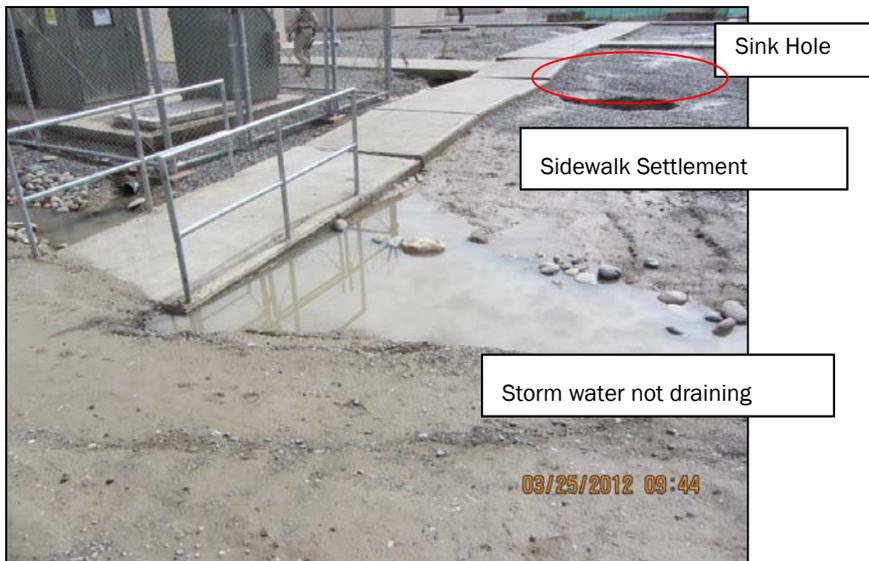
Figure 5 - Soil Failure around Transformer 8

During the March 25, 2012 inspection, we observed a sink hole developing and general structural settling around transformer 8 due to collapsible soil conditions.¹⁹ As a result, the transformer concrete pad is at risk of structural failure. Failure of this transformer would result in a loss of electrical power over a large portion of Camp Pamir, causing significant financial loss and increasing the risk of injury through fire and electrical shock. The location of transformer 8 is noted in figure 2. Figure 5 shows the area surrounding transformer 8 and some of the problems that we observed, including a sink hole, sidewalk settlement, and standing storm water.

¹⁹ In its response to this report, USACE-TAN stated that it has submitted a basic contract change to ANA Kunduz Garrison Utility Upgrade (W5J9JE-12-C-0021) to Omran Holding Group to repair the referenced sinkhole.

USACE/TAN submitted a basic contract change to W5J9JE-12-C-0021, ANA Kunduz Garrison Utility Upgrade, to Omran Holding Group to repair the referenced sinkhole.

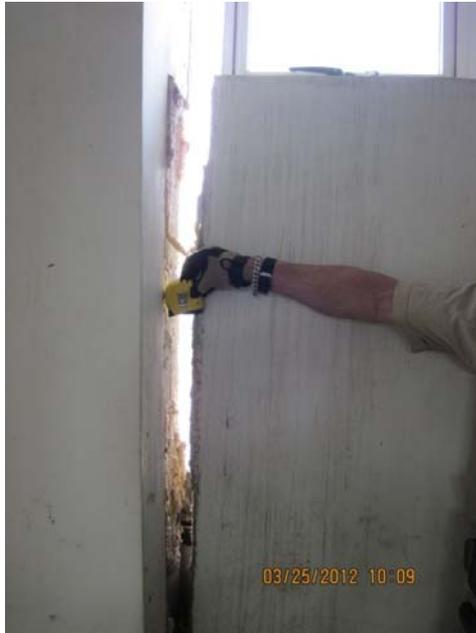
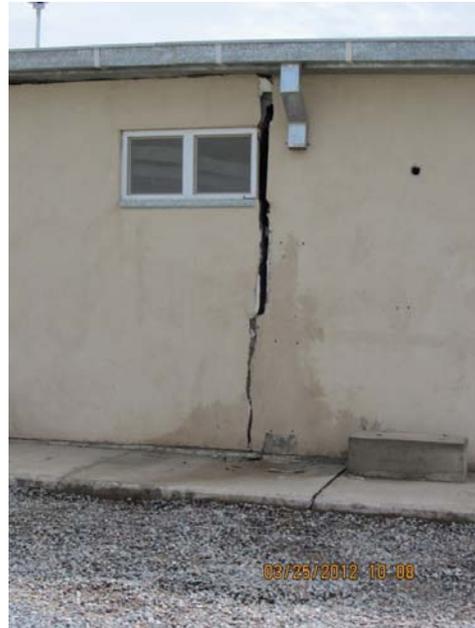
During our inspection on March 25, 2012, we observed that building 603 (latrine)²⁰ was unusable due to structural failure because of soil subsidence.²¹ We also noted that building 604 (barracks)²² adjacent to the latrine was beginning to settle and was at risk of failure. USACE-TAN officials attributed the structural failure to water infiltrating into the soil underneath the building. The location of these facilities is noted in figure 2. Figures 6 and 7 are examples of wall separation, both inside and outside building 603.

Figure 6 - Interior of Building 603

Figure 7 - Exterior of Building 603

²⁰ In its response to this report, USACE-TAN stated that a replacement latrine is included in a modification to contract W5J9JE-11-C-0076, Biltek, Garrison Expansion (phase III) project.

A latrine to replace the condemned latrines is included in a modification to contract W5J9JE-11-C-0076, Biltek, Garrison Expansion (Phase III) project.

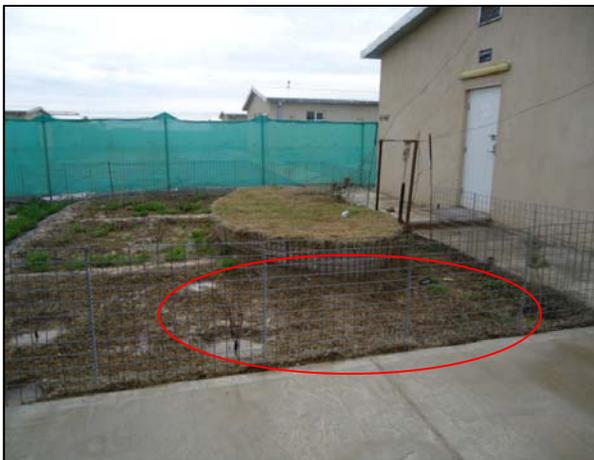
Figure 8 - Improper Grading and Landscaping

During our site inspection on March 25, 2012, we observed improper landscaping and site grading, which further exacerbated the impact of collapsible soil conditions at Camp Pamir. In accordance with the contract technical requirements, DynCorp was to design and provide landscaping for the compound and provide grading around facilities to slope away from all sides of the buildings at a minimum of 3 percent for 3 meters. We did

not observe any contractor-installed landscaping or graded sloping away from buildings.²³ The lack of adequate landscaping, along with improper grading, enables water to infiltrate under buildings and camp facilities, placing extra loading on the collapsible soil and further contributing to soil subsidence and structural failures.

²³ In its response to this report, USACE-TAN stated that it is addressing the drainage issues through the ANA Building Repair contract (W5J9JE-12-C-0031). It further noted its contractor will extend concrete aprons around the perimeters of 61 buildings to a minimum slope of 0.5 percent and a distance of 1.5 meters away from the building foundation.

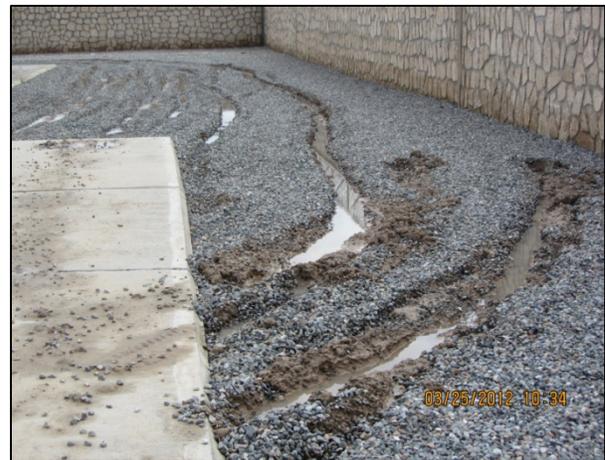
Figure 9 - Ruts from Off-Road Driving

Sidewalks were also not built in accordance with contractual specifications, which required them to be wide enough to be used as fire lanes and service roads for vehicle access close to camp facilities. We noted off-road vehicle traffic and vehicle parking adjacent to camp facilities instead of in authorized parking areas, which left deep ruts in the soil. Shipping containers were placed in improper locations as well. These practices, along with the relatively flat terrain and improper grading, further contribute to soil subsidence and structural failures by putting extra loading on the soil and allowing water to infiltrate under building foundations.

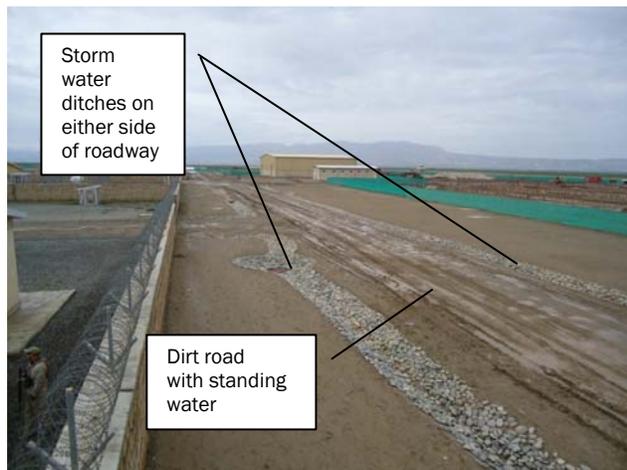
Figure 10 - Standing Water on Road Indicating that Water is Not Draining into Storm Water Ditches as Designed

As part of the design of Camp Pamir, the contract required DynCorp to develop a road network to support vehicle traffic; and the drainage plan indicated that all roads were to be constructed so that water would drain into the storm water ditches. Our review found the contractor's drainage plan was designed to divert all storm water off-site in an efficient manner. However, we observed that actual road construction and grading did not reflect this design.²⁴ The entire site was relatively flat, instead of having the required slope. Without the

appropriate road grading, water accumulated on the road surfaces and drainage channel, indicating improper drainage. Figure 10 illustrates standing water on one of the road surfaces.

In commenting on a draft of this report, USACE-TAN concurred with the recommendations and noted steps it has taken or plans to take to address drainage and road grading issues under current contracts. For example, USACE-TAN stated that it is addressing the drainage issues at Camp Pamir through an existing ANA building repair contract. Among other things, its contractor will supply and install 600 downspouts to ensure that rainwater is diverted away from the buildings. USACE-TAN further noted that its contractor will construct an asphalt paving system designed to carry 40 metric ton five-axle vehicles over roads within the existing garrison compound and including a storm drainage system.
