SIGAR 15-25 Inspection Report

ANA Camp Commando Phase II: Power Plant and Fuel Point Not Fully Operational Nearly Two Years after Project Completion

JANUARY
2015

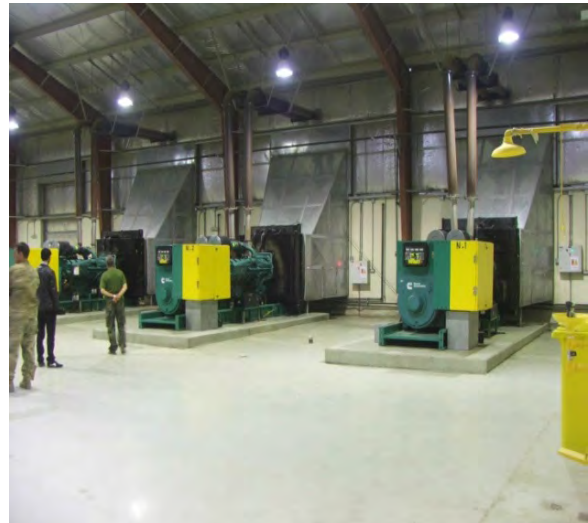
Photo 1 - Power Plant with Generators

In its final payment certificate, dated February 18, 2013, USACE's contracting officer's representative stated that all contract requirements had been satisfactorily met. However, during our two site visits in 2014, we discovered that deficiencies existed. For example, the power plant's master control panel and switchgear were not functioning as required for parallel operation of the generators. Among the problems was the software for synchronizing the generators, which was not working properly. As a result, only one of the four primary generators could operate at a time.

Further, changing power from one generator to another could not be completed without interruption. Also, since the power changeover could not be done electronically, as required, it had to be completed manually.

In comments on a draft of our report, USACE stated that an improper and unauthorized connection to a transformer damaged equipment in the power plant and caused the problems with the electrical system that we observed during our inspection. Specifically, ANA personnel made an improper connection to a transformer on or around July 6, 2012, resulting in damage to two transformers, several sections of medium voltage cables, and the main power distribution panel for the plant. USACE noted that the damage caused by the ANA occurred after USACE and the power plant's operation and maintenance (O&M) contractor performed a warranty inspection and found the power plant constructed by the Phase II contractor fully operable. USACE determined that the damage to the electrical system was beyond the control, responsibility, or liability of the Phase II contractor. The O&M contractor was able to repair the transformers and cables, but not the main distribution panel.

We found that the power plant's generators did not run in parallel as intended, and only one generator could run at a time, rather than four. This meant that Camp Commando only had 25 percent of the intended power availability that it should have at any given time to accommodate peak demands or other contingencies. In addition, because the generators did not run in parallel, the camp's power supply had to be interrupted to allow manual change-over from one operating generator to another for maintenance, or during emergencies. To compensate for the power shortage, Camp Commando used "spot" generators to provide power to key areas, including garrison perimeter security systems, the Special Forces compound, and some areas within the School of Excellence.¹³ U.S. mentors stated that the camp had 19 spot generators, but that some of them were not functioning because they needed repair.

In October 2014, USACE officials provided us with documentation showing that it paid a new contractor about \$2.1 million in Phase III to complete work on or make repairs to the camp's power system. The officials noted that the initial contract to repair the power plant's electrical system was awarded for approximately \$1.9 million. This was followed by two modifications to address additional problems with the power system, including the need to replace the original master control panel, repair the generators, and synchronize the generators to allow for parallel operation so that the power plant could operate up to four generators simultaneously. These additional issues had a combined price of about \$243,000. The modifications also called for the purchase of some new equipment, such as the purchase and installation of a sixth generator. According to Combined Security Transition Command-Afghanistan (CSTC-A) officials, USACE confirmed that the repairs needed to allow for parallel operation of the generators were made in Phase III.

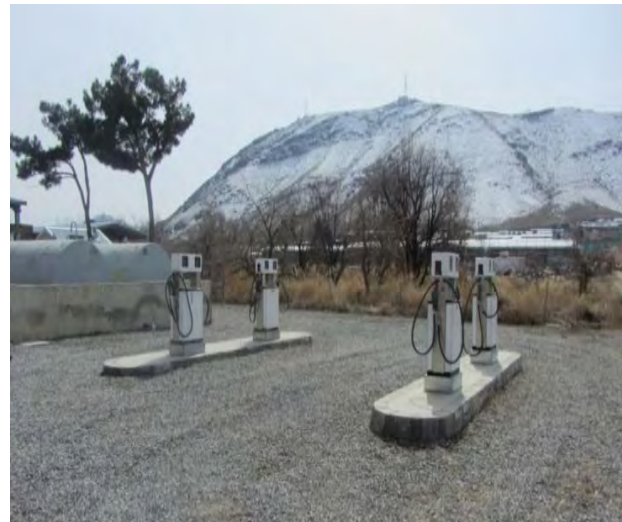
Photo 2 - Fuel Point with Tanks and Pumps

Camp Commando's Phase II fuel point was expected to provide a centralized location for refueling ANA vehicles and to improve accountability for fuel. The contract required the fuel point to have fuel pumps, 38,000 liters of diesel storage capacity in two above-ground tanks, and 1,000 liters of motor fuel in above-ground storage tanks.¹⁰ The storage facilities were to be built within a concrete containment area (see photo 2).

While all of the components were provided and the fuel point was constructed, we found that the fuel pumps were not operational and, at the time of our inspection, had not been tested and commissioned as the contract required. This deficiency was noted on the DD Form 1354 on April 7, 2012, and neither USACE nor CSTC-A could demonstrate that testing and commissioning ever occurred.¹¹ However, USACE letter C-0015, dated February 17, 2013, stated that the Phase II work had been completed and all issues had been resolved. As stated previously in this report, USACE asserts that the pumps were tested and commissioned. Nevertheless, our two site inspections in 2014 confirmed that the fuel pumps were not operating and had not been tested and commissioned. Further, due to the inoperable fuel pumps, USACE could not have checked for deficiencies within key operational systems, such as the leak detection and auto-close pump nozzle systems. As discussed later in this report, although this fuel point was never fully operational, the U.S. government has built a second fuel point for the ANA on Camp Commando under the Phase III contract.

Our inspection revealed, and ANA officials confirmed, that the camp has never used the fuel point as intended, and, specifically, has never used the fuel pumps. During our site visits, ANA officials told us that—in addition to the fuel pumps not being tested and commissioned—another reason for not using the fuel point was that sufficient space did not exist between the fuel pump islands for vehicles to access the pumps. During our April 2014 inspection, we took measurements and confirmed that the fuel pump islands were properly positioned according to the construction drawings and that sufficient space existed for vehicle access, including large vehicles such as Mine-Resistant Ambush Protected vehicles. Still another reason ANA officials cited for not using the fuel point was its close proximity to the fire station, which they said violated building codes. However, we were unable to find language in the International Building Code that would prevent these two structures from being located near each other. Lastly, ANA officials told us that although they have not used the fuel pumps, they have been using the fuel point's two diesel storage tanks to store fuel.

The CSTC-A officials noted that they were not aware of any known issues preventing its use. USACE officials noted that the fuel point was usable, with one exception. In October 2014, USACE officials stated that the manufacturer did not program the pumps with the necessary coding information, and, as a result, there was no ability to pump fuel through the system. However, in comments on a draft of our report in December 2014, USACE noted that the fuel point constructed in Phase II was fully operational. Despite the conflicting assertions by USACE, our inspection clearly showed that the fuel pumps were never operational and that even though the fuel point—which cost \$332,000 to construct—has never been fully used as intended, a second, larger fuel point was being built by a new contractor under Phase III at the time of our February and April 2014 site visits. According to USACE officials, the cost to construct the new fuel point was approximately \$1 million. In October 2014, USACE officials told us that the new fuel point had been completed, but, for reasons unknown to them, it also had not been used. In its comments on a draft of a report, USACE stated that the ANA needs a centralized fuel point for all garrison tenants to enable the ANA to manage and track its fuel consumption. In addition, USACE commented that CSTC-A will continue to train, advise, and assist the ANA in proper fuel management.
