SIGAR 17-36 Inspection Report

**Baghlan Prison: After More Than 3 Years,
Structurally Damaged Buildings Have Not
Been Repaired, and New Construction
Deficiencies Have Been Identified**

APRIL
2017

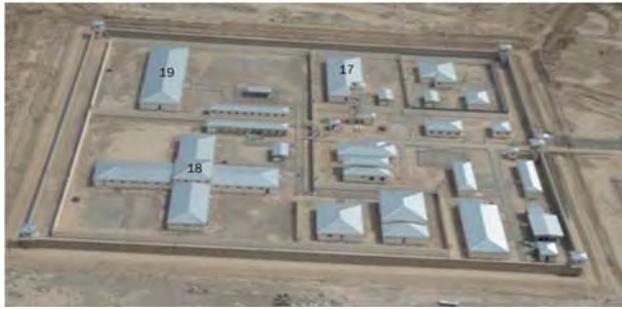
Photo 1 - Baghlan Prison's Most Damaged Buildings

Notes: Building 17 is the detention center, building 18 is the men's barrack, and building 19 is the maximum security barrack.

In May 2014, INL contracted with Hask Engineering Services (Hask), an Afghan firm, to conduct a geotechnical and materials study to document the existing soil conditions at the facility and the materials that OHG used in its construction. INL believed that the study would allow it to determine the underlying causes of building settlement and to identify any further actions that may be required to address existing soil conditions. Hask completed the study in July 2014 and concluded that severe collapsible soils were identified under damaged buildings 17, 18, and 19.

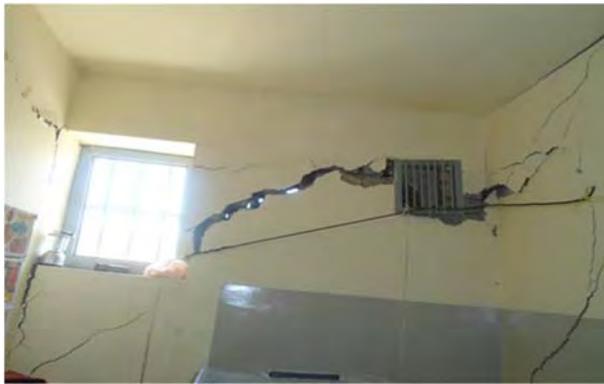
Photo 2 - Example of Structural Damage to the Detention Center

In May 2014, we reported that after the Baghlan prison was completed, the settlement of soil underneath the facility caused structural damage to three buildings. As a result, OHG demolished one building and indicated that the two others with collapsing walls would likely need to be rebuilt. Photo 1 shows an aerial view of the prison and identifies the most seriously damaged buildings—the detention center (17), men's barrack (18), and maximum security barrack (19). Photo 2 shows some of the damage to the detention center, which OHG mostly demolished in January 2014 due to safety concerns.⁴

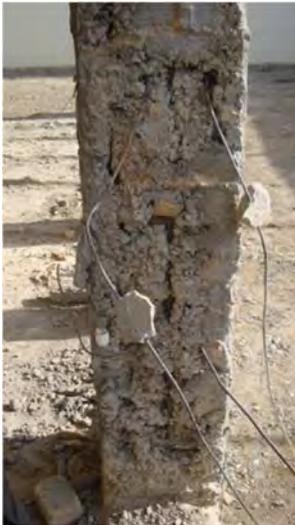
Photo 3 - Improperly Cast Concrete Support Column at the Detention Center Before Demolition

Suraya’s design drawings for the Baghlan prison called for concrete moment frame construction throughout the facility.¹⁰ Under this type of construction, beam-column joints are designed to resist the flexing, axial, and shearing actions that result as a building sways during an earthquake. One industry standard for this form of construction requires concrete support columns to be cast in a manner that results in a solid fill with no gaps or loose aggregate.¹¹ Based on photos of the detention center that INL gave us in April 2014, it is evident that the concrete for at least one support column was not cast properly, thereby potentially compromising the structural integrity of the building. The column in question had large voids because the concrete did not fill the spaces around the vertical reinforcing bars, stirrups, and aggregate. This effect is referred to as “honeycombing,” which is generally caused by using improper or faulty concrete vibrators, improper placement procedures, poor vibration procedures, inappropriate concrete mixtures, or congested reinforcement. Photo 3 shows a concrete column in the Baghlan prison’s detention center before it was demolished, and photo 4 shows an example of a properly cast column at Herat University.

In a written response to us, INL agreed that photo 3 indicates a significant amount of unacceptable material and honeycombing within the column. INL further noted that State made this point explicit in its January 2015 response to the cure notice, which stated, “Failed concrete core tests and photographic evidence of poorly constructed support columns supports the opinion that OMRAN Holding Group took shortcuts and did not construct the prison according to approved plans and specifications.” In its response, OHG did not accept responsibility for the defective workmanship.

- 3. Prepare or commission a study of the concrete support column and infill wall construction deficiencies to determine the extent of those problems and submit the results to the contracting officer to consider when making the final decision on whether to take any action against OHG.**

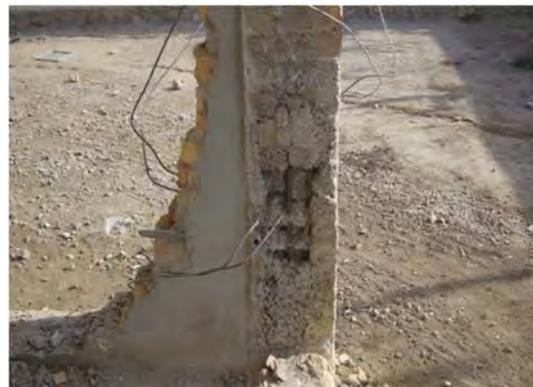
Photo 5 - Demolished Detention Center Wall with No Isolation and Connector Joints

Based on demolition photos for the detention center, it is clear that the masonry infill walls were not isolated, through the use of isolation joints, from vertical and lateral loads of the moment frame. Photo 5 shows an example of

INL agreed that by not following American Concrete Institute specifications for the separation of the columns and infill walls, OHG produced a structurally deficient wall. This has created the potential for structural failure of the brick infill walls. INL recorded this deficiency in its September 2013 structural damage report and notified OHG of its responsibility to take corrective action in the October 2013 cure notice. According to INL officials, OHG has not accepted responsibility for this defective workmanship.
