SIGAR 18-01 Inspection Report

**Kabul Military Training Center Phase IV:
Poor Design and Construction, and Contractor
Noncompliance Resulted in the Potential
Waste of as Much as \$4.1 Million in Taxpayer
Funds**

**OCTOBER
2017**

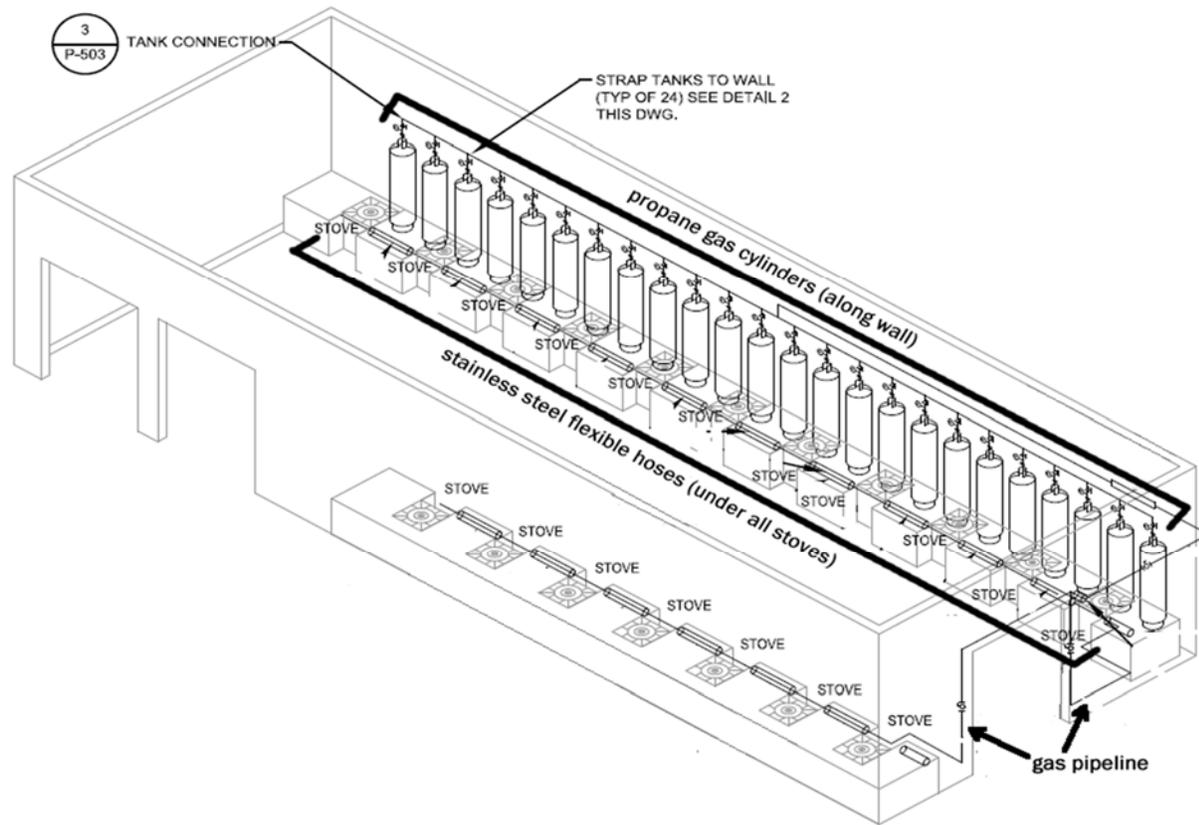
Figure 1 - Configuration of the Gas Supply System for DFAC 510’s Kitchen

However, USACE did not follow the NFPA standards. Specifically, USACE developed and approved technical specifications that called for “zero clearance” between the propane gas cylinders and the DFACs, which violates NFPA requirements.⁸ We found that all 54 100-pound gas cylinders—24 for DFAC 510 and 30 for DFAC 511—were located flush against the outside wall of the kitchens where gas stoves were located (see figure 1 for DFAC 510’s kitchen configuration). In addition, we found that the gas cylinder storage area contains exterior lights, which are ignition sources and could cause an explosion if gas is released. As a result, the location of these gas cylinders creates a safety hazard to kitchen workers and personnel eating in the DFACs.⁹

In March 2017, USACE told us the gas supply system’s configuration is a safety issue only if the gas cylinders rupture, thereby allowing gas to escape. USACE also told us that because the gas cylinders are outside the building, air circulation is not a problem. However, NFPA 58 does not make a distinction about whether air circulation negates the requirement for a minimum distance between a building and gas cylinders. Additionally, NFPA 58 prohibits ignition sources within 10 feet of propane gas tanks. Further, USACE did not provide us with any documentation approving a deviation from the NFPA standards or contract requirements. In July 2017, in its written comments to a draft of this report, USACE stated that placing the propane gas cylinders next to the building was a violation, and, as a result, the contract requirements did not comply with NFPA 58.

- a. move the propane gas cylinders at least 10 feet away from the walls of DFACs 510 and 511;
 - b. replace all welded connections used on pipelines 50 millimeters or less in diameter that are supplying propane gas in DFACs 510 and 511 with threaded connections;

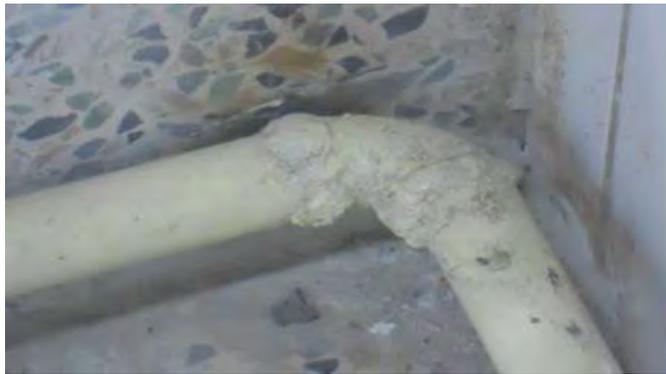
Photo 1 - Poorly Welded Gas Pipeline Connection Inside DFAC 510's Kitchen

The contract's technical specifications and NFPA 58 required that the pipelines supplying propane gas to the DFAC kitchens use threaded connections if the pipe diameter is 50 millimeters or less and welded connections if the diameter is greater than 50 millimeters. Welded connections have a higher potential to crack than threaded connections, and, as a result, have a higher potential for allowing gas to escape. USACE told us the DFAC gas lines varied in size between 13 and 64 millimeters and that because it did not know the location of the welded pipeline in photo 1, it could not comment on whether it was more than 50 millimeters. However, we found that all the propane gas pipelines were welded together inside DFAC 510, and according to the design

documents, all of those pipes were 50 millimeters or less and therefore required threaded connections.

Our inspection of these welds also revealed poor workmanship with MegaTech applying too much welding rod material when connecting the pipes, which can clog the pipes and cause the joint to leak. Photo 1 shows a poorly welded gas pipeline in DFAC 510's kitchen.¹⁰ USACE acknowledged that the welds were "not the highest quality," but added that the performance of a weld is more important than its appearance. In May 2017, USACE told us the propane gas pipelines were pressure-tested and accepted, but it would consider replacing the welded pipes that were less than 50 millimeters. However, USACE has not

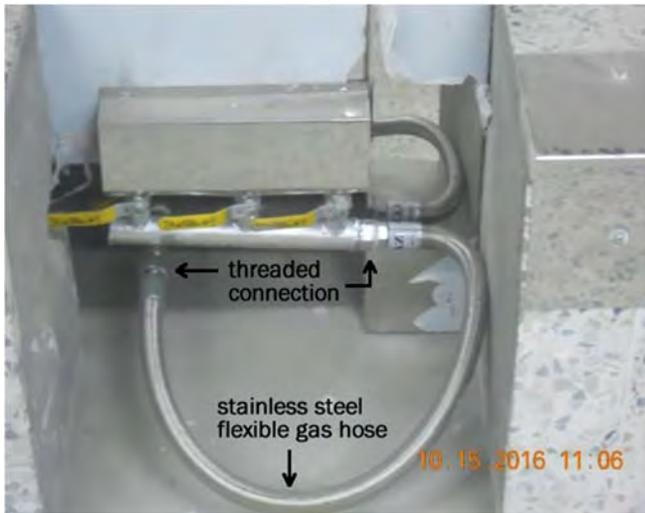
Photo 2 - Stainless Steel Flexible Gas Hose with Threaded Connections on Both Ends

The contract's technical specifications required the gas supply line's final connection to have quick disconnect devices. They safeguard against wear and tear when the hoses need to be cleaned or repaired because they are easier to disconnect and reconnect than threaded lines.¹¹ However, we found that the gas hoses were installed with threaded connections (see photo 2). Once the hoses deteriorate, which is more likely with threaded connections, they become difficult to reattach, which can result in the threads being stripped away over time. This can lead to gas escaping from the hoses and possibly result in an explosion. In May 2017, USACE said the flexible gas hoses used in the DFACs have one end with a threaded connection and the other end with a quick disconnect device. USACE also said that this configuration allows the entire stove assembly to be removed for cleaning while keeping the threaded connection intact, thereby nullifying safety concerns. However, we found that USACE approved MegaTech's product submittal for stainless steel flexible hoses for gas lines with noncompliant threaded connections on both ends in April 2016. USACE did not provide us with any documentation showing that it approved the deviation from the approved submittal, which required the use of quick disconnect devices instead of threaded connections.

- c. replace the threaded gas supply line's final connections to the DFAC kitchen stoves with quick disconnect devices;
 - d. move the gas line service valves and piping in DFAC 511 away from the electrical disconnect devices; and

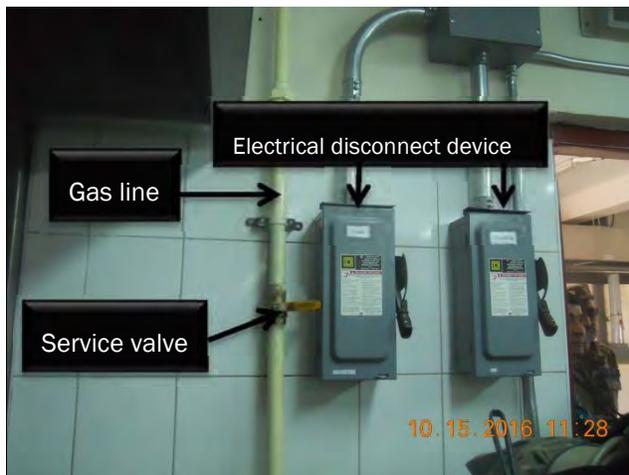
Photo 3 - Gas Line Service Valve Installed Inside DFAC 511 and Next to Electrical Disconnect Devices

Gas Line with Cut-Off Valve Was Installed Inside Instead of Outside DFAC 511 and Next to Electrical Disconnect Devices

MegaTech installed the gas line service valve for DFAC 511 next to the electrical disconnect devices, which violated the design drawings, NFPA 70, and the National Electrical Code. The placement of the service valve on the gas line inside DFAC 511 and next to electrical disconnect devices creates a safety hazard. Specifically, a gas leak—especially one through the service valve—plus a spark from the electrical disconnect device could cause an explosion. USACE could not provide us with any documentation showing that it approved the deviation from the design drawings. Photo 3 shows the service valve located next to the electrical disconnect devices inside DFAC 511.¹²

placing the gas line service valve next to electrical disconnect devices did not constitute a code violation. USACE said the gas line valve located inside the kitchen is a service valve, and the primary shut-off valve is located on the exterior of the building. However, Section 500.1 of the National Electrical Code prohibits the placement of electrical devices in close proximity to flammable gases and vapors, and it makes no distinction about the type of gas line or valve used.

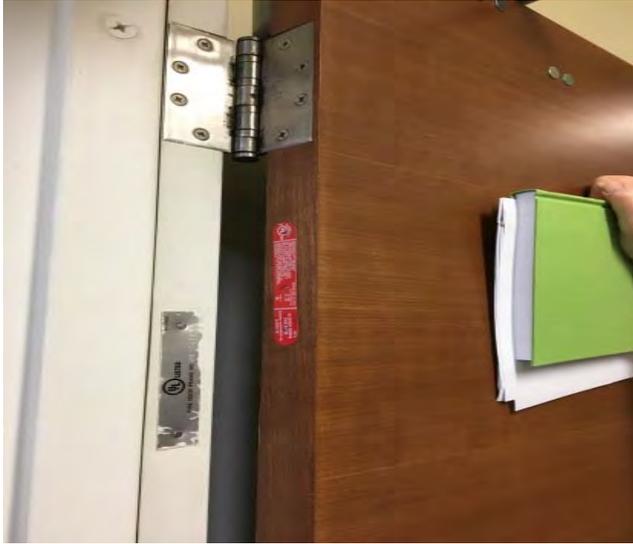
Photo 4 - Certified Fire Door Label Placed on Door and Doorframe

The Phase IV contract required the fire-rated door manufacturer to be certified by Underwriters Laboratory (UL), Factory Mutual Engineering and Research (FM), or Warnock Hersey International (WHI) to ensure that the doors meet UL and NFPA standards for withstanding fire conditions. Once a manufacturer’s product passes UL and NFPA tests, the manufacturer is considered approved, and its fire doors and other products that have passed the tests are listed in the certification agency’s directory of acceptable fire-rated products.¹⁵

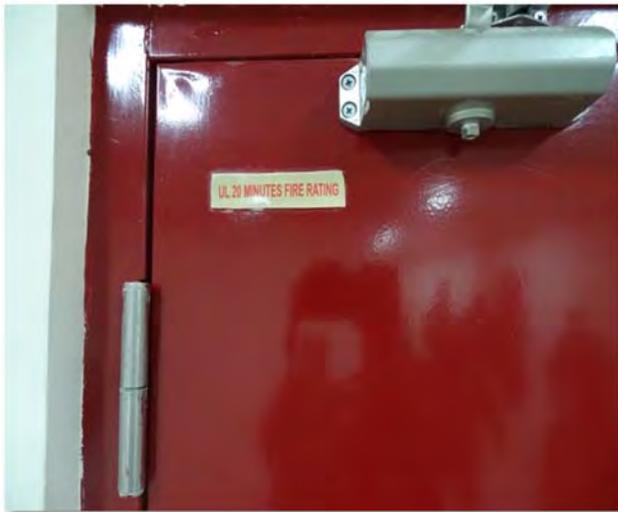
Photo 5 - Door at KMTC with Counterfeit UL Labels

- Forty-two doors in DFACs 510 and 511, and barracks 303, 304, and 523 had noncompliant labels attached to them. The labels had only the initials "UL" and a fire rating (see photo 5). We determined that the labels were noncompliant because they did not list the name of the manufacturer, Kent Corporation, or have raised letters. In addition, we found that Kent Corporation is not UL-, FM-, or WHI-certified. Because the labels are not compliant with contract requirements and the

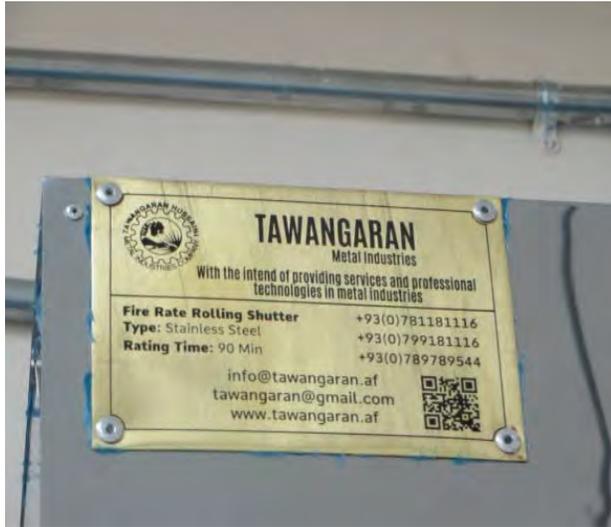
Photo 6 - DFAC 510 Door with Stated Fire Rating Time of 90 Minutes and No Certification

- Seven fire doors in DFACs 510 and 511 had labels that included the name of the manufacturer and a fire rating, but not the name of an authorized certifying agency, specifically UL, FM, or WHI (see photo 6). The doors were manufactured by Tawangaran Metal Industries, an Afghan company, but USACE did not approve them. In addition, Tawangaran Metal Industries did not have any products listed in the UL, FM, or WHI directories of acceptable fire-rated products.

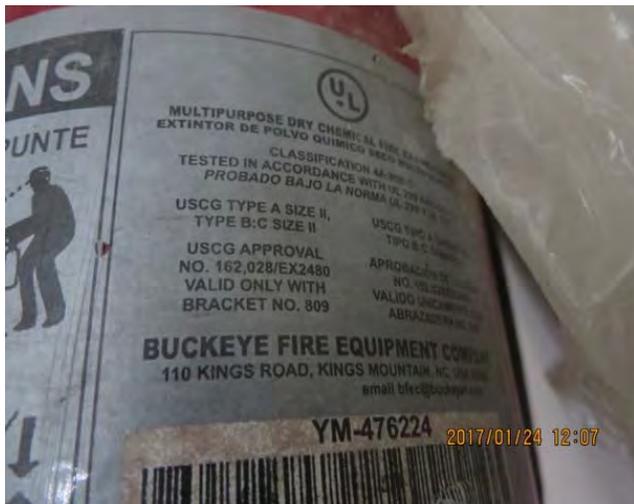
Photo 8 - Counterfeit Buckeye Fire Extinguisher in Storage Building without "S" Stamped in Label

During our site visits, we found that only 81 of the 88 fire extinguishers had been installed, including 17 that had counterfeit labels attached to them and 5 that Buckeye did not manufacture. The 17 fire extinguishers had physical characteristics that were not consistent with those made by Buckeye. For example, authentic ones have “S” stamped in the label (see photo 7). If the stamp is not in the label, it indicates that the fire extinguisher is counterfeit. Photo 8 shows a KMTTC fire extinguisher with no “S” stamped in the label, indicating that Buckeye did not manufacture it, and, as a result, it is counterfeit.²⁰

MegaTech’s installation of 17 counterfeit fire extinguishers and 5 extinguishers not manufactured by Buckeye, and its failure to install 7 fire extinguishers resulted in USACE overpaying MegaTech by an estimated \$1,452.²¹ USACE could not provide us with any documentation showing that it approved a product submittal for fire extinguishers or that it modified the contract to allow the noncompliant ones.

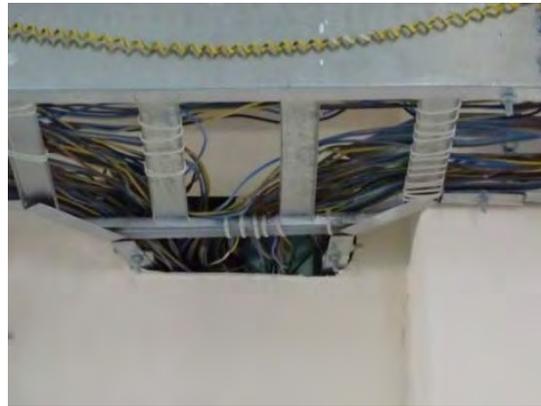
Photo 10 - Wall Opening with No Fire Stop in a Barrack

- **Fire stops.** The contract required fire stops to be used in the DFACs and barracks to form an effective barrier against the spread of flames, smoke, and gases, and to maintain the integrity of the fire-rated walls. Fire stops are used when holes are made in the walls to install wiring, air ducts, or other structures. A fire stop consists of foam, latex, or other flame-resistant materials, and it is used to fill the space in the hole so smoke and flames are less likely to travel from room to room. Photo 9 shows a compliant fire stop. We found that MegaTech did not install any fire stops in the new DFACs or barracks; photo 10 shows a wall opening in one of the barracks. In May 2017, USACE stated that the fire stop issue was under review and it was working to resolve the matter.

- e. install fire stops and correct the exit signage throughout the KMTC Phase IV facilities.
- 2. Examine all fire extinguishers and direct MegaTech to replace counterfeit or missing extinguishers.**
