SIGAR 18-09 Inspection Report

**Afghan Ministry of Defense Headquarters Security
and Support Brigade: Facility Construction
Generally Met Contract Requirements, but Three
Safety-Related Concerns Need to Be Addressed**

**OCTOBER
2017**

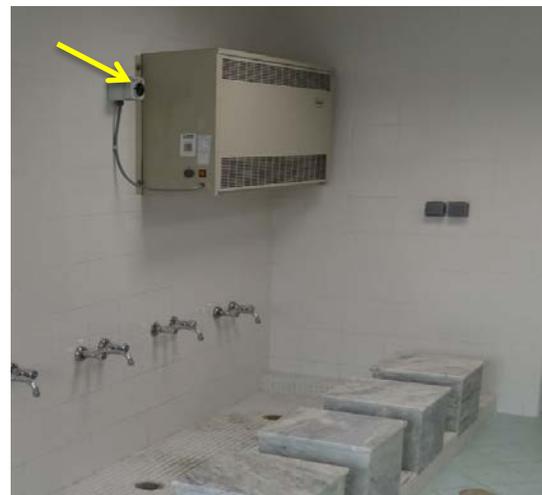
During our February 6, 2016, site visit, we found three electric heaters in the administration/barrack building that Gilbane Federal installed above the ablution washing stations.⁹ Our review of the as-built drawings showed that the electric heaters were installed in the location specified in the drawings.

AFCEC indicated that the installed electric heaters above the ablution washing station were acceptable because the design required ground fault circuit interrupter (GFCI) connections for the heaters in this wet area.¹⁰ However, we found that Gilbane Federal installed electric heaters with an on-off disconnect switch, instead of the required GFCI connection (see yellow arrow in photo 1). GFCI connections would protect people from severe or fatal electric shock if they operated the heater with wet hands or touched a heater with a ground fault, but the installed on-off disconnect switches would not.

that the HEPOL disconnect switches had GFCI safety features. Because the electric heater controls and disconnects are within reach of people with wet hands, people could be shocked or electrocuted if they touch a faulty heater with no GFCI device to stop the accidental flow of electricity through their wet hands and body. In its comments on a draft of this report, AFCEC stated that the heaters’ installation is consistent with the governing code. However, without GFCI protection, the electric heaters with disconnect switches in the ablution areas present a safety hazard to personnel there.

Photo 1 - On-Off Disconnect Switch for the Heater Installed Above an Ablution Washing Station

With respect to the GFCI connections, we disagree with AFCEC's statement that the disconnect switch is not a safety issue. As we note in the report, GFCI connections would protect people from an electric shock if they operate the electric heaters with wet hands or touch a heater with a ground fault. The disconnect switch does not offer this protection. However, because the warranty period is over, AFCEC is not likely to recoup the cost for the GFCI connections that Gilbane Federal did not install. As a result, we revised recommendation one to

recommend that AFCEC update the as-built drawings, give these revised drawings to the MOD HSSB facility managers, and alert them of the potential risks.

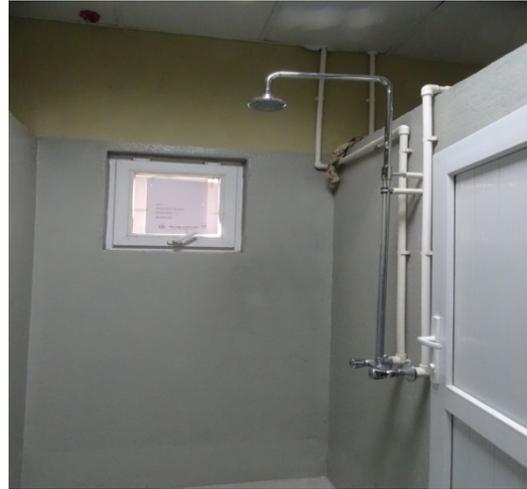
During our February 2016 site visit, we found that the hot water pipes in the medical clinic were not insulated as the contract required. According to the medical clinic's drawings, "All hot water piping shall be insulated." Hot water pipes are insulated to conserve energy and protect people exposed to them from being burned. AFCEC officials stated that the hot water heater would not deliver water that is more than 120 degrees. The "General Facility Requirements" paragraph in task orders 0049 and TG06 required the hot water temperature setting be 120 degrees Fahrenheit. Neither task order granted an exception for omitting insulation on the hot water pipes. However, we found uninsulated hot water pipes on the medical clinic's restroom walls that were within reach of occupants (see photo 2). As a result, both water and energy will be needlessly wasted before hot water reaches plumbing fixtures, and the pipes may become too hot and burn people who come into contact with them.

Photo 2 - Uninsulated Exposed Piping in the Medical Clinic

With respect to the uninsulated pipes, we disagree with AFCEC's assertion that the hot water distribution system may never exceed 120 degrees. Because the system does not have a temperature limiting device, the water temperature may rise above 120 degrees Fahrenheit, creating a safety hazard because the exposed hot water pipes are not insulated. However, because the warranty period is over, AFCEC is unlikely to recoup the cost for the insulation that Gilbane Federal did not install. As a result, we removed recommendation three and incorporated this issue into our revised first recommendation that AFCEC update the as-built drawings to reflect as-built conditions, and give the revised drawings to the MOD HSSB facility managers.

SIGAR Comment 9: We do not agree with AFCEC’s assertion that the hot water distribution system may never exceed 120 degrees. Because the system does not have a temperature limiting device, the water temperature may rise above 120 degrees Fahrenheit, creating a safety hazard because the exposed hot water pipes are not insulated. However, because the warranty period has expired, AFCEC is unlikely to recoup the cost for the insulation that Gilbane Federal did not install. As a result, we eliminated recommendation three and incorporated this issue into our revised first recommendation that AFCEC update the as-built drawings, give the revised drawings to the MOD HSSB facility managers, and alert them of the potential risks.

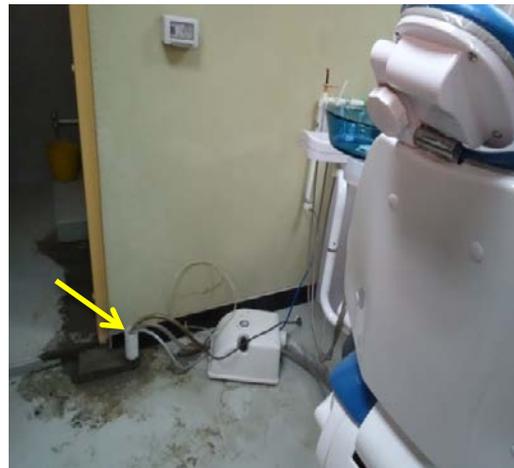
Furthermore, the dental room on the ground floor was not constructed with a floor drain. The approved design did not require it, but a drain was needed for the wastewater from dental equipment. The clinic's staff mitigated this deficiency when they moved the dental office to a doctor's office with an adjoining latrine. They created a floor drain by cutting the concrete floor and installing a drain line for the dental equipment and tying it into the latrine's waste line (see photo 3). The lack of adequate planning and coordination with Afghan personnel during the early stages of the medical clinic's design ultimately resulted in the medical staff switching offices to meet their needs.

Photo 3 - Dental Office Moved to Doctor's Office where Plumbing Drain Line for Equipment Is Connected to Floor Drain in the Latrine

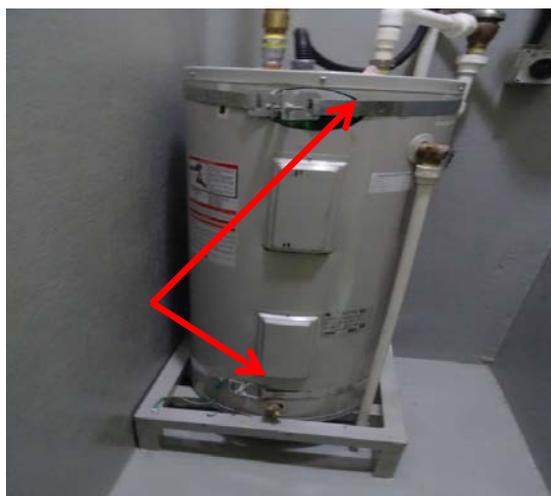
During our February 2016 site visit, we found that the water heater on the first floor of the medical clinic was installed with seismic straps in accordance with the design drawings (see photo 4).¹² However, we found that the water heater on the ground floor was mounted on the wall close to the ceiling with no seismic straps. According to an Afghan official, the ground-floor water heater that we observed mounted on the wall was a replacement water heater that RPC Aldridge Company, an Afghan contractor, installed during the warranty period. In their comments on a draft of this report, AFCEC and CSTC-A stated that RPC Aldridge Company did not install any water heaters under the three task orders and the company was a subcontractor to IDS, the MOD's operation and maintenance contractor. They also stated that the U.S. government did not pay for this replacement water heater or its installation.

Photo 4 - First-Floor Water Heater Correctly Installed on the Floor with Seismic Straps

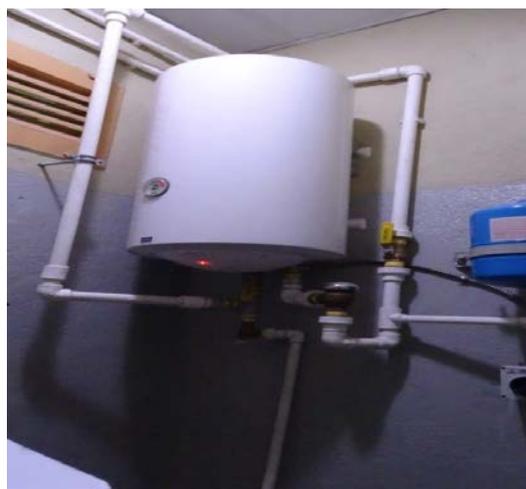
Installing the water heater on the wall without seismic straps does not conform to the contract drawings and fails to meet International Plumbing Code requirements (see photo 5).¹³ This also creates a safety hazard because Kabul experiences frequent seismic activity. Therefore, the personnel in the clinic may face increased risk of injury if the heater falls over.

Photo 5 - Ground-Floor Water Heater Incorrectly Installed on the Wall Without Seismic Straps

Regarding the fourth recommendation to install seismic straps on a ground-floor water heater, CSTC-A and AFCEC stated that the U.S. government did not pay for this replacement water heater or its installation. As a result, we removed this recommendation from the report.

SIGAR Comment 10: According to the information we obtained, RPC Aldridge installed the replacement water heater. Furthermore, in their comments, CSTC–A and AFCEC stated that the U.S. government did not pay for this replacement water heater or its installation. As a result, we revised the report to reflect that this is an operation and maintenance issue and eliminated recommendation four.
