**SIGAR 18-63 Inspection Report**

**Wardak Prison: Inadequate Department of  
State Oversight and Contractor Non-Compliance  
Have Increased Safety and Health Risks and  
Resulted in Wasted U.S. Funds**

## Wardak Prison: Inadequate Department of State Oversight and Contractor Non-Compliance Have Increased Safety and Health Risks and Resulted in Wasted U.S. Funds

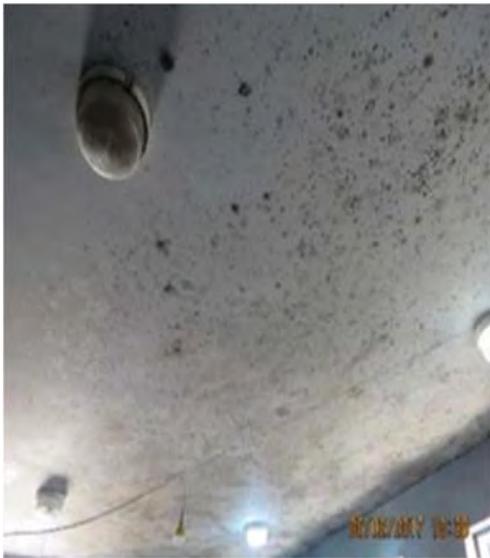
The International Mechanical Code states that occupied buildings should have natural or mechanical ventilation to ensure that there is adequate airflow and exchange. However, we found that the prison design did not provide for any mechanical ventilation systems within the prison complex. As a result, mold is growing on the ceilings and walls of staff and inmate work and living spaces (see photos 1 and 2). This mold can negatively affect the health of staff and inmates.

**Photo 1 - Ceiling Mold at the Inmate Housing Clinic Building**

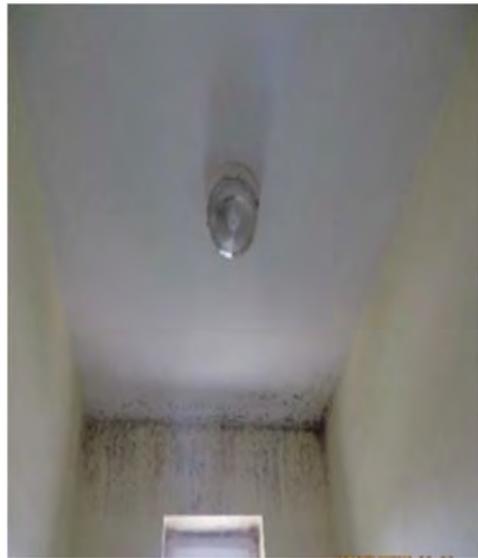
**Photo 2 - Ceiling and Wall Mold at the Juvenile Housing Building**

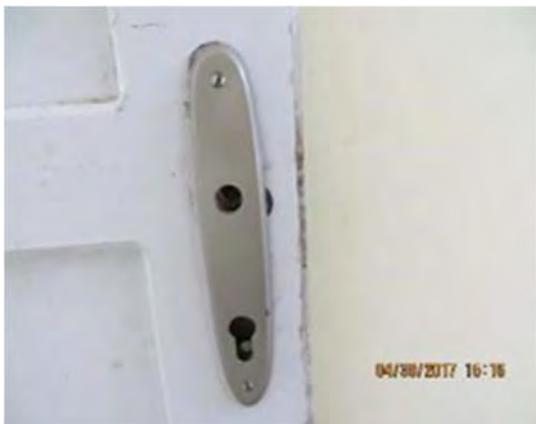
The contract's technical specifications required ARAO to install detention-grade hardware—specifically, locks, latches, handles, and hinges—on all doors throughout the Wardak prison. However, we found that ARAO installed ordinary, less durable door hardware, and we saw broken hardware throughout the prison (see photos 3 and 4). Ordinary, non-detention-grade door hardware breaks more easily than detention-grade hardware, and increases replacement costs. In addition, the broken hardware could be used as improvised weapons.

**Photo 3 - Broken Door Hardware in the Dining Hall Building**

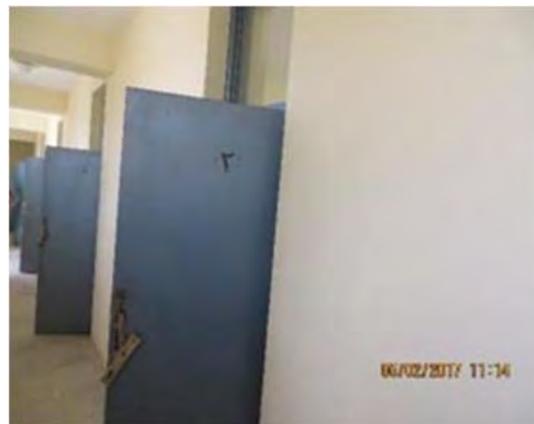
**Photo 4 - Broken Door Hardware in the Family Visitation Building**

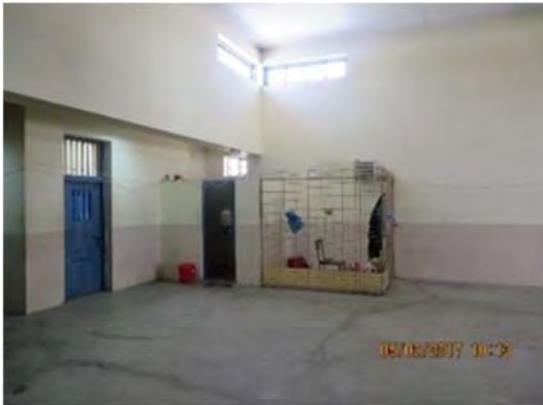
The contract's technical specifications required ARAO to install expansion and control joints in the floors and walls of all buildings the Wardak prison. These joints absorb stresses resulting from expansion and contraction due to changes in the concrete's temperature. We found that ARAO did not install expansion and control joints in any of the prison buildings. As a result, cracks have developed in multiple buildings, such as the male detention building and the industrial building (see photos 5 and 6). These cracks can multiply over time and weaken the integrity of the walls and floors, creating both unsightly and unsafe conditions.

**Photo 5 - Cracks in the Male Detention Building's Floor**

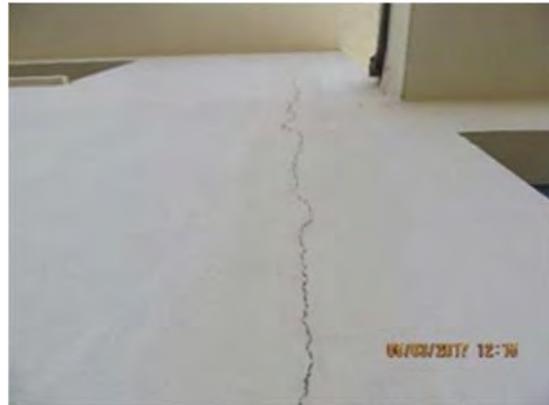
**Photo 6 - Cracks in the Industrial Building's Wall**

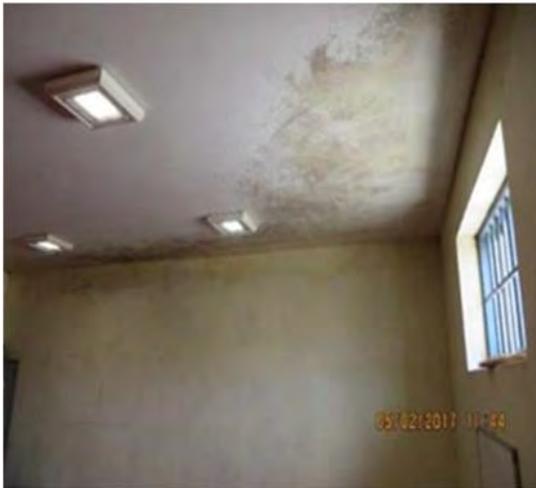
The contract's technical specifications required ARAO to install watertight building roof assemblies. However, we found that ARAO did not install these assemblies on buildings throughout the facility. As a result, water is penetrating the roof slabs and staining the ceilings (see photos 7 and 8). In addition, because the water is accumulating, the ceilings are staying moist, causing mold to grow in some places and creating a health hazard for building occupants. Wet conditions can also promote corrosion of the roof slabs' concrete steel reinforcing bars.

**Photo 7 - Water Damage to the Male Detention Building's Ceiling**

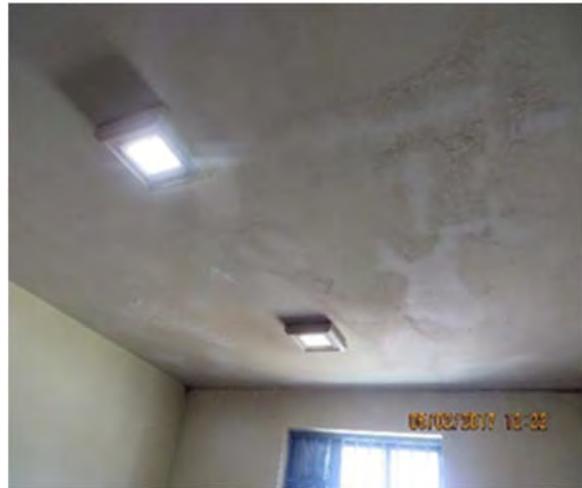
**Photo 8 - Water Damage to the Female Detention Building's Ceiling**

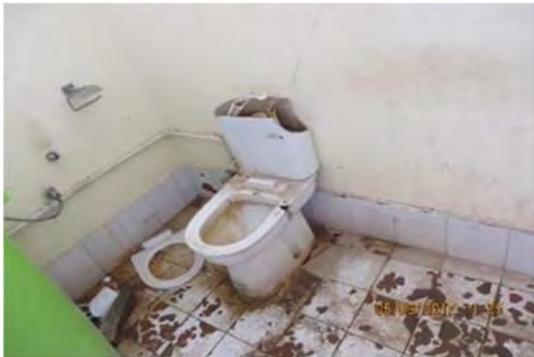
We also found that the Wardak prison is not being adequately maintained. For example, we found broken plumbing fixtures, missing floor tiles, broken electrical fixtures, and exposed electrical wiring (see photos 9 and 10). According to a senior prison official, prison personnel do not conduct routine maintenance. A senior prison official told us that INL made provisions to maintain the prison for 6 months after project turnover. However, the MOI is now responsible for the prison's maintenance. The official also stated that he does not have enough maintenance staff and needs at least four personnel to cover the necessary mechanical, plumbing, electrical, and structural maintenance of the prison.

**Photo 9 - Broken Toilet in the Guard Quarters Building**

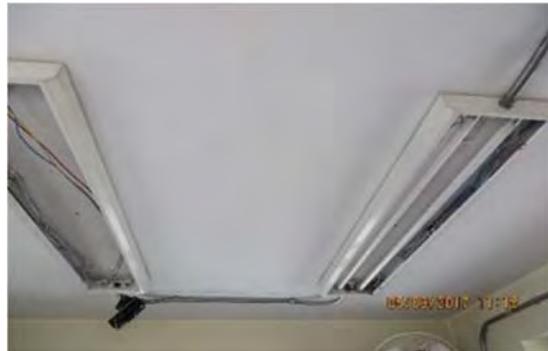
**Photo 10 - Broken Light Fixtures in the Guard Quarters Building**
