**SIGAR 19-04 Inspection Report**

**Afghan National Police Women's Compound  
at the Ministry of Interior: Construction  
Generally Met Requirements, but Use and  
Maintenance Remain Concerns**

OCTOBER  
2018

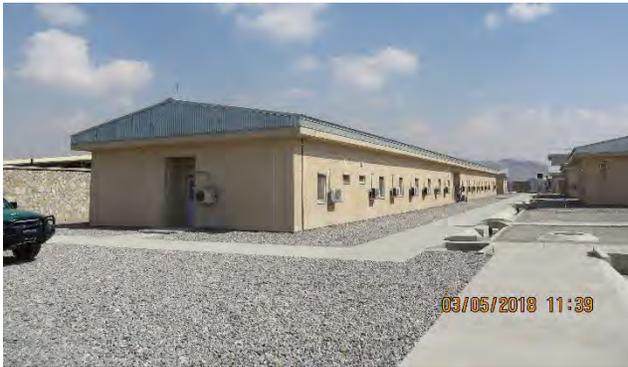
**Photo 1 - Barrack at the ANP Women's Compound**

We visited the ANP women's compound on November 15, 2017, five times from March 5 through 17, 2018, and on April 8 and 23, 2018. We found that ACCU generally constructed the facilities in accordance with the contract requirements. For example, photo 1 shows the barrack, which ACCU constructed according to floor plans and with the specified number of rooms. Further, all windows, doors, and heating and cooling units were installed and working properly, with the exception of doors that did not have the required thumb latches on the inside. As another example, we found that the administration building contained the required number of offices, and each office was built as designed. We also found that the heating, cooling, and electrical systems in the buildings were installed and working properly. In addition, the latrine facility contained the required number of toilets and sinks, and the facility had running water. Further, ACCU constructed the stone veneer

perimeter wall with entrance gates according to contract specifications. Lastly, none of the facilities had visible signs of defects in the floors, walls, or ceilings.

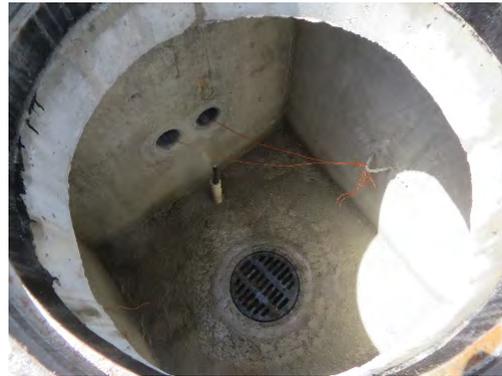
**Photo 2 - Communications Manhole With No Cable Racks**

- 
3. ACCU did not install cable racks in the communication manholes.

The contract's technical specifications and design drawings required cables to be supported by galvanized metal cable racks installed on the walls of the communication manholes. These racks were to have a plastic coating over the galvanized metal and be equipped with adjustable hooks and insulators.<sup>a</sup> However, as shown in photo 2, ACCU did not install cable racks, and the cables hang loosely. As a result, the cables may sit in rainwater and be a safety risk for maintenance workers.

On June 10, 2018, USACE provided us with a written response to the list of deficiencies and stated that it would direct ACCU to take corrective action if the deficiencies were valid. USACE also stated that it would send its local national quality assurance representative to the site to take photos and investigate the deficiencies. On July 20, 2018, USACE provided us with documentation, including photos, confirming that the seven deficiencies were valid and showing that ACCU had taken corrective action to address four of them along with the four items with operational issues. Then, on August 28, 2018, USACE provided us with documentation and photos approving ACCU's material requests and confirming that the contractor had installed those materials to correct the remaining three deficiencies.
