SIGAR 19-09 Inspection Report

**Afghan National Army Camp Commando
Phase III: Facility Construction and Renovation
Generally Met Contract Requirements, but
Three Construction Deficiencies Increased
Safety Risks**

**DECEMBER
2018**

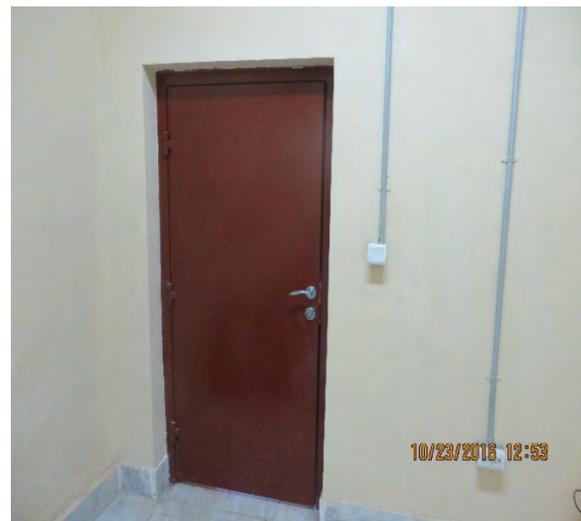
Photo 1 - Non-Fire-Rated Door Installed in Renovated Training Classroom Building 402

We also found that ECC installed 40 interior doors in the renovated buildings. However, the doors were not manufactured by Changchun Zhucheng or any other company approved to manufacture certified fire-rated doors (see photo 1). The contract's technical specifications and design drawings required the 40 interior doors to be fire-rated for intervals of 20 to 45 minutes, depending on their location within the buildings. In addition, the technical specifications required door, frame, hardware, and other components of the fire door assembly to be (1) manufactured to the specifications needed to withstand a fire, (2) tested to National Fire Protection Agency or UL standards, and (3) certified by one of the independent testing agencies.

USACE photos, door product data, and daily reports confirm that ECC installed noncertified interior doors manufactured by Omran Steel Tech, an Afghan company, in the renovated buildings. We reviewed ECC's fire door submittals and found that USACE approved the Omran Steel Tech fire doors even though the company is not certified by one of the three independent testing agencies. USACE's approval of these noncertified doors raises safety concerns for occupants of the renovated buildings. We could not determine how much the Omran Steel Tech doors cost because the cost was combined with other construction items. Therefore, we could not determine whether USACE overpaid ECC for the noncertified doors.

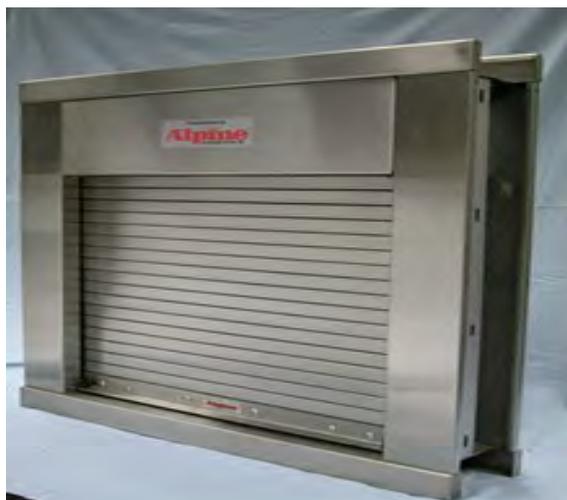
Photo 2 - Certified Fire-Rated Rolling Counter Door Manufactured by Alpine

ECC's product submittal proposed using "Fire-Shut" rolling counter doors from Alpine, an American company, and the submittal showed that Alpine's proposed products complied with the contract requirements (see photo 2). In December 2013, USACE approved ECC's submittal for the Alpine doors. However, ECC did not install those doors in the DFAC. After reviewing photos we provided on March 9, 2017, an Alpine representative told us the doors were not Alpine's products. Instead, ECC installed noncertified rolling counter doors from an unknown manufacturer (see photo 3). After we informed USACE about the product substitution, USACE contacted Alpine to determine whether ECC had purchased fire-rated rolling doors from the company. Alpine informed USACE that it could not find any records showing that ECC had purchased its doors. USACE acknowledged that ECC substituted doors that did not meet the contract requirements and that its quality assurance process did not discover the deficiency.

An Alpine representative told us the Alpine rolling door in photo 2 costs \$3,481. Based on our research in the Kabul market, we found that the cost of a rolling door similar to the one in photo 3 is about \$1,550. However, we could not determine whether USACE paid ECC the higher amount because the costs for the doors were combined with other contract costs.

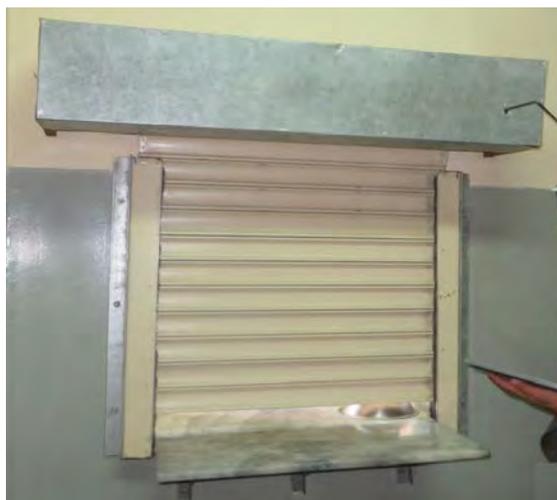
Photo 3 - Noncertified Rolling Counter Door Installed in the DFAC

ECC constructed a 2-hour-rated firewall separating the kitchen, food preparation, and dishwashing area from the serving and dining areas, as the contract required. The construction contract also required ECC to install two labeled, 90-minute, fire-rated rolling counter doors certified by an independent testing agency complete with hardware, accessories, and an automatic closing device. However, we found that ECC installed noncertified rolling counter doors, which increases the risk of death or injury to DFAC staff and soldiers dining in the facility should a fire occur.

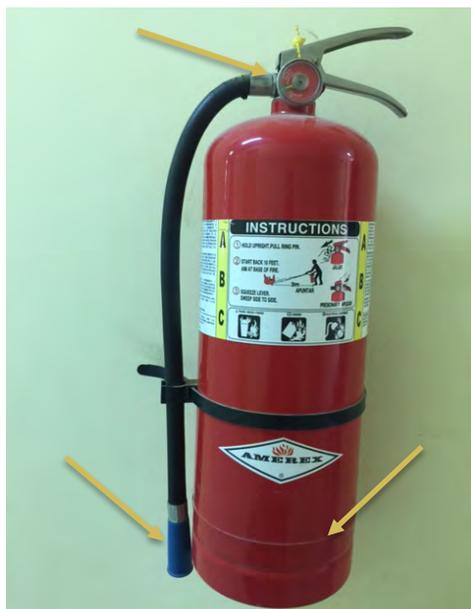
Photo 4 - Counterfeit Amerex Fire Extinguisher

We inspected each of the 27 fire extinguishers and found that 8 were not made by Amerex and had been installed after the facilities were turned over to the Ministry of Defense. We determined that the remaining 19—installed in 11 buildings—were counterfeit Amerex extinguishers because each had six to eight counterfeit

indicators.⁶ None of the 19 fire extinguishers had a unique serial number on the UL label, and some of the UL labels had printing and spelling errors. Further, all 19 fire extinguishers had counterfeit pressure gauges, canisters with welds or seams, and non-Amerex nozzles and hoses. For example, some of the extinguishers had blue nozzles, which are not found on authentic Amerex extinguishers. In addition, we found extinguishers with two-piece canisters and rolled seams at the bottom instead of one-piece canisters with a straight, smooth finish—another characteristic of Amerex fire extinguishers.

Counterfeit fire extinguishers create a safety hazard because they may not work as intended if a fire occurs. For example, the extinguishers could accelerate a fire if they do not contain the proper fire suppressant materials. In addition, pressure gauges on counterfeit fire extinguishers may not function or may give false readings. Photo 4 shows a fire extinguisher installed at Camp Commando with at least three counterfeit indicators: seams near the bottom, a blue nozzle, and an off-center pressure gauge. Photo 5 shows an authentic Amerex fire extinguisher, which USACE approved for the Camp Commando facilities.

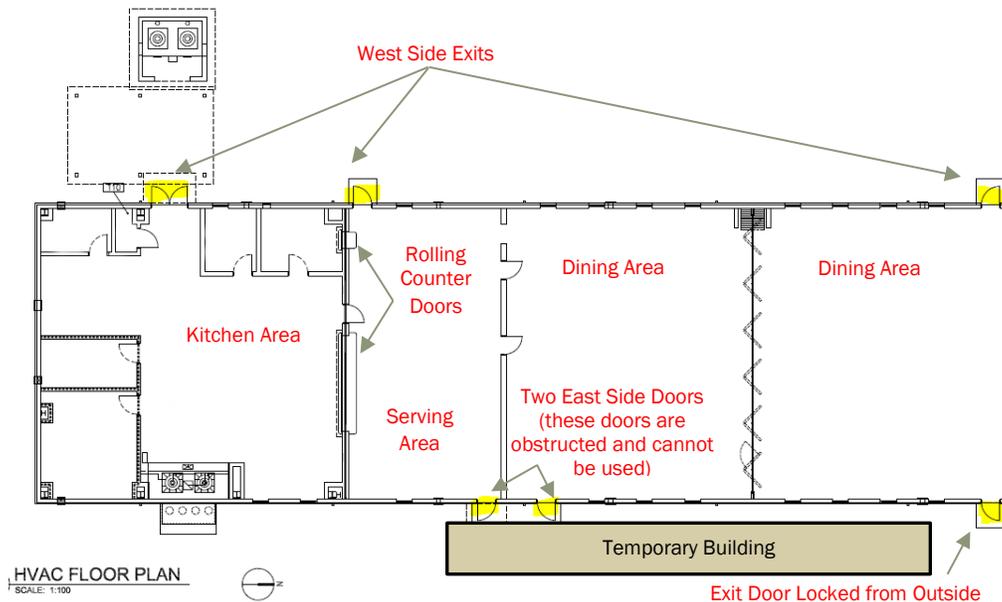
Figure 1 - Design Drawing of Camp Commando Phase III DFAC

ECC installed panic hardware on each of the six DFAC exit doors, as the contract required. Panic hardware, also known as an exit device, is designed to give building occupants fast, easy egress from buildings during an emergency, such as a fire. ECC constructed the DFAC with one exit in the kitchen, two exits in the serving area, and three exits in the dining area. Three of the exits are on the east side of the DFAC, and the other three are on the west side (see figure 1).

During our October 2016 and March 2018 site visits, we found that the panic hardware was broken on all three exit doors on the DFAC's east side and that slide bolts were added to lock the doors from the outside (see photo 6). According to DFAC staff, the three east side exits are locked at all times. As a result, occupants cannot use two exit doors from the dining area and one exit door from the serving area. In addition, during our March 2018 site visit, we found that a temporary building had been built next to the DFAC's east wall, which would prevent two of the exit doors—one from the serving area and one from the dining area—from opening even if they were unlocked. We also found that the panic hardware on all three doors on the west side of the DFAC was broken, and slide bolt locks had been installed on the outside of these doors. The facility manager told us the west side doors are locked when the facility is not in use, but unlocked when personnel are dining.

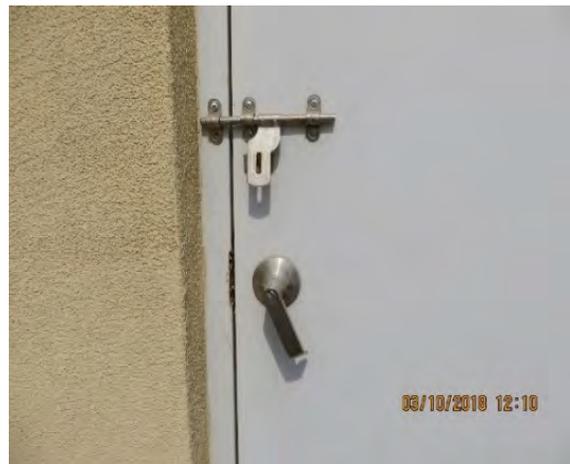
Photo 6 - East Side Exit Door Slide Locked from Outside

During our March 2018 site visit, we learned that the DFAC was serving between 400 and 450 personnel at each meal, even though it was designed to serve 218. This raises concerns about how quickly a staff this size will be able to evacuate through the one usable exit door on the west side of the dining area in the event of a fire or other emergency. In addition, we found that ECC installed two gas stoves in the DFAC as required and the Camp Commando staff added five more stoves. We also found that neither of the two heat detectors in the kitchen was functioning.

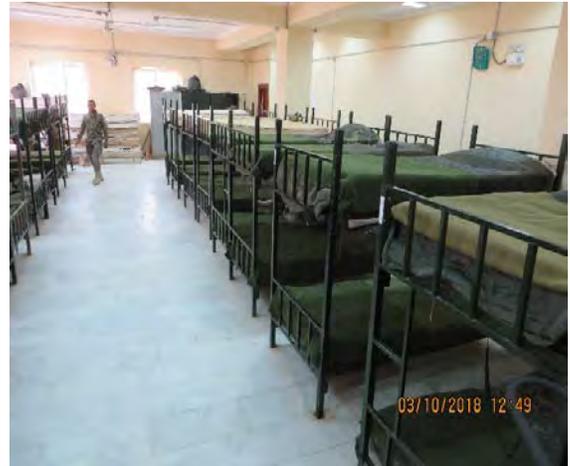
Photo 7 - Renovated Building 404 Used as Barrack Instead of Training Classroom Building

ECC renovated four existing buildings into training classrooms as the contract required.¹² During our March 2018 site visit, we found that two of the renovated buildings (402 and 404) were being used as barracks to house ANA personnel (see photo 7). An ANA official said the lack of adequate housing space for new Commando students made it necessary to convert the two buildings into barracks. This conversion occurred after CSTC-A transferred the phase III facilities to the Ministry of Defense. New students live in these barracks for 3 months, after which time they depart and are replaced by another group of students.

In accordance with codes for design and construction applicable to the contract, the renovated training classroom buildings were intended to be used for assembly purposes. However, they are now being used for residential purposes. The International Building Code and Life Safety Code have different design requirements for assembly and residential areas. Furthermore, the heating, ventilation, and air conditioning systems in these converted classrooms may not be able to provide adequate living conditions for occupants residing in the spaces for longer periods than originally intended.

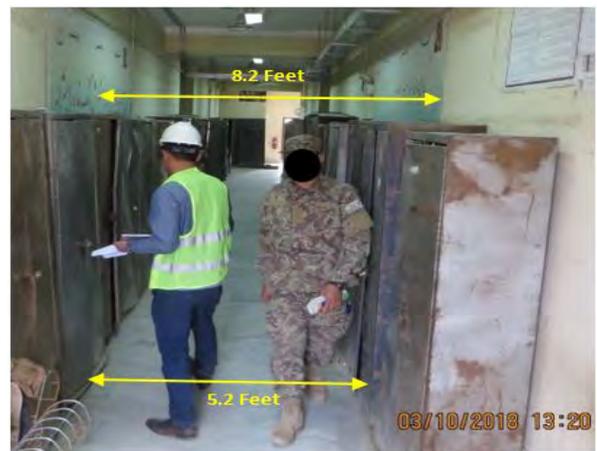
Photo 8 - Lockers on Both Sides of Corridor Walls in Renovated Classroom Building 402

Our greatest concern is that the occupants of the renovated Classroom Building 402 can exit only through an obstructed central corridor to a single exit door on the west end of the building and a double exit door on the east end. According to the design, the corridor should have an unobstructed width of about 8.2 feet, and 6.5 feet near the west exit because of the storage room. We found that ECC constructed the corridor according to these requirements. However, during our October 2016 site visit, we found that the ANA had installed lockers on both sides of the wall for the entire length of the corridor to serve as personal storage for the 244 students occupying the building. In March 2018, we saw that the lockers were still on both sides of the corridor. The addition of these lockers has reduced the corridor width to 5.2 feet (see photo 8). As a result, fewer building occupants can pass through the corridor simultaneously, which could increase safety risks in the event of a fire or other emergency.

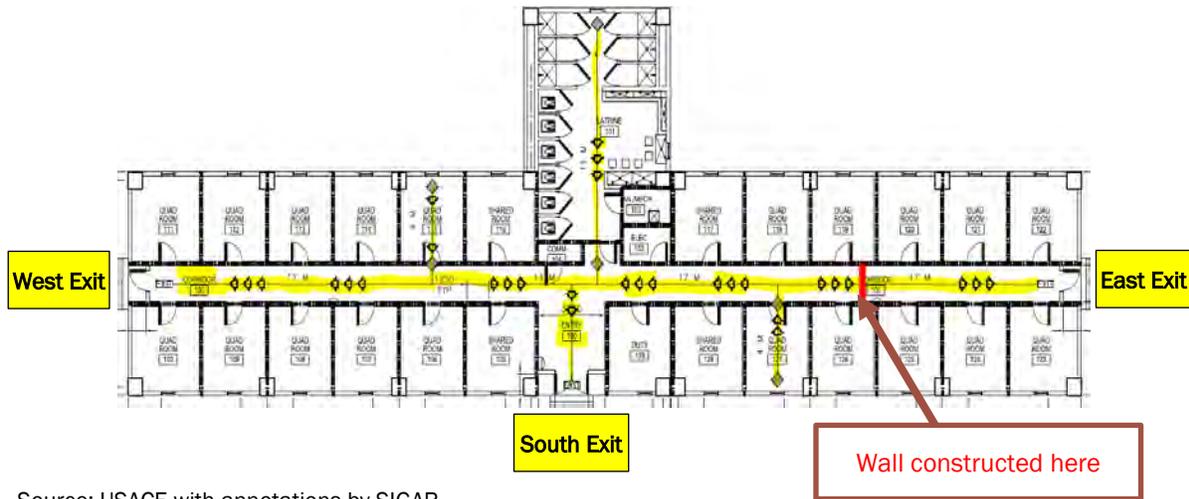
Figure 2 - Planned Egress Route in Noncommissioned Officers' Barrack 603

ECC constructed noncommissioned officers' Barrack 603 with three building exits in accordance with the design drawings. ECC installed a single exit door on the building's east and west ends, and a double exit door on the south end, which serves as the main entrance. The building's intended egress path is highlighted in yellow in figure 3.

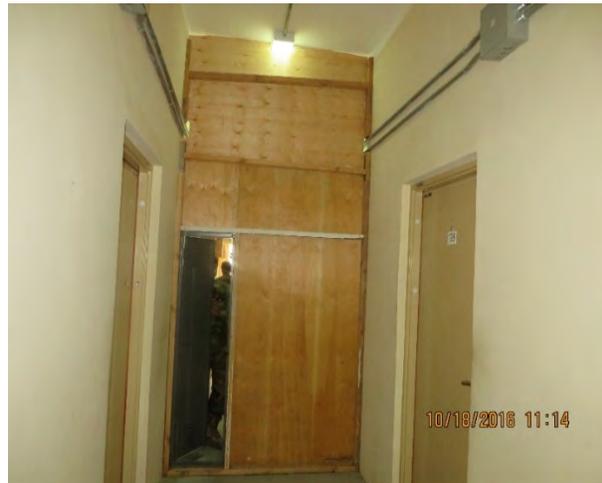
Photo 9 - Permanent Wooden Wall Blocking Main Corridor of Noncommissioned Officers' Barrack 603

During our June 2016 site visit, we found that ANA personnel had used furniture, bookcases, and boxes to construct a wall across the width of the corridor that restricted access to six rooms and the east exit. A locker door served as the entry to the restricted area. During our October 2016 site visit, we found that the ANA had replaced the makeshift wall with a permanent wooden wall and locker door for entry (see photo 9). An ANA official told us the ANA installed the wall and door to create a restricted area to use as a radio and communications room and planning area for special operations. However, the permanent wall and door have reduced the width of the egress path from the unrestricted area to the east exit from 67 inches to 17.8 inches. In addition, ANA officials deactivated the smoke detectors in that section of the building because the special operation equipment was causing the detectors to go off. The reduced size of the corridor and deactivated smoke detectors have created a safety hazard for building occupants.
