SIGAR 19-36 Inspection Report

Kang Border Patrol Headquarters: Construction Generally Met Contract Requirements, but Deficiencies Exist, and the \$5.2 Million Project Has Not Been Used or Maintained

APRIL
2019

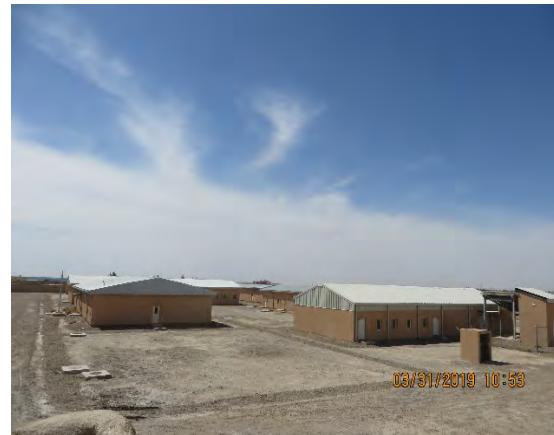
Photo 1 - Unused Buildings at the Kang Border Patrol Headquarters

During our August 2017 site visit, we found that none of the Kang Border Patrol headquarters' 29 newly constructed buildings and support facilities were being used. According to the Kang commander, the MOI decided not to use the new construction at the compound as a border patrol headquarters, but he did not provide a reason. As a result, the new construction has never been used since it was completed in February 2013 (see photo 1).
