SIGAR 20-21 Inspection Report

Kajaki Dam Irrigation Tunnel: The \$27.3 Million Tunnel Is Not Operating Properly Due to Construction Deficiencies and a Maintenance Issue

**JANUARY
2020**

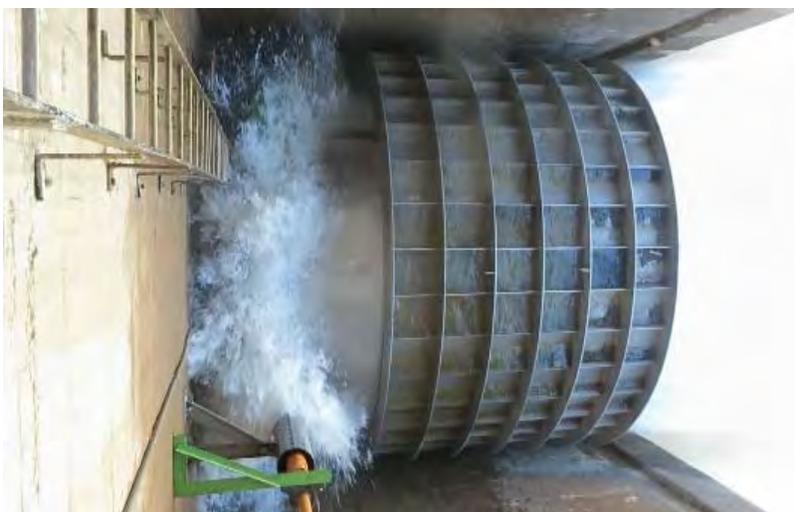
Photo 1 - New Cone Valve with Excessive Backsplash

Because the contract performance specifications required all cone valves to be functional from 0 to the 100 percent open position without backsplash and vibration, METAG still did not have a workable solution. In March 2017, USACE approved another METAG proposal to install a fixed hood over each cone valve to manage the water flowing backward from the aeration holes. However, this solution also proved ineffective, and USACE issued METAG a stop-work notice in April 2018. USACE suspended all construction work related to the cone valves due to the continued deterioration in their performance and the

associated damage the deficient performance was causing to ancillary equipment, specifically the actuator stem shafts, pressure sensor conduits, and access ladders.⁹

During our site visit, we observed that the backsplash increased as the valve opening percentage rose. Excessive backsplash not only forces the water backwards, it also floods the chamber, preventing access to the valve during an emergency. In addition, the constant flow of high-pressure backsplash exposed the cone valves, hoods, and other equipment to ongoing, unplanned, and severe vibration. This vibration on the valve body could cause the concrete pedestals supporting the valves or the valves themselves to crack. Further, in low temperatures, backsplash will cause ice to form, which could further degrade the cone valve's functionality.

In August 2018, USACE directed METAG to resume the work on the cone valves with a newly approved method designed to protect the actuator stem shafts, sensor conduits, and access ladders from backsplash. The approved method was to install new backflow protection devices. However, during our March 2019 site visit, we observed that excessive backsplash was still hitting the stem shafts, sensor conduits, and ladders, indicating that this new method was either ineffective or not completed. We also found that the valves did not close properly, or at all, when closing from an open position of greater than 60 percent. Despite these deficiencies, USACE accepted the deficient valves and hoods with excessive backsplash in September 2018.

- 1. Notify the MEW of the irrigation tunnel's two construction deficiencies and the maintenance issue so that the ministry can take whatever action it deems appropriate to correct them.**

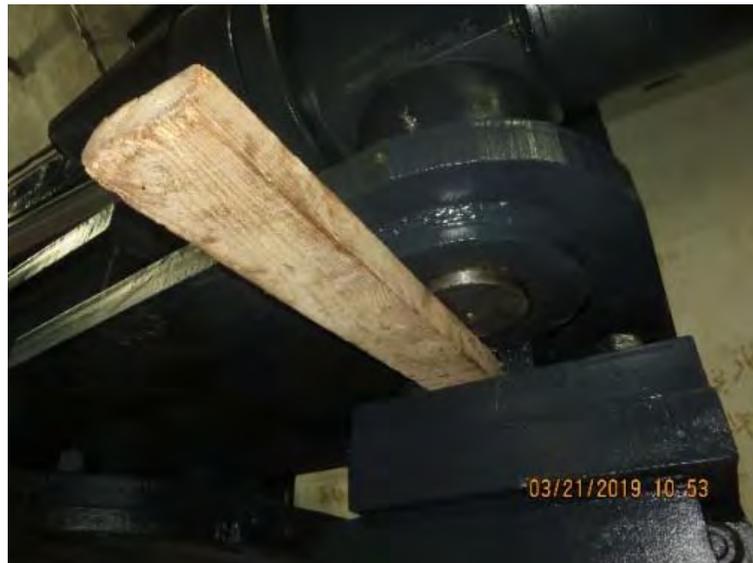
During our March 2019 site visit, we found that the Kajaki Dam's irrigation tunnel was operating and adequately diverting water for irrigation. However, we found one maintenance issue that affects the proper operation of the tunnel. Specifically, we determined that the pins on the three emergency closure valves that connect the hinge on the valve body to the lifting cylinder were not properly fastened and unable to stay in the intended position, either open or closed. As a temporary solution, MEW maintenance staff were using a board to support the pins (see photo 2). According to the machine operator, METAG installed the pins correctly, but the pins loosened overtime; MEW staff could not explain how this happened. If an emergency occurs that requires operating the valves, they will not work because the pins are not in place.

Photo 2 - Lumber Supporting the Emergency Closure Valve Pins

To correct this maintenance issue, an engineer with the company that manufactured the hydraulic system would need to evaluate the system and determine why the pins failed. Based on our discussions with MEW maintenance staff at the dam, we found that they do not have the level of technical training and experience required to inspect, understand, evaluate, diagnose, and make the needed repairs. In addition, the diagnostic instruments and specialized tools needed for the job and the replacement parts are not manufactured or readily available in Afghanistan.
