SIGAR 20-45 Inspection Report

**Afghan Ministry of Interior Security Upgrades:
Project Was Generally Completed According to
Contract Requirements, But Construction and
Maintenance Problems Exist**

**JULY
2020**

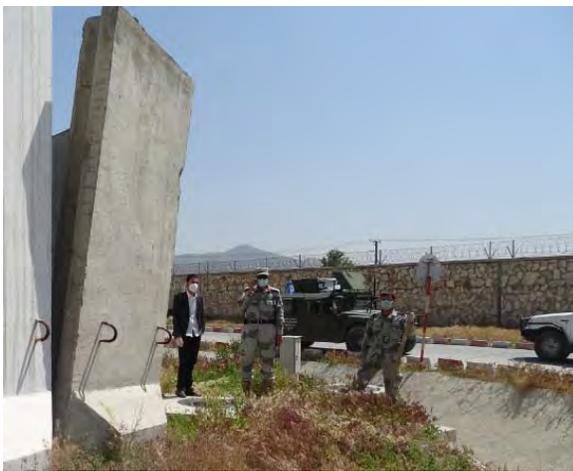
One of the concrete barriers surrounding the parking lot was at risk of falling over (see photo 1). We conducted an initial site visit on February 5, 2020, and a follow-up visit on May 21, 2020, to more closely inspect the ground around the unstable concrete barrier. We found that the soil surrounding the unstable concrete barrier had weakened, and adjacent concrete barriers were also leaning (see photo 2). An MOI official said the ministry notified ACF about the unstable concrete barrier before the project's completion.

Based on our engineering assessment, we determined that the concrete barrier became unstable for two reasons. First, ACF did not properly compact the soil, as required under the contract.⁴ Second, the soil around the barriers weakened due to rainwater draining from the parking lot through the concrete barrier's drainage hole at ground level and into the nearby drainage ditch.⁵ If not addressed, the unstable concrete barrier could fall over, damaging the surrounding storm ditches and potentially causing serious injury to anyone nearby.

Photo 1 - Unstable Concrete Barrier

⁴ The contract required concrete barriers to be placed on either paved areas or surfaces comprised of a minimum of 150 mm (6 inches) of compacted aggregate base course material (compacted to 95 percent maximum dry density standards).

⁵ Per the approved grading plan, the parking lot's slope was designed so rainwater would flow toward the affected concrete barrier and into the adjacent drainage ditch.

USACE also requested that we remove our characterization of the leaning concrete barrier as a construction deficiency. USACE states that it did not agree that the concrete barrier was at risk of falling over due to the contractor not adhering to contract requirements. USACE said the field density test results provided to us showed no issue with soil compaction. However, the field density tests USACE provided us were performed in February, June, July, and August 2017. These tests were conducted in various areas of the planned parking lot before it was paved, and were not performed under or near the planned location of the concrete barriers. Furthermore, the test results that USACE provided were dated before soil compaction around any of the concrete barriers took place. Therefore, the tests do not confirm that ACF provided acceptable compaction near the tilting concrete barrier. In sum, although all field density tests we received show good results for the few places that were tested, none were specific to the soil near or directly under the leaning concrete barrier cited in the report.

properly compacting the soil and rainwater draining from the parking lot through the barrier's drainage hole at ground level. On May 21, 2020, we performed a follow-up site visit to inspect the leaning concrete barrier more closely. MOI staff reported to us that even during construction the rainwater drainage was beginning to weaken the stability of the soil and affect that section of the concrete barrier wall. In addition, we did not find any evidence that the structure was damaged due to a vehicle impact or an intentional move, as USACE stated. Rather, we found that soil instability and erosion near the tilting concrete barrier and adjacent manholes had progressively worsened to the point that nearby barriers were tilting as well. This observation nullifies USACE's suggestion that impacts or movements by MOI staff or equipment caused the issue. As a result, our description of the leaning concrete barrier as a construction deficiency remains in this report

- 1. Notify the MOI about the three construction deficiencies—the concrete barrier at risk of falling over, noncompliant ground cable, and uninstalled card readers—so the MOI is aware of them and can take whatever action it deems appropriate.**
- 2. Notify the MOI of the three operation and maintenance problems—nonworking streetlights, missing panic bars and unauthorized exterior padlocks on ECP building exit doors, and damage to a guard shack roof—so the MOI can take whatever action it deems appropriate to correct them.**

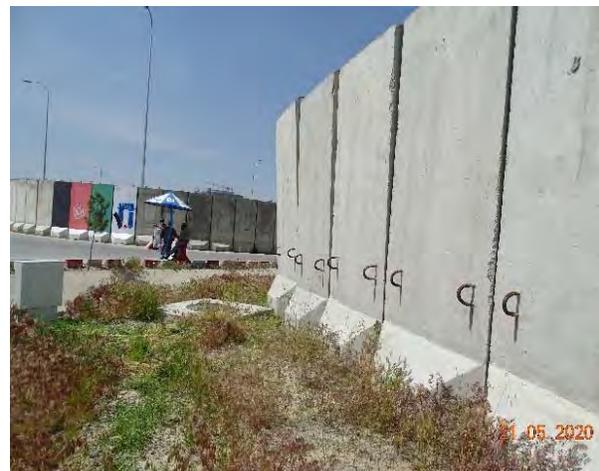
Photo 2 - Adjacent Leaning Concrete Barriers

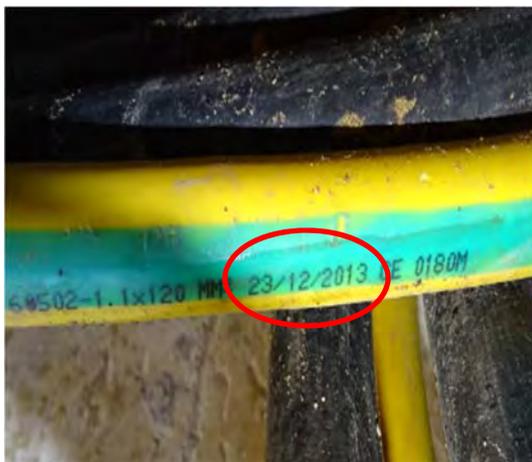
The contract required that “wires and cables manufactured more than 12 months prior to date of delivery to site shall not be used.”⁶ During our February 20, 2020, site visit, we found that ACF installed a noncompliant ground cable in the new electrical manhole in front of the ECP building. The cable was dated December 23, 2013 (see photo 3), but ACF did not complete the project until March 5, 2019, more than 5 years later. Aging cables are a main cause of electrical cable failure and may lead to reduced conductivity.

Photo 3 - Noncompliant Ground Cable

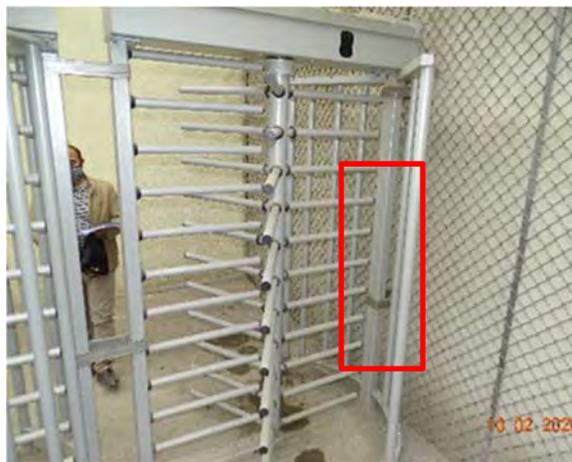
Contract requirements called for ACF to install card readers on both sides of all three turnstiles located at the entry and exit of the ECP building. The card readers help ensure that only authorized personnel can access the MOI headquarters complex, a location that has been the site of insurgent attacks in recent years.

While the as-built drawings showed that the card readers were installed as required, during our site visit on February 10, 2020, we did not find any card readers on the turnstiles, or any evidence that they had been installed and then removed (see photo 4). We also found no evidence that card readers had ever been approved, purchased, or turned over to the MOI. Without card readers, the building's security is compromised.

Photo 4 - Missing Card Readers on Turnstile

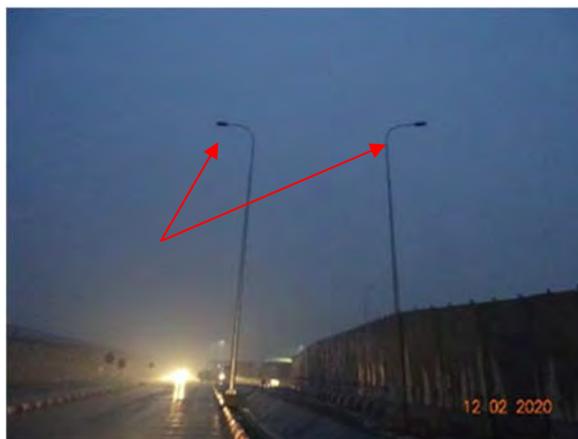
We found that 85 of the 90 streetlights at the MOI headquarters complex did not work (see photo 5). On July 10, 2018, ACF notified USACE that some streetlights had stopped working. The notification letter described that ACF's investigation into the problem had found "no issues with [streetlight] design or construction," and that the absence of "standard and stable voltage (400Y/230V) of city power...seems to be the issue."⁷ According to the same ACF notification letter, the MOI headquarters' maintenance contractor, IDS International, agreed with ACF's assessment.

During our site visits, we found only 5 of the 90 streetlights worked. Therefore, it does not appear that the MOI took any of the corrective actions recommended by ACF to operate and maintain the streetlights. Without the lights, street safety and security is compromised due to the lack of visibility.

Photo 5 - Nonworking Streetlights

1. The MOI should install electrical equipment that will fix voltage irregularities.
2. The MOI should work with Da Afghanistan Breshna Sherkat to solve the problem.⁹
3. The MOI should use new electrical power generators.

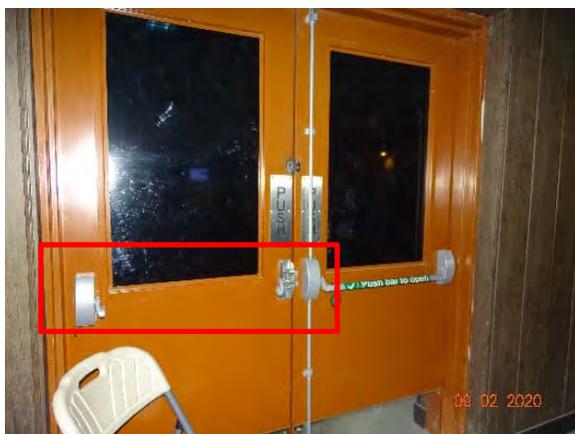
During our February 9, 2020, site visit, we found that two of the ECP building's seven exit doors were missing panic bars, which can be pushed to quickly leave the building in a fire or other emergency (see photo 6). Additionally, the MOI installed padlocks on the outside of five of the doors (see photo 7), which could trap occupants inside during an emergency.¹⁰ The MOI's changes to the approved and installed door hardware on the building exit doors creates serious safety hazards for ministry staff and visitors.

Photo 6 - Missing Panic Bar on Exit Door

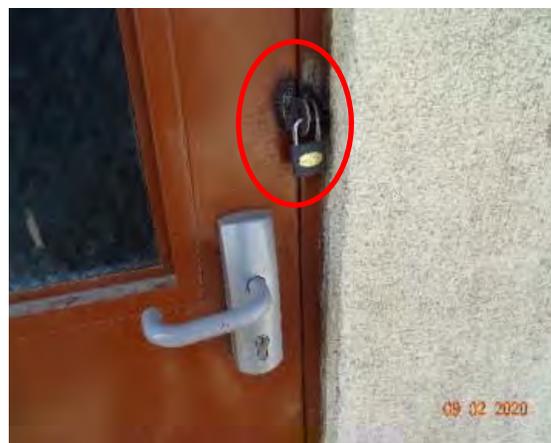
Photo 7 - Example of Padlocked Exit Door

¹⁰ The five padlocked doors are 103B, 108B, 110, 115A, and 115C.

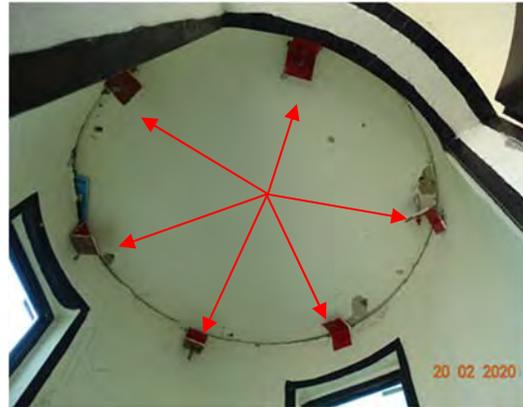
During our February 5, 2020, site visit, we found that the roof of a guard shack was separated from its structure. This happened when the MOI moved the shack from its original location outside the parking lot entry checkpoint to its current location inside the lot. All six angle brackets securing the roof to the walls became detached (see photo 8). Although the roof was still in position, the damage could result in a roof that leaks. It also presents a safety hazard if the MOI decides to move the structure again and the unsecured roof becomes completely detached.

Photo 8 - Interior of Damaged Guard Shack

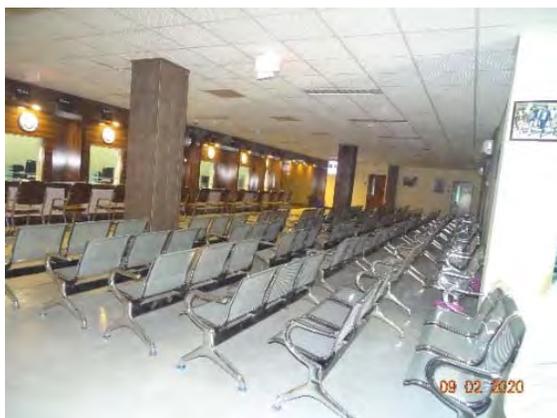
We also found that the ministry determined that it did not need the ECP building for security screening and modified it to be a public service center and communications office (see photo 9). The MOI built a new bathroom and kitchen facility behind the building, neither of which was part of the original design or ACF's contract. The MOI has spent close to \$200,000 (about 15 million afghanis) on the additional renovations.

Photo 9 - EPC Building Interior

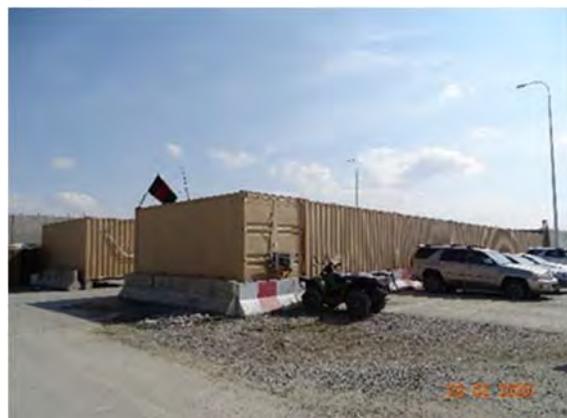
Additionally, we found that the MOI was using 25 percent of the parking lot to accommodate shipping containers that are being used as barracks for the MOI's Crisis Response Unit (see photo 10). In conjunction with this accommodation, the 52 Jersey barriers were moved by the MOI from their original location to inside the parking lot.

Photo 10 - Crisis Response Unit Barracks in MOI Parking Lot
