**Special Inspector General for
Afghanistan Reconstruction**

SIGAR 21-30 Inspection Report

Kandahar Solar Power Plant: Project Was Generally Completed According to Contract Requirements

APRIL
2021

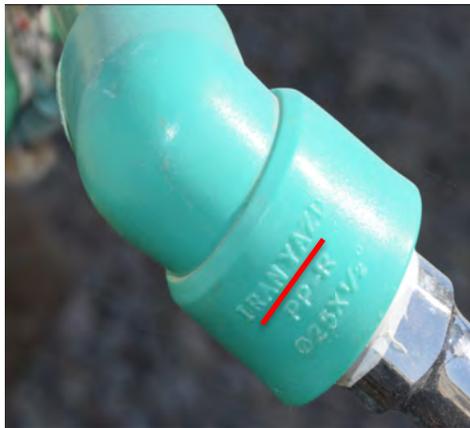
Photo 2 - Prohibited Piping from YAZD Pipe

To facilitate solar panel cleanings, Dynasty constructed a new cleaning system, including a water well with associated piping, pumps, and water storage tanks. The cleaning system is mostly underground and distributes water around the grounds to spray hoses near solar panels. The construction contract and U.S. federal law prohibited the use of Iranian-made materials in the facility. However, during our inspection, we found that a section of the cleaning system’s above ground piping was manufactured in Iran (see photos 2 and 3).

YAZD Pipe, an Iranian firm, manufactured the green piping in these photos. Our visual inspection confirmed approximately 66 feet of above ground piping was Iranian.⁵ Because Iran is subject to U.S. economic sanctions, the purchase and installation of the YAZD piping appears to have violated contract requirements and the Federal Acquisition Regulation.⁶ During a December 2020 meeting, we brought this issue to USAID’s attention so the agency could determine appropriate corrective actions.⁷

- 1. Determine whether Dynasty violated contract terms citing the Federal Acquisition Regulation in the installation of Iranian-manufactured piping, and take appropriate action to hold the contractor accountable.**
- 2. Advise Dynasty about the faulty wiring connections and unsecured exposed wiring that are creating a safety and fire hazard, as well as the maintenance issues involving the cracked concrete and missing mortar, so that Dynasty can take whatever action it deems appropriate.**

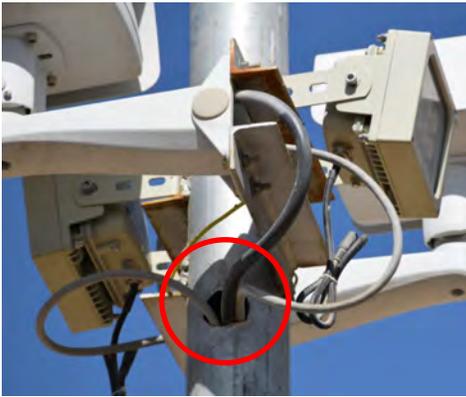
Photo 4 - Unsealed Opening in Pole

The power purchase agreement requires that Dynasty's construction and equipment installation meet applicable International Electrotechnical Commission standards.⁸ These standards call for all electrical connections to be sealed so that wiring is not exposed to various weather conditions. During our site visit, we found multiple instances where Dynasty's electrical workmanship was substandard. Specifically, Dynasty did not seal openings where wire entered poles. We also found exposed wiring or splices at the exterior of some lighting and security camera poles, and in and around some guard towers (see photos 4 through 7). Although these issues do not affect the plant's ability to produce electricity, the deficiencies leave exposed wires susceptible to environmental deterioration or damage. In the guard towers the exposed wiring and connections present a safety and fire hazard to personnel working there.

Advise Dynasty about the faulty wiring connections and unsecured exposed wiring that are creating a safety and fire hazard, as well as the maintenance issues involving the cracked concrete and missing mortar, so that Dynasty can take whatever action it deems appropriate.

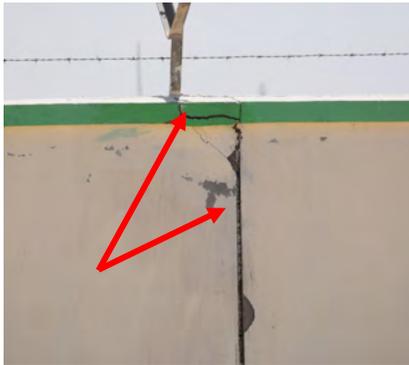
Photo 8 - Cracks in Boundary Wall

During our site visit, we found three maintenance issues at the solar power plant. Specifically, we found that 17 of the 36 security cameras (47 percent) were nonfunctional. We also found cracks in facility's boundary wall and on the roof of the control building (see photos 8 and 9). Further, we found mortar missing from stones that form the boundary wall's foundation (see photos 10 and 11). These were not identified during the project's final inspection in December 2019. While they do not affect the solar power plant's ability to operate as intended and produce electricity, the issues indicate Dynasty's difficulty in properly maintaining the plant.
