SIGAR Inspection 13-10

## Bathkhak School: Unauthorized Contract Design Changes and Poor Construction Could Compromise Structural Integrity

JULY  
2013

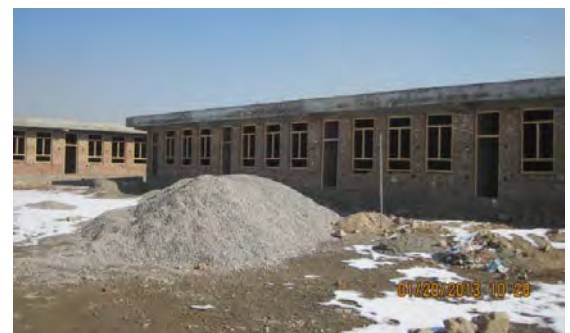
Two 5-classroom buildings under construction instead of single 10-classroom building

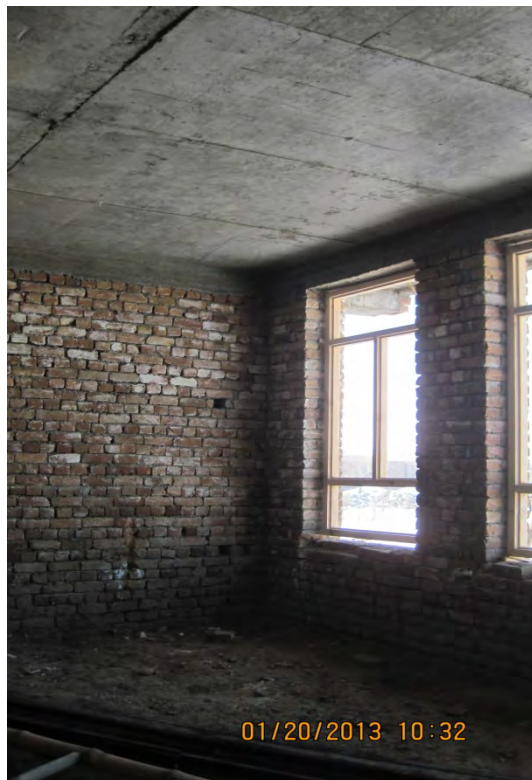
**Photo 2 - New Classroom Construction with Brick Walls and Concrete Ceiling/Roof**

We conducted our inspection of the Bathkhak school construction site on January 20, 2013. Based on our observations and review of design and contract documents, the new school facilities are not being built in accordance with contract requirements. We found that instead of a single 10-classroom building, two 5-classroom buildings were being built, and building materials specified in the contract were not being used. For example, brick was being used for the interior and exterior walls instead of the required concrete masonry unit block also known as cinder block. Similarly, wooden window frames were installed instead of the required vinyl frames. Furthermore, a concrete slab ceiling/roof had been installed rather than the wood-trussed roof framing system with sheet metal roofing (see photo 2).

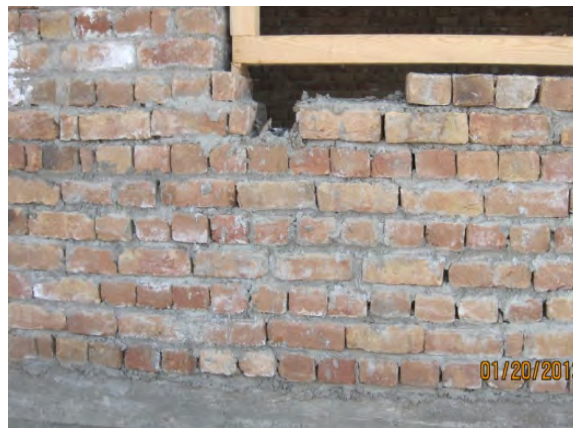
**Photo 3 - School Building's Exterior Brick Wall with Gaps in the Mortar**

During our inspection, we observed several construction deficiencies associated with poor workmanship that could lead to future structural problems for the Bathkhak school. For example, we noted inadequate amounts of mortar being used, which left large gaps between bricks of the school building's interior and exterior walls (see photo 3). The walls make up the structure supporting the concrete ceiling/roof and, as such, need to be laid properly with sufficient amounts of mortar to help resist structural failure.

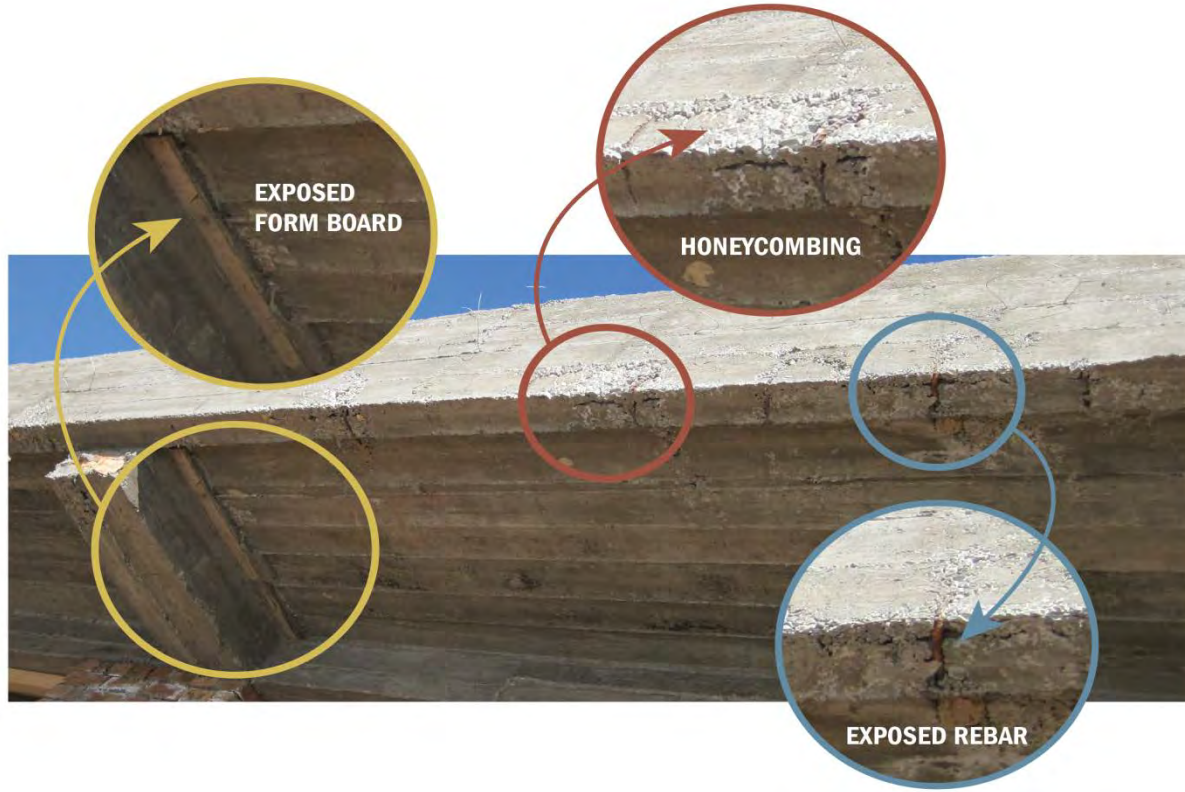
**Photo 4 - Concrete Ceiling/Roof Showing Poor Workmanship**

Our engineer examined the concrete roof and structural components and noted three areas of poor workmanship: (1) honeycombing, also known as "rock pockets," in the set concrete; (2) exposed rebar; and (3) concrete form boards that had not been removed before the

concrete hardened. Honeycombing is evidence of poor concrete consolidation, which may be caused by too dry a mix, incorrect aggregate size relative to the rebar's clearance, or inadequate vibration during pouring of the concrete leaving air bubbles in the concrete mix.<sup>10</sup> Depending on the location of these defects, honeycombing can significantly weaken the structure. Exposed rebar will eventually rust and compromise the integrity of the concrete and cause it to fail.<sup>11</sup> Lastly, the concrete form boards, which should have been removed, will eventually rot, leaving a space between the roof and the supporting beams, which will weaken the overall structure (see photo 4).

Our examination of the new school buildings' interior concrete ceilings revealed that large stones—up to 5 centimeters (2 inches) in diameter—had been included in the concrete mixture. Stones of this size normally will sink to the bottom of the mixture and weaken the structure. Similar to the exterior roof, we also observed honeycombing on the interior ceiling of the building, which could also significantly weaken the structure.
