SIGAR 14-31 Inspection Report

SALANG HOSPITAL: LACK OF WATER AND POWER SEVERELY LIMITS HOSPITAL SERVICES, AND MAJOR CONSTRUCTION DEFICIENCIES RAISE SAFETY CONCERNS

JANUARY
2014

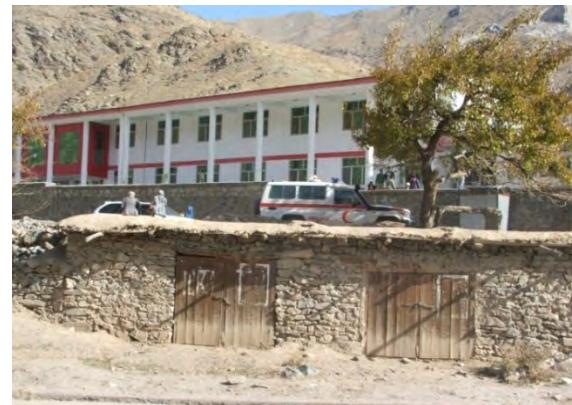
Photo 1 - 20-Bed Salang Hospital

- The original design drawings called for a one-story, 15-room hospital building; a one-story four-stall toilet facility; and a guard shack. However, we found that a two-story building had been built. It was an 18,300-square-foot structure, more than three times larger than the 5,300-square-foot building called for in the original design plans. We could not find any documentation showing that the Bagram Regional Contracting Center contracting officer had modified the contract to approve the two-story building, as was required under the contract.³ According to a Provincial Reconstruction Team record of a meeting with an Afghan Ministry of Public Health official, the Department of State member of the team stated that the Ministry and the provincial government approved the alternate design; however, no documentation exists to confirm that these officials approved the design. The State Department representative also noted that the alternate design was necessary because the hospital's irregularly shaped lot would not accommodate the design called for in the contract documents. However, it is unclear to us why the lot could not accommodate the hospital as originally designed, but could accommodate a facility that had a larger footprint than was called for under the contract. See Appendix II for a comparison of the originally-designed building's footprint and that of the building that was actually constructed.

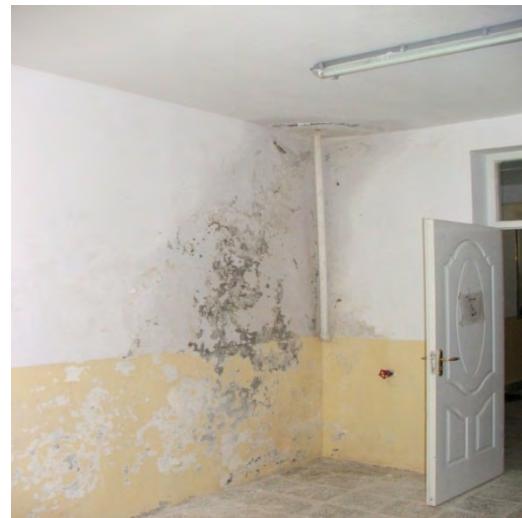
Photo 2 - Leaky Roof Damages Ceilings and Walls

- The hospital staff told us the hospital roof was leaking, causing mold and mildew on the ceiling and walls. Our inspection confirmed the presence of mold and mildew (see photo 2). The statement of work required that the concrete roof slab be hot-tarred to provide waterproofing prior to installing wooden trusses to support the corrugated metal roof. Photos contained in the contract files show that the hot-tarring was not done. Photos also show that the wooden trusses on top of the concrete slab roof were not covered with plywood and tar paper, as required. Our inspection confirmed these construction deficiencies.

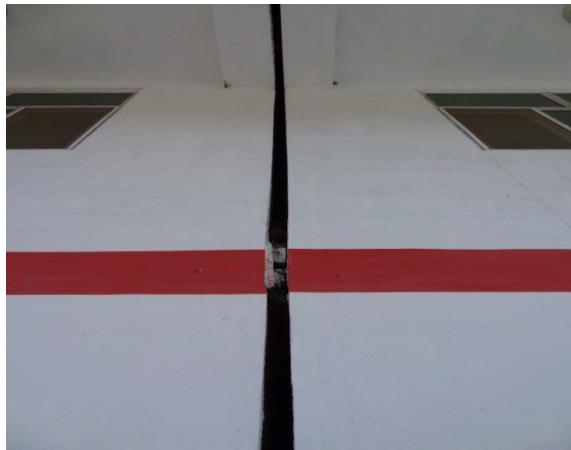
Photo 3 - Excessively Wide Expansion Joint

- First, we observed a vertical expansion joint that basically cuts the hospital structure in half (see photo 3). The gap is about 3 inches wide and has no concrete or reinforcing steel providing a connection across the joint. In essence, the hospital consists of two separate buildings under one corrugated metal roof. Due to missing design documents, we do not know whether the expansion joint was a

requirement. However, based on the industry standards⁶ for design, only very large or very long structures would normally have this type of an expansion joint. Our engineers believe that the existence of this 3-inch wide expansion joint and the fact that it is unreinforced makes the hospital highly susceptible to earthquake damage.

- 1. Identify the contracting officer(s) responsible for oversight of the Salang hospital construction activities and determine:**
 - (a) why the hospital was not built according to contract specifications and acceptable construction standards;**
 - (b) why required documents were not placed in the CIDNE database;**
 - (c) what disciplinary action, if any, should be taken against the contracting officer(s) who failed to provide required oversight.**
- 2. Perform a physical inspection of the building, including appropriate engineering tests and analyses, and, given its location in a high seismic activity zone, determine what corrections are required to ensure the structural integrity of the building.**

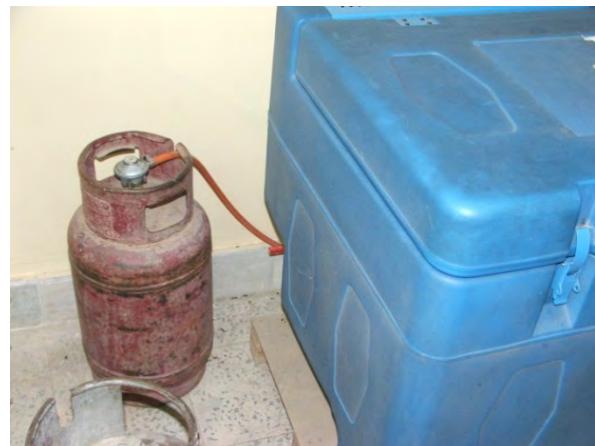
Photo 4 - Propane Supply for Refrigerator

Salang hospital is not providing many of the services it was intended to provide and is operating well below its capacity. As noted earlier, the hospital was designed to provide surgical and X-ray services, a pharmacy, and a laboratory, as well as pediatric, dental and mental health services. Although the hospital treats about 70 patients per day and is open 24 hours a day with staff available for night-time emergencies, it does not and cannot provide many of these intended services. For example, the doctors we spoke to on site confirmed they are not qualified surgeons, and the hospital does not have a functioning surgery unit. In addition, the X-ray machine is stored in a locked room and is not used because parts are missing and there is not enough electricity to operate it. The hospital staff also told us the ministry provides some medicine and vaccines, but without electricity it is hard to refrigerate them. As a "work around" measure, the hospital is using a propane-operated cooler for vaccine storage (see photo 4).

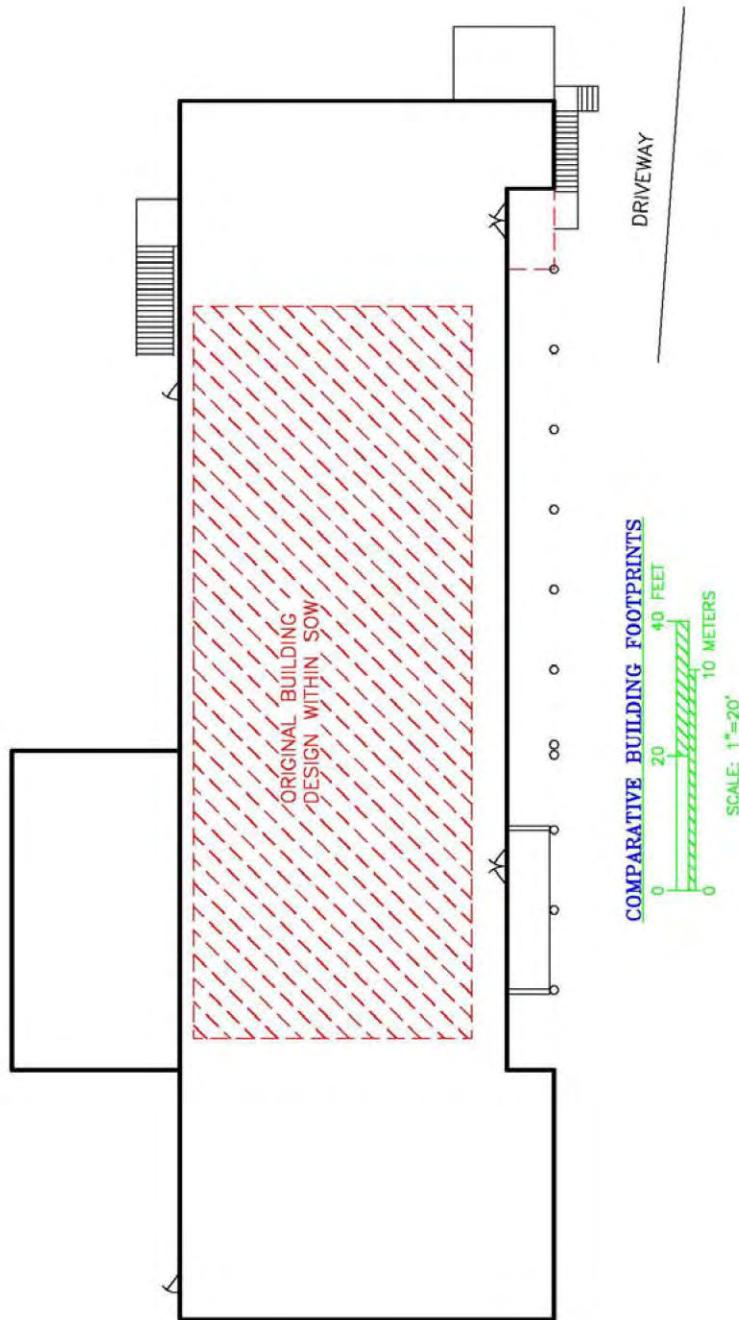
APPENDIX II - COMPARATIVE BUILDING FOOTPRINTS

Note: The outer black lines show the 9,150 square foot footprint of the 18,300 square foot two-story hospital building actually constructed by the contractor. The shaded red box within the black lines shows the relative size of the 5,300 square foot footprint that the Salang hospital would have occupied had it been constructed in accordance with the designs provided for in the contract. It remains a question as to why the lot was inappropriate for the 5,300 square foot building, but suitable for the 18,300 square foot building.
