**Special Inspector General for
Afghanistan Reconstruction**

SIGAR 21-06 Inspection Report

Pol-i-Charkhi Prison Wastewater Treatment Facility: Project Was Generally Completed According to Requirements, but the Contractor Made Improper Product Substitutions and Other Construction and Maintenance Issues Exist

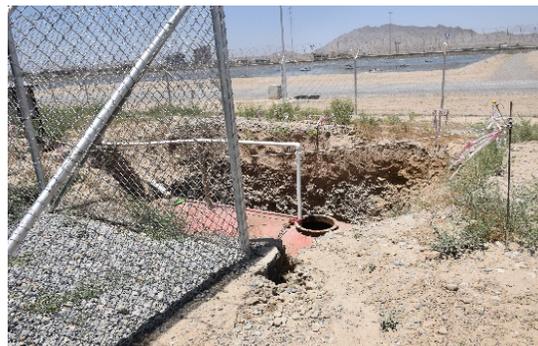
Photo 2 - Temporary Septic Tank Still in Use

We also found that Biltek had not removed an exposed septic tank used by the company's temporary office and housing area occupied during construction of the wastewater treatment facility (see photo 2). The tank is next to the well house, and we found sewage spilled on the ground. Because the temporary office area is still in use, the temporary septic tank requires continued pumping, which causes the spilled sewage. Spills this close to the water well could potentially contaminate the water supply, which could be a contributing cause for the contaminated drinking water we found when we tested the tap water in the newly constructed administration building.

- 1. Direct Biltek to correct the eight construction deficiencies identified in the report before the 1-year warranty on the wastewater treatment facility expires on April 14, 2021.**
- 2. Advise Biltek and the current operation and maintenance contractor, Kabul Cummins Technical Services Co., of the six remaining safety and maintenance issues—detached pond liner air vents, usage of the temporary septic tank, contaminated drinking water, lack of personal protective equipment, inadequate lighting in the bar screen chamber, and improperly working aerators—so it can take whatever action it deems appropriate to correct them.**

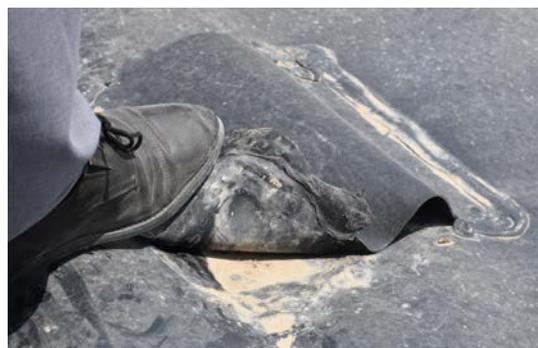
Photo 3 - Detached Pond Liner Air Vent

In addition, during the treatment process, wastewater flows into each of the four aeration ponds through a secure underground piping system. The ponds are about 5 meters (16.4 feet) deep and have waterproof liners that prevent contaminated wastewater from entering the ground. The liners have air vents evenly spaced near the top of the aeration ponds, according to the design. We verified that Biltek installed these air vents in the correct locations. However, we found that some were detached from the pond liner (see photo 3). This leaves the ground underneath the vent covers susceptible to wastewater infiltration, which could possibly contaminate groundwater. According to emails between INL officials in Washington, D.C., and Kabul, they are aware of the problems with the pond liners and requested that Biltek make appropriate repairs.

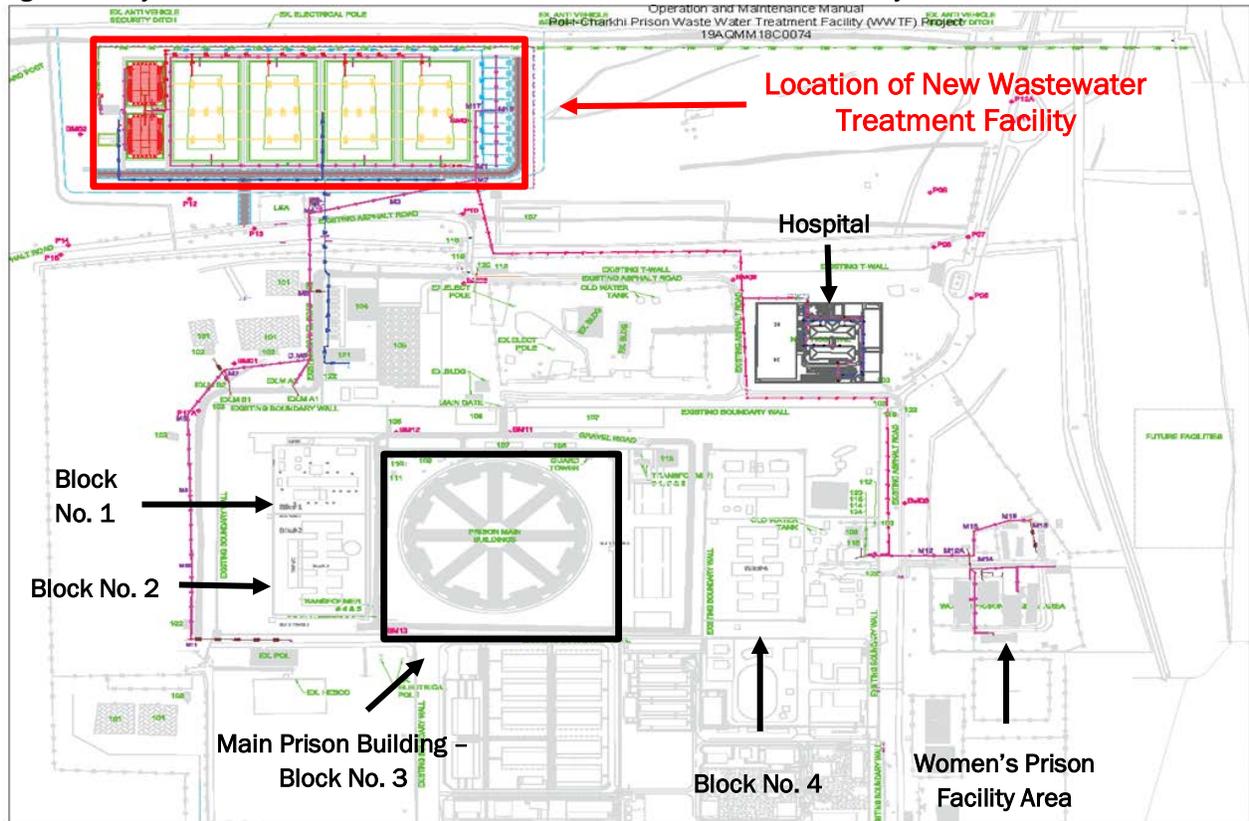
Figure 1 - Layout of Pol-i-Charkhi Prison and the Wastewater Treatment Facility

Figure 1 shows the general layout of Pol-i-Charkhi prison and the new wastewater treatment facility.

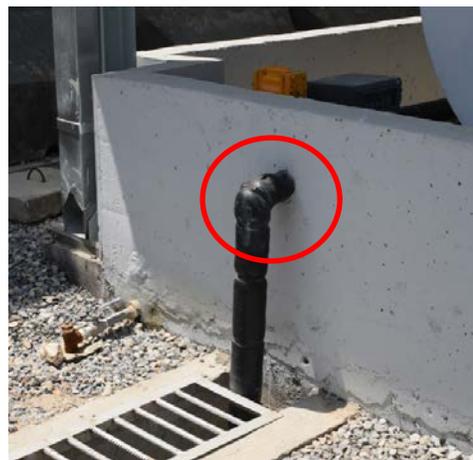
Photo 4 - Fuel Pipe Improperly Routed through Containment Wall

Biltek also improperly routed a fuel pipe through a concrete containment wall. The contract's design drawing specifically instructed that the fuel pipe entering and leaving the 6,200-liter (1,638-gallon) fuel tank not go through the structure's concrete containment wall. Instead, according to the design, the pipe was to be routed over the top of the wall. We found that Biltek routed the pipe through the concrete wall in two locations. This makes it harder to disconnect or replace the pipe if necessary. The improper construction also limits the expansion or contraction of the fuel pipe that occurs during temperature changes or movement from site settlement or earthquakes, making the pipe susceptible to breaking and leaking fuel.

Construction Deficiency	Description
<p>1. Biltek improperly routed a pipe through the concrete containment wall in two locations.</p>	<p>The contract's design drawing required a solid concrete wall around the 6,200-liter (1,638-gallon) fuel tank to contain a fuel spill or leak. The drawing specifically instructed that the fuel pipe entering the tank from the fill station and the fuel pipe leaving the tank to supply the generator should not go through the concrete containment wall, and instead be routed over the top of the wall. However, Biltek routed the pipe through the wall in two locations (see photo 5 for an example of this in one location). This makes it harder to disconnect or replace the pipe if necessary. Additionally, this inflexible penetration limits the expansion and contraction of the fuel pipe that occurs during temperature changes, movement from site settlement, or earthquakes, which make the pipe susceptible to breaking, possibly resulting in a fuel leak.</p>

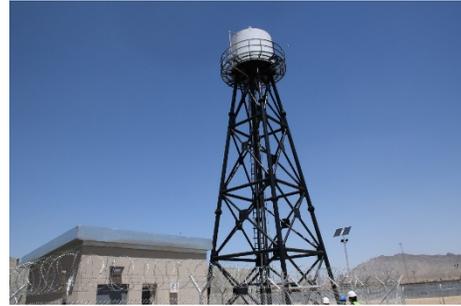
Photo 5 - New Water Tower and Well House

In a final example of Biltek's failure to conform to design or contract requirements, Biltek did not construct the tower for the water storage tank as required. Specifically, the contract required the installation of an elevated 13,000-liter (3,434-gallon) water storage tank that sits atop a 15-meter- (49.2-foot)-tall steel tower. The contract required the water tower to be grounded by a 25-millimeter (.98-inch) copper cable that protects the tank and its sensors from damage due to lightning strikes. We found that Biltek did not ground the water tower, thereby increasing the chance that a lightning strike could damage the sensors that control the well pump's operation.⁸ Appendix III contains additional details about these and the remaining deficiencies.

The contract included the installation of an elevated 13,000-liter (3,434-gallon) water storage tank. The tank sits atop a 15-meter (49.2-foot)-tall steel tower (see photo 7). The design drawings required the water tower to be grounded by a 25-millimeter (0.98-inch) copper cable that protects the tank and its sensors from damage due to lightning strikes.^b We found that Biltek did not ground the water storage tank's steel support structure. Not doing so increases the chance lightning could damage the sensors that control the well pump's operation.

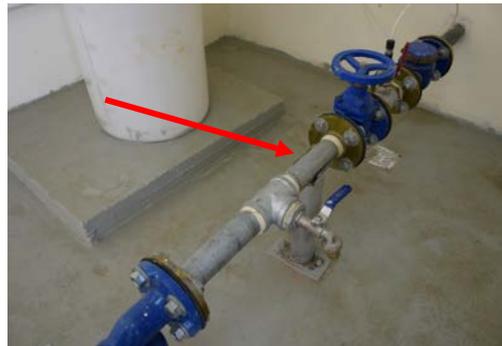
Photo 6 - Missing Pressure Gauge in Well House Pipe

Biltek installed the check valve, gate valves, air relief valve, and flow meter in the well house piping system. However, during our site visit, we determined that Biltek did not install the required pressure gauge (see photo 8), which shows the well pump's operating pressure. Without a pressure gauge, maintenance staff cannot confirm that the well pump is operating properly and could have problems troubleshooting.
