SIGAR 18-76 Inspection Report

**Marshal Fahim National Defense University: Phase I
Construction Generally Met Contract Requirements,
but Non-Compliant Fire Doors and Inadequate
Maintenance Place Building Occupants at Risk**

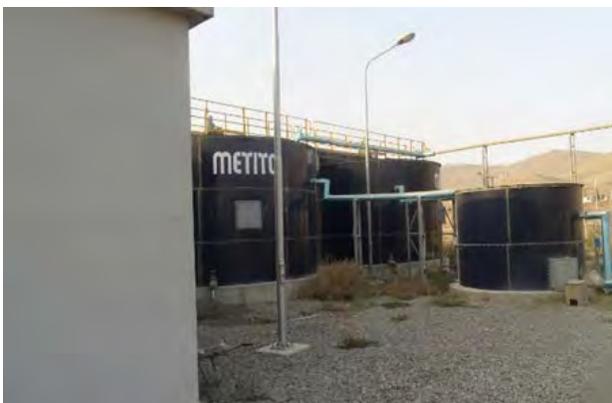
Photo 1 - Unused Wastewater Treatment Plant

According to the facility manager, the wastewater treatment plant, which cost \$1.8 million, has not been used since 2015 (see photo 1).¹¹ The facility manager stated that the plant had not received the required maintenance because the materials needed to operate the plant, such as chlorine, chemical oils, and spare parts were not available. Currently, the untreated wastewater is being pumped into a tank in the non-functional wastewater treatment plant (see photo 2). This wastewater remains untreated, is discharged from the plant through a series of ditches, and flows from the MFNDU towards a nearby village. This untreated wastewater

can spread disease and contaminate drinking water sources, which can result in significant health risks, such as the spread of cholera or hepatitis, if the untreated water reaches a community's water source.
