USAID'S AFGHANISTAN DRIP IRRIGATION
DEMONSTRATION PROJECT: MOST
DEMONSTRATION PLOTS THAT SIGAR
INSPECTED WERE NOT BEING USED AS
INTENDED

SEPTEMBER 2020

SIGAR 20-53-SP

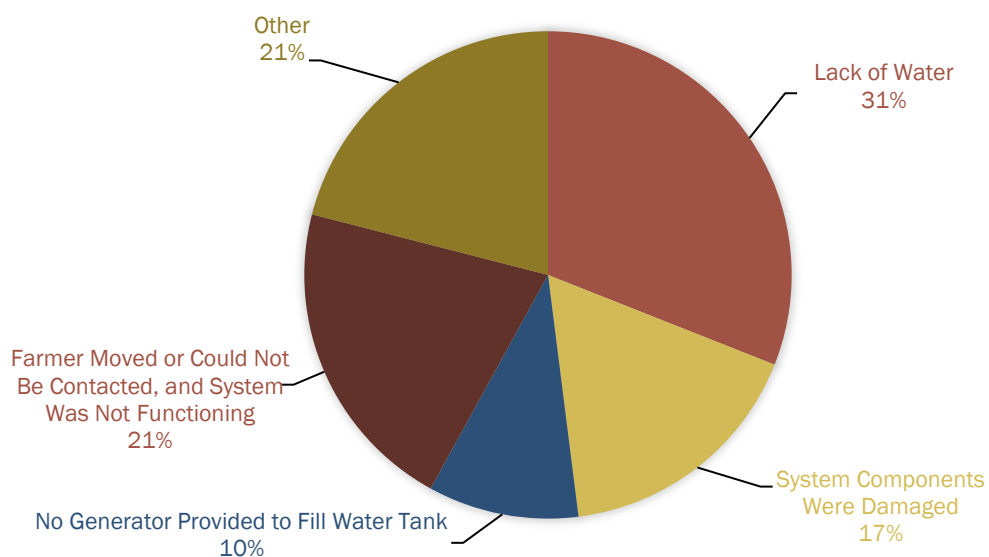
Figure 1 depicts the reasons why the drip irrigation demonstration plots were not being used by the Afghan farmers.

Figure 1 - Reasons Why Drip Irrigation Systems Are Not Being Used

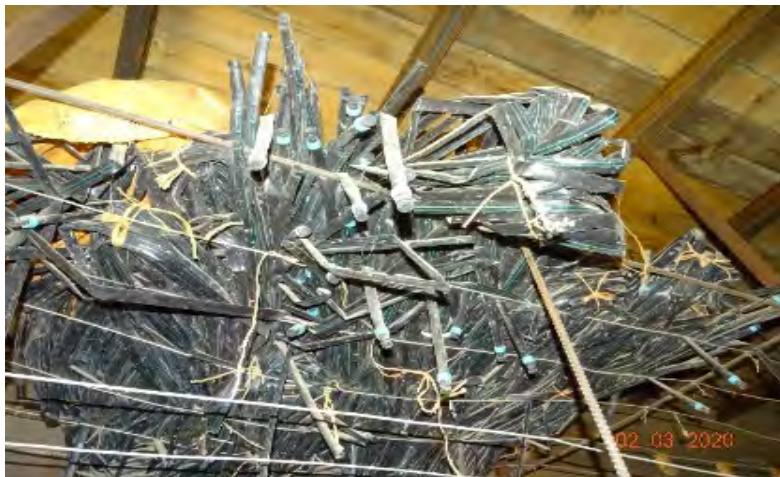
At one Jalal Abad village drip irrigation demonstration plot in Jowzjan Province, inspectors found all of the drip irrigation piping components had been removed from the field and haphazardly strewn about in the farmer's house. According to the farmer, he removed the drip irrigation pipes from the field because of a lack of water and due to a leak in the water tank.

Photo 1 - Irrigation Piping Components Stored within Farmer's House

- 1. Take the appropriate oversight actions, including site visits to ensure that the demo plots are being used as intended.**
- 2. Conduct an engineering evaluation of the water pipeline intersecting the Jalal Abad irrigation canal to determine what steps should be taken to maintain the integrity of both the canal and the water pipeline.**

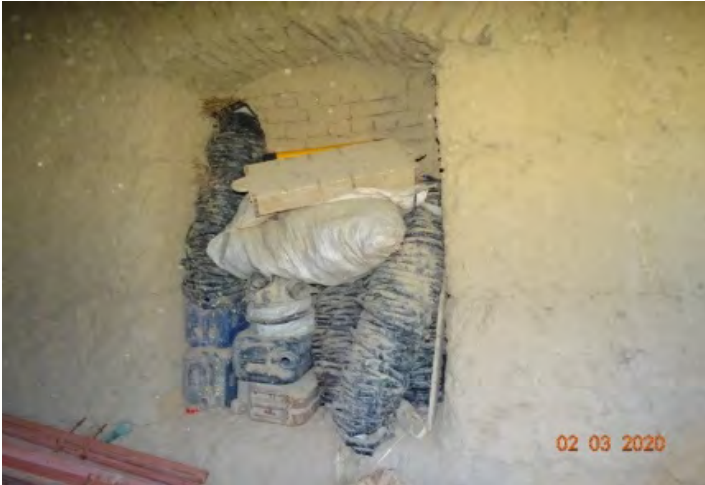
The farmer told our inspectors that the project was started and completed in 2017. There was no piping or drip system installed on site and all the system components were stored in the farmer's house. According to the farmer, the pipe components were removed due to the lack of water.

Photo 2 - Irrigation Piping Components Stored Within Farmer's House

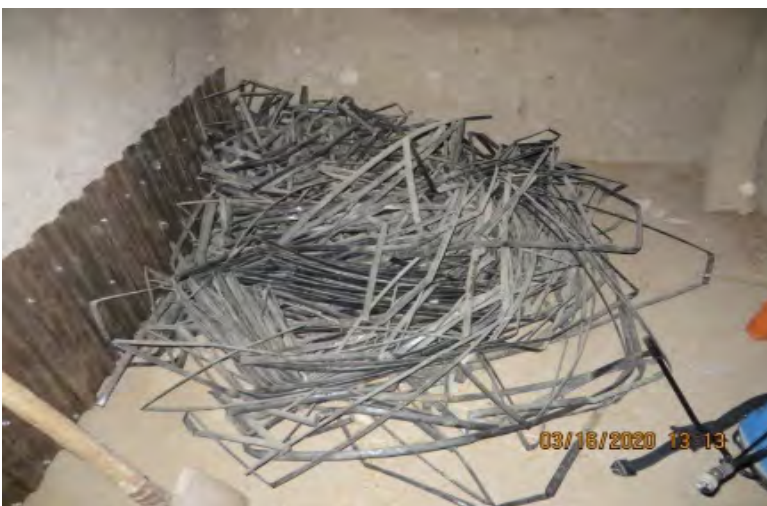
On this farm, the farmer told SIGAR inspectors that the drip irrigation project was completed in 2018. The SIGAR inspectors observed that the drip irrigation system was not installed and the components were located in the house. The farmer stated he removed the drip irrigation system because he could not afford fuel for the generator to operate the drip irrigation system.

Photo 3 - Irrigation Piping Components Stored Within Farmer's House

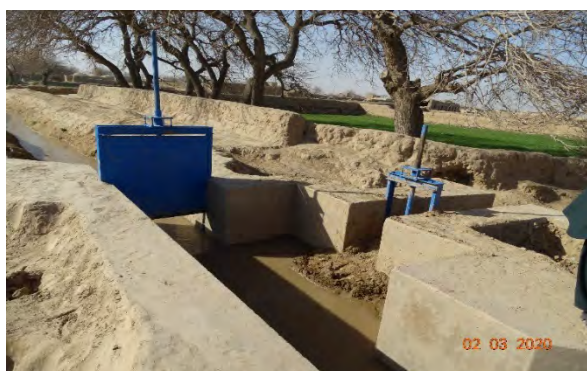
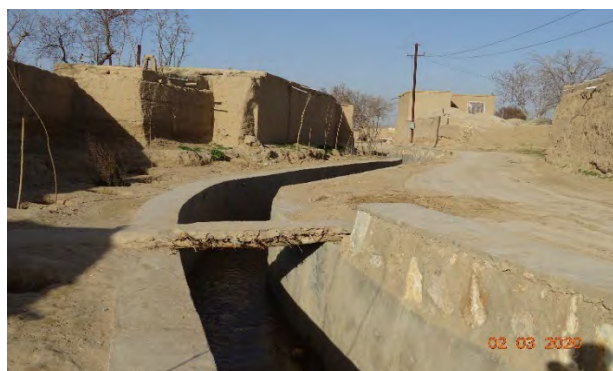
The Hasan Abad irrigation canal is 12.6 kilometers in length with a total irrigable area of 1,120 hectares and cost \$581,475 to construct. SIGAR inspectors who examined the irrigation canal on March 2, 2020, observed that the canal was complete. A community member said the canal was very useful to the community because the canal will help avoid wasting water.

Photo 4 - Hasan Abad Canal

Photo 5 - Hasan Abad Canal

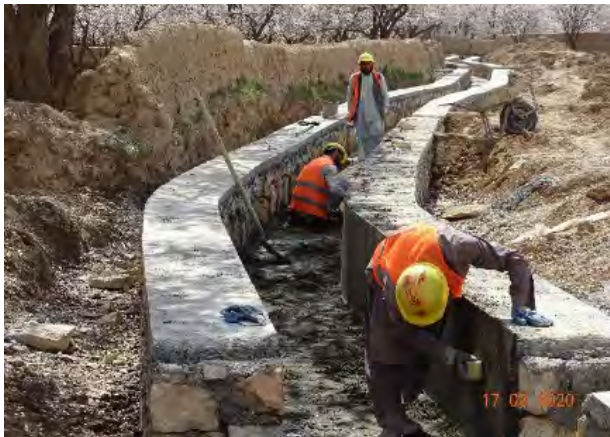
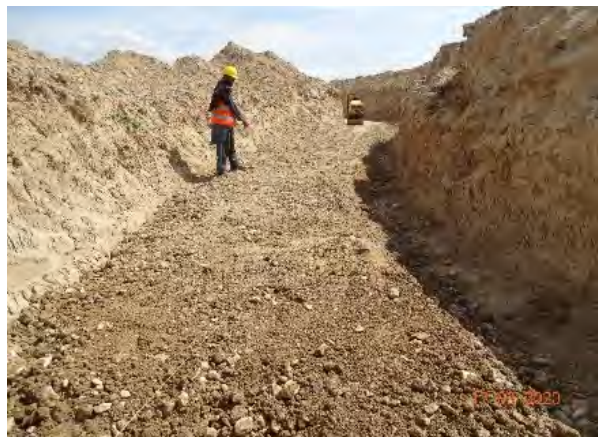
The Joyzendan irrigation canal is planned to be 3.19 kilometers in length with a total irrigable area of 760 hectares and cost \$236,145. As of May 2, 2020, construction work on the canal was ongoing, with about 50 percent of work completed, according to SIGAR inspectors. SIGAR interviewed the SWIM engineer on-site, who said that the canal's completion date is expected to be September 25, 2020.

Photo 6 - Joyzendan Canal

Photo 7 - Joyzendan Canal

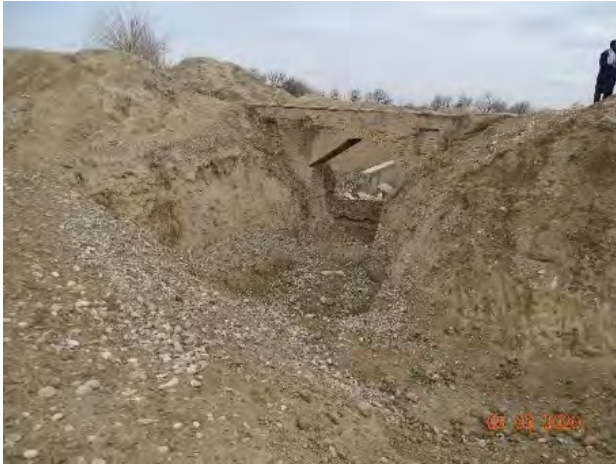
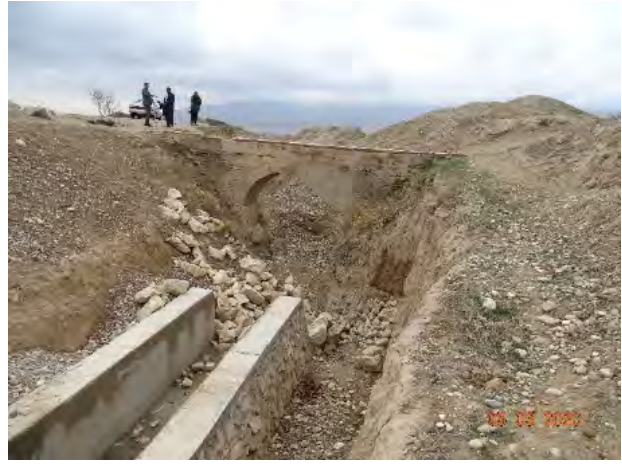
The Balkh irrigation canal is planned to be 14.4 kilometers in length with a total irrigable area of 5,040 hectares. The canal was scheduled to be completed by April 2020, at a cost of approximately \$1 million. However, according to SIGAR inspectors who interviewed the canal site engineer on March 5, 2020, work on the project had stopped because the subcontractor had been fired for non-performance. According to the site engineer, the construction work for this canal was started in 2018 and the subcontractor was terminated in August 2019. At the time the contract was terminated a little more than 50 percent of the work had been completed.

In May 2020, DT Global, the implementing partner, told SIGAR inspectors that it is performing maintenance with local laborers on the canal and a new Request for Performance (RFP) has been prepared and will be competed with a selected group of contractors. The current estimated completion date for the Balkh canal project is now January 2021. Additionally, DT Global informed SIGAR that the terminated subcontractor had not been paid for work that was not completed and DT Global had completed a review of cost and technical proposals for the completion of the canal and does not anticipate needing additional funds to complete the project.

Photo 8 - Balkh Canal

Photo 9 - Balkh Canal

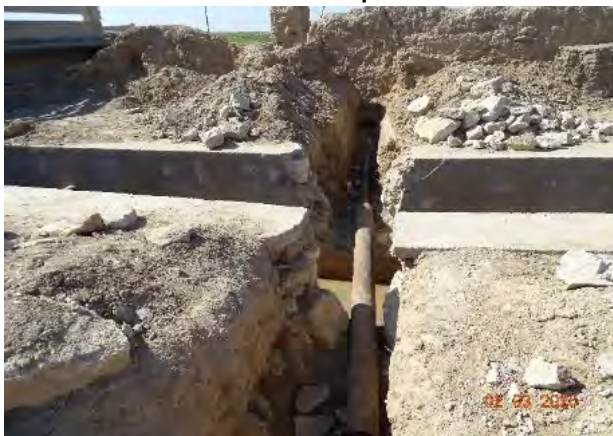
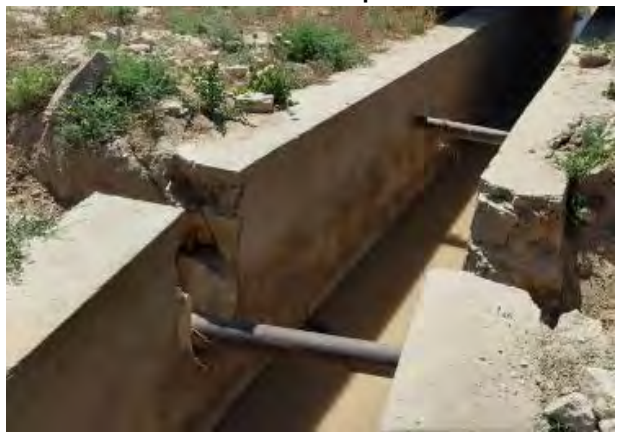
The Jalal Abad irrigation canal is planned to be 8.56 kilometers in length with a total irrigable area of 2,200 hectares and cost about \$1.1 million. According to SIGAR inspectors who examined the irrigation canal and interviewed a site engineer on March 2, 2020, the construction work was started in September 2018, and was completed in December 2019. The construction work included both stone masonry and irrigation gates.

Overall, the canal construction appeared structurally sound; however, a section of the wall had been breached to install a water pipeline (See photos below). According to SIGAR engineers, this situation could pose a threat both to the functioning and the integrity of the canal. For example, (1) the irrigation water supply could be insufficient due to the breach in the canal walls, (2) the supporting soil stability around the canal walls could be compromised by water flowing into the intersecting water pipeline trench, (3) the stability of the water pipeline trench could become compromised over time by irrigation water flooding, and (4) over time the degradation of a protective steel pipe sleeve—due to rust and water flow erosion—covering the water pipeline could cause the pipe sleeve to crack or break leading to a damaged or broken waterline.

Photo 10 - Section of Jalal Abad Canal Wall Breached to Install a Water Pipeline

Photo 11 - Different Angle of Jalal Abad Canal Wall Breached to Install a Water Pipeline

SWIM conducted an engineering evaluation at one crossing point in early July 2020 and corrected the situation to ensure the integrity of both the canal and the water pipeline. The MRRD and officials from the River Basin Authority and local communities were consulted and approved the measures undertaken by SWIM.

MRRD completed its pipeline work in August 2020 and SWIM has conducted an engineering assessment for the second crossing point. SWIM has addressed the structural issues at the two locations where the pipeline bisects the canal to protect the integrity of the canal and the water pipeline.
