SIGAR 20-21 Inspection Report

Kajaki Dam Irrigation Tunnel: The \$27.3 Million Tunnel Is Not Operating Properly Due to Construction Deficiencies and a Maintenance Issue

**JANUARY
2020**

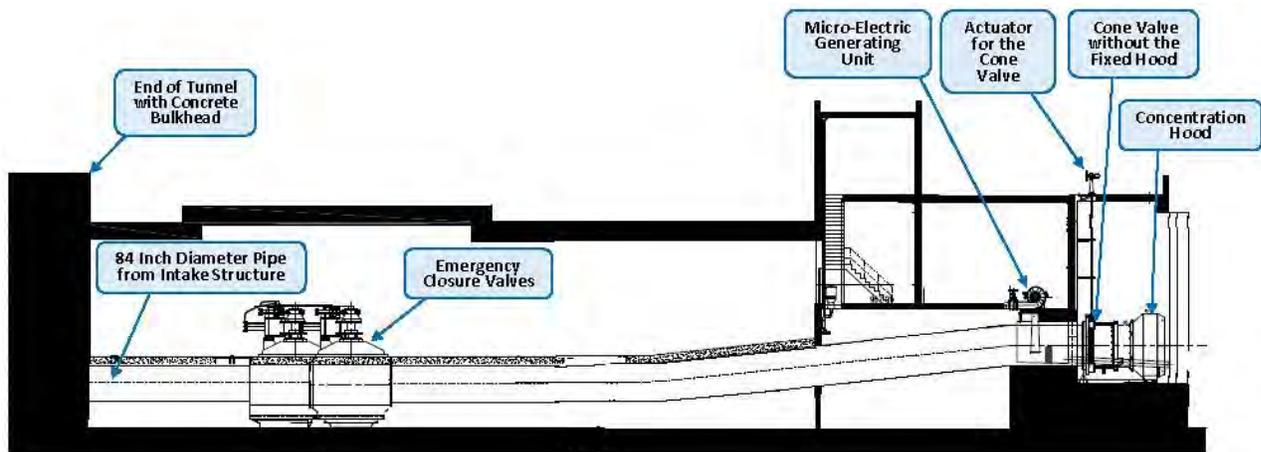
Figure 1 - Cross Sectional Schematic View of the Kajaki Dam Irrigation Tunnel

On January 30, 2013, the U.S. Army Corps of Engineers (USACE) awarded a \$25.6 million firm-fixed-price contract to Metag Insaat Ticaret A.S. (METAG), a Turkish firm, to repair the irrigation tunnel's intake structure, refurbish the emergency closure valve, replace the cone valve, and replace the micro-electric generating unit (see figure 1).²
