SIGAR 14-31 Inspection Report

SALANG HOSPITAL: LACK OF WATER AND POWER SEVERELY LIMITS HOSPITAL SERVICES, AND MAJOR CONSTRUCTION DEFICIENCIES RAISE SAFETY CONCERNS

JANUARY
2014

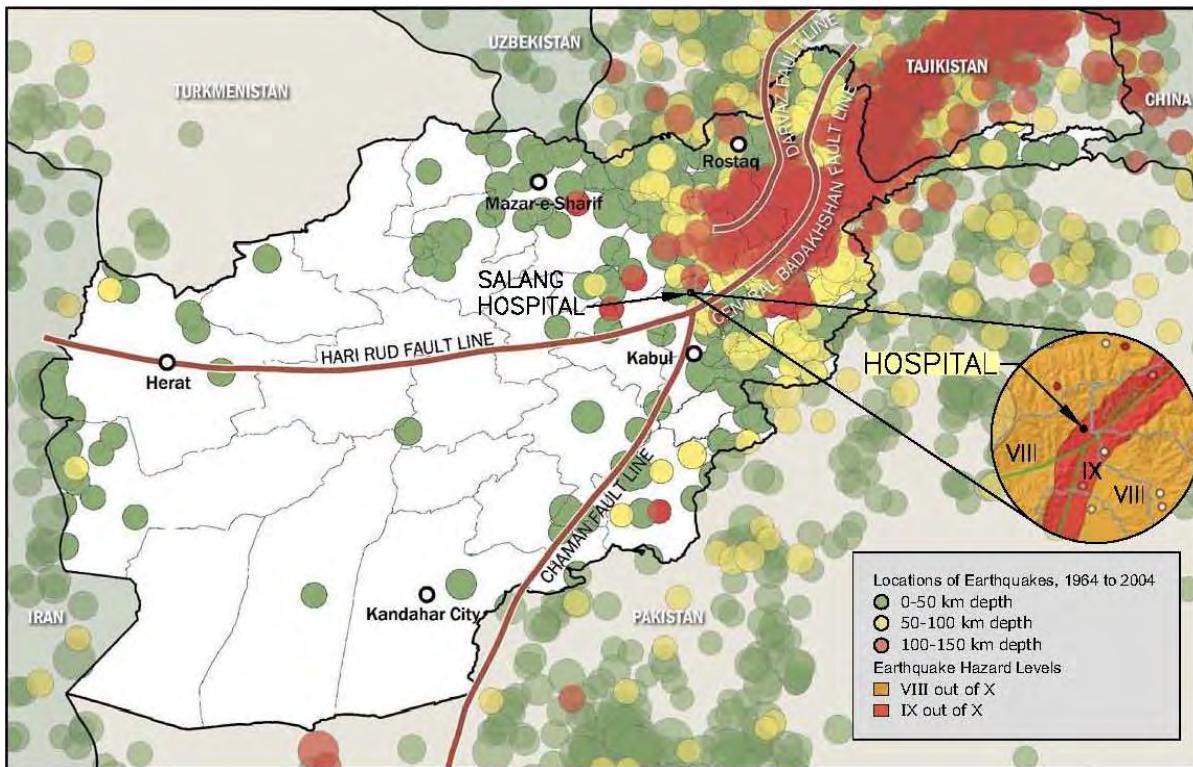
Figure 1 - Location of Earthquakes in Afghanistan from 1964 through 2004

1997 to 2007.⁴ Substandard construction that does not meet industry earthquake standards⁵ exposes the structures involved to increased earthquake vulnerability. Figure 1 shows the proximity of Salang hospital in relationship to the intersection of the Chaman, Hari Rud, and Central Badakhshan fault lines and the location of earthquakes that have occurred in Afghanistan from 1964 through 2004.

According to U.S. Geological Survey data, Salang hospital is located in the second highest seismic intensity zone in Afghanistan. The Chaman and Badakhshan fault lines represent the centerline of a 15 to 25 kilometer wide swath of potential destruction during a seismic event. The U.S. Geological Survey characterizes the seismic activity and potential damage for this zone as Level IX out of X. Level IX activity is described as: "Violent shaking with people forcibly thrown to the ground, monuments and columns fall, and most unreinforced masonry buildings will suffer heavy to very heavy structural damage."
