Office of the Special Inspector General for Afghanistan Reconstruction

June 25, 2015

I am writing to request additional information about the U.S. Agency for International Development's (USAID) Partnership Contracts for Health (PCH) program, which USAID funds through on-budget assistance to the Afghan Ministry of Public Health (MOPH). The program is intended to support the MOPH's efforts to deliver basic health services to the Afghan people. As of March 2015, USAID had disbursed over \$210 million to support this program. My office's initial analysis of USAID data and geospatial imagery has led us to question whether USAID has accurate location information for 510—nearly 80 percent—of the 641 health care facilities funded by the PCH program.<sup>1</sup>

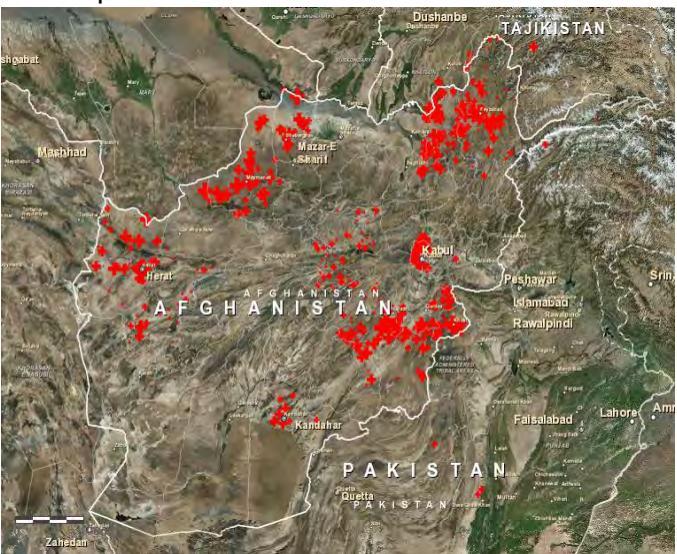
Figure 1 - USAID-Reported Geospatial Coordinates for 551 Partnership Contracts for Health Facilities

In an attempt to verify the accuracy of the location data for the 551 facilities, we obtained and analyzed geospatial imagery for these locations, shown in figure 1.<sup>3</sup> We found the following weaknesses in the data for 56 of those locations:

- Thirteen coordinates were not located within Afghanistan:
  - six were located in Pakistan,
  - o six were located in Tajikistan, and
  - one was located in the Mediterranean Sea.

Source: Army Geospatial Center/DigitalGlobe Inc. Note: Coordinates shown in Pakistan and Tajikistan are as reported by USAID. An additional facility, reportedly located in the Mediterranean Sea, is not depicted on the map above.

To provide meaningful oversight of these facilities, both USAID and MOPH need to know where they are. Accordingly, for all PCH facilities listed in enclosure II, I request that USAID provide correct, updated location coordinates or, as appropriate, non-geospatial confirmation of the physical location and existence of these facilities.

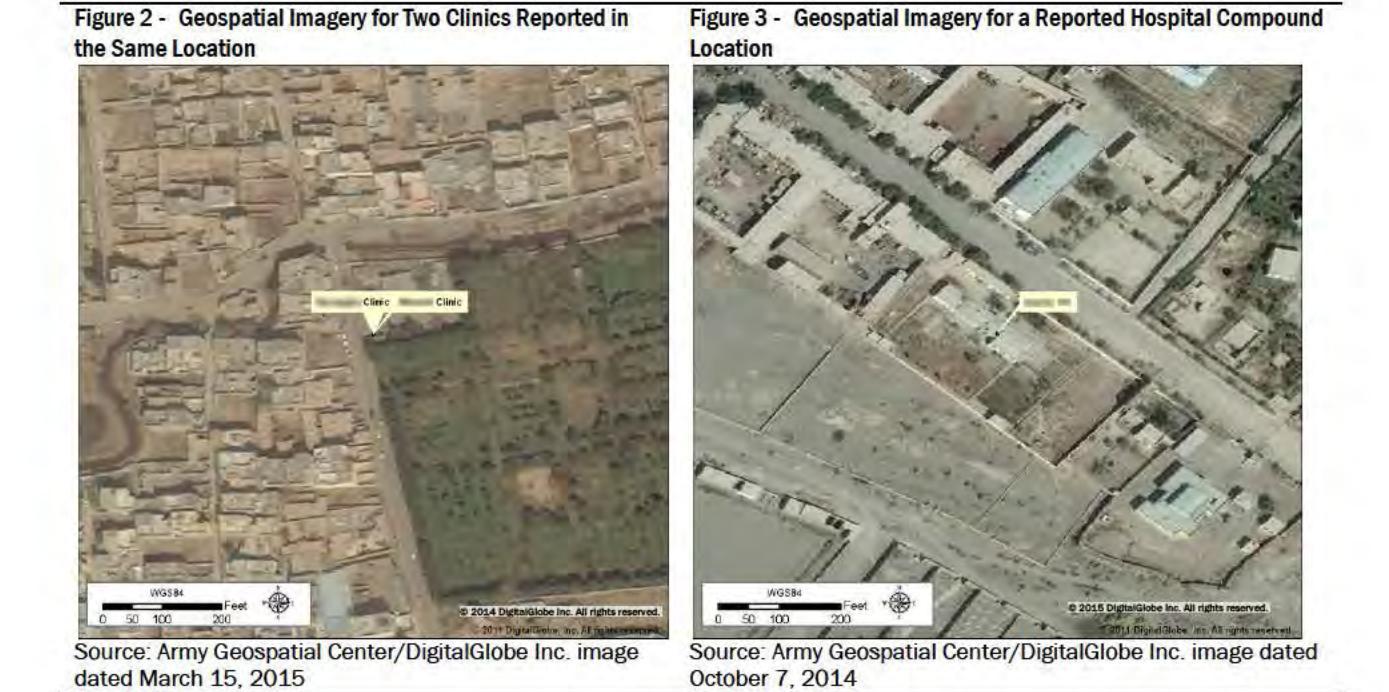
- Coordinates for 30 facilities were located in a province different from the one USAID reported.
- In 13 cases, USAID reported two different funded facilities at the same coordinates (see figure 2 for sample imagery).

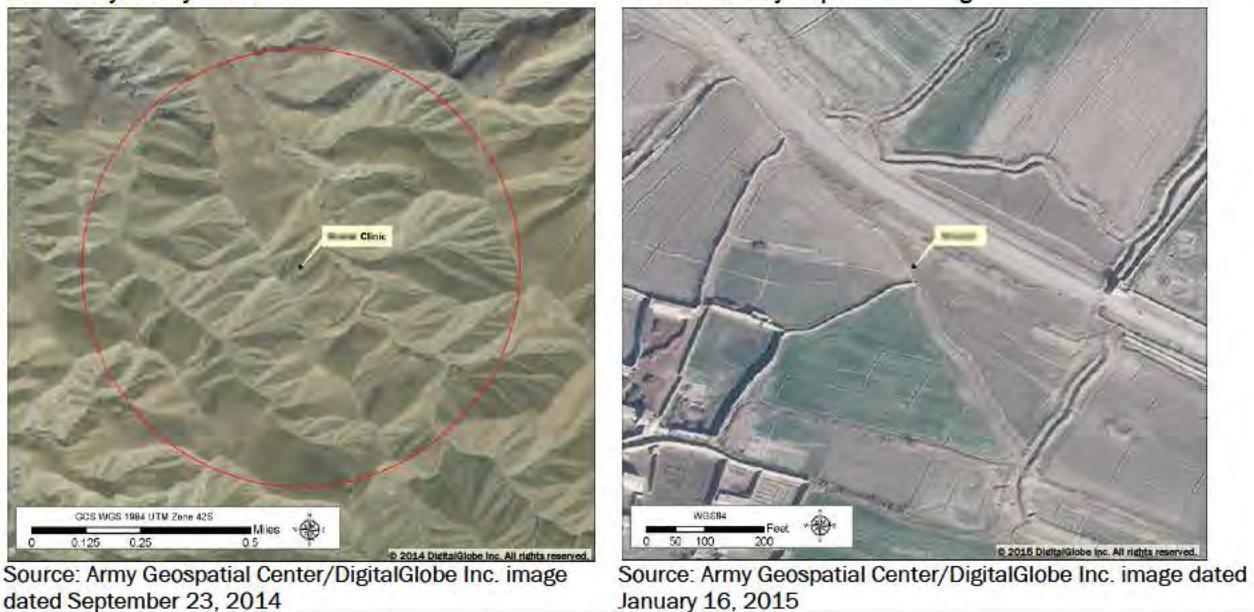
Figure 4 - Geospatial Imagery for a Reported Clinic Location Without Any Nearby Structures

- 152 coordinates clearly identified a specific structure or compound in the reported location (see figure 3 for a sample image).<sup>5</sup>
- 189 showed no physical structure within 400 feet of the reported coordinates, and a subset of 81, or just under half of these locations, showed no physical structure within a half mile of the reported coordinates (see figure 4 for a sample image).
- 154 coordinates did not clearly identify a specific building (see figure 5 for a sample image).
