**INSPECTION OF MAHMOOD RAQI TO NIJRAB ROAD**

**PROJECT IN KAPISA PROVINCE:**

**CONTRACT REQUIREMENTS MET;  
BUT SUSTAINABILITY CONCERNS EXIST**

SUBJECT: SIGAR Inspection Report 09-02: Mahmood Raqi to Nijrab Road Construction  
Project in Kapisa Province: Contract Requirements Met, But Sustainability  
Concerns Exist

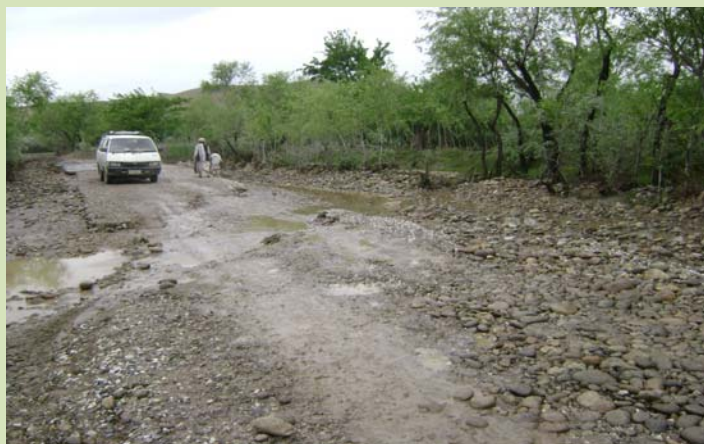
*The road from Mahmood Raqi to Nijrab before construction, April 2009 (Photo provided by SIGAR)*

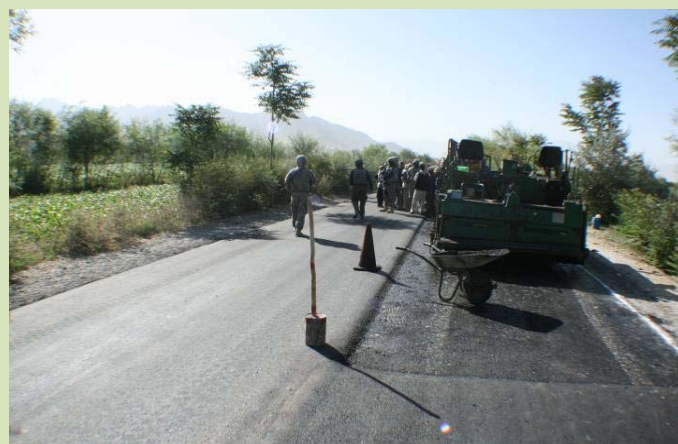
*The road to Nijrab during construction, August 2009 (Photo provided by SIGAR)*

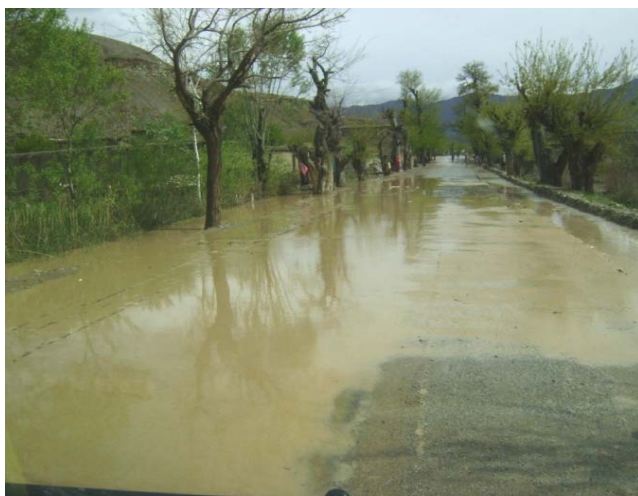
**Site Photo 1: Example of a flooded portion of the road prior to construction. The road was subsequently leveled and re-paved. (Photo provided by Kapisa PRT)**

road flooded and turned to mud (see photos 1 and 2). In the higher elevations and colder sections of the province, the roads experienced ice and snow accumulations that left steep uphill sections largely impassable and dangerous for traffic. In the hot, dry months of summer and early autumn, traffic on the roadway was subjected to swirling clouds of dust that at times limited visibility to less than 3 feet. These hazards were accentuated by several sections of the road with hairpin turns to accommodate the steep grades and sections where the road narrowed to less than one lane wide.

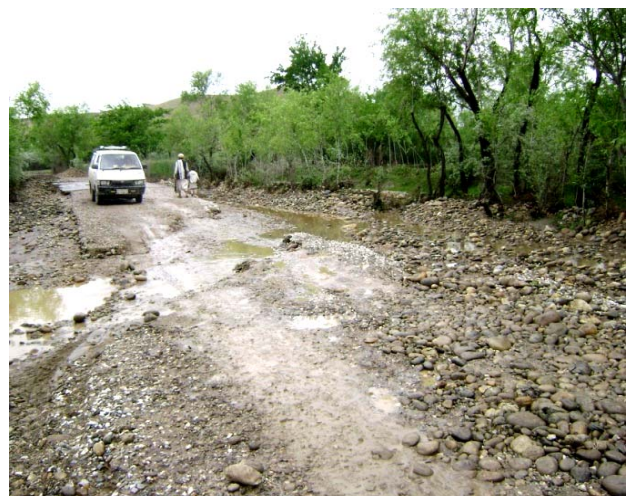
**Site Photo 2: Another part of the road as it existed prior to the start of construction. This section has since been repaired and a box culvert was constructed to divert water away from the road. (Photo provided by Kapisa PRT)**

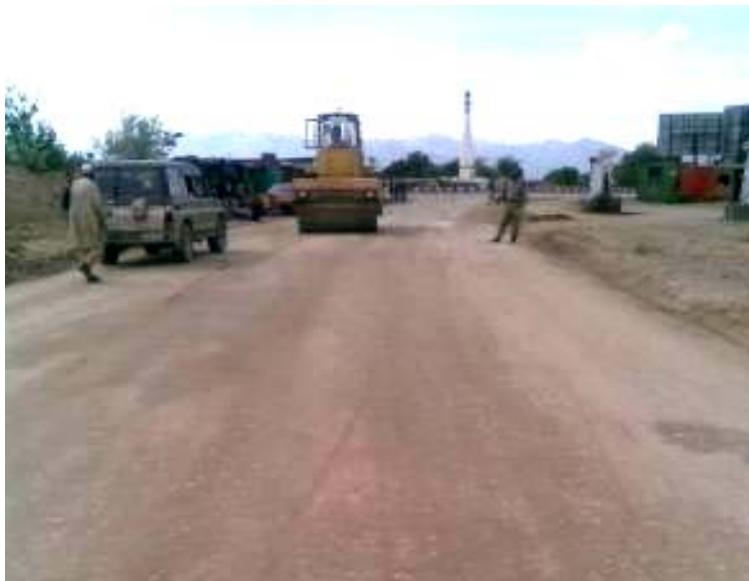
**Site Photo 3:** A view of the Mahmood Traffic circle facing west along the road to Nijrab in April 2009 shortly after the project's earth work phase commenced. The photo shows the road's sub-grade layer being compacted with a vibratory drum roller. (Photo provided by Kapisa PRT)

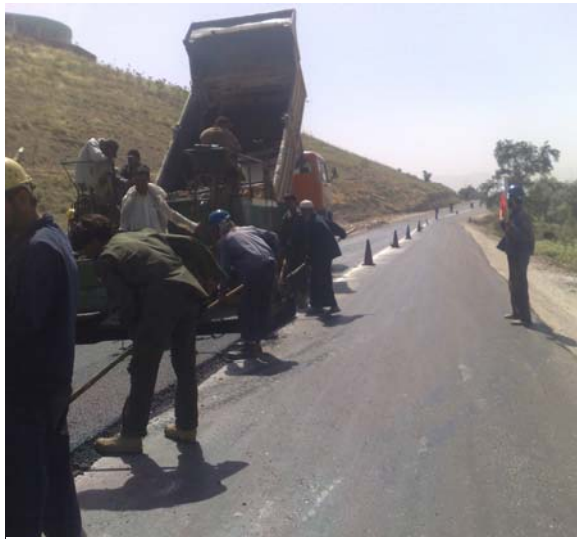
*Asphalt Wear Course:* The Statement of Work required the contractor to place the asphalt wear course with a thickness of 4 cm and width of 7 m laid from the middle of the road.

**Site Photo 4: Placement of the asphalt wear course with proper traffic control measures by having a signalman present and traffic cones. (Photo provided by Kapisa PRT)**

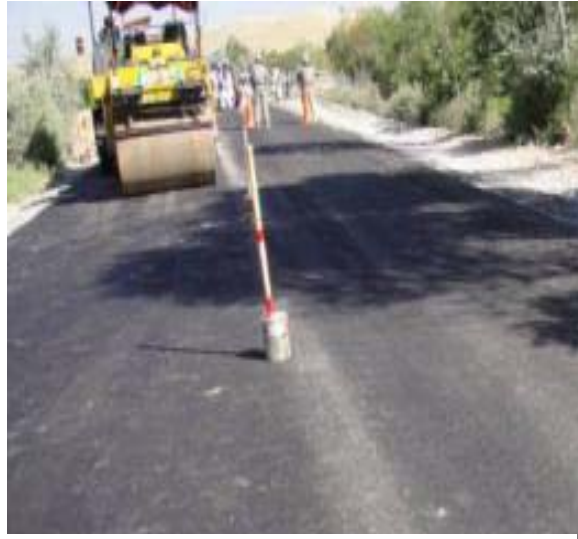
**Site Photo 5: Newly placed asphalt wear course with vibratory drum rollers performing compaction. (Photo taken by SIGAR)**

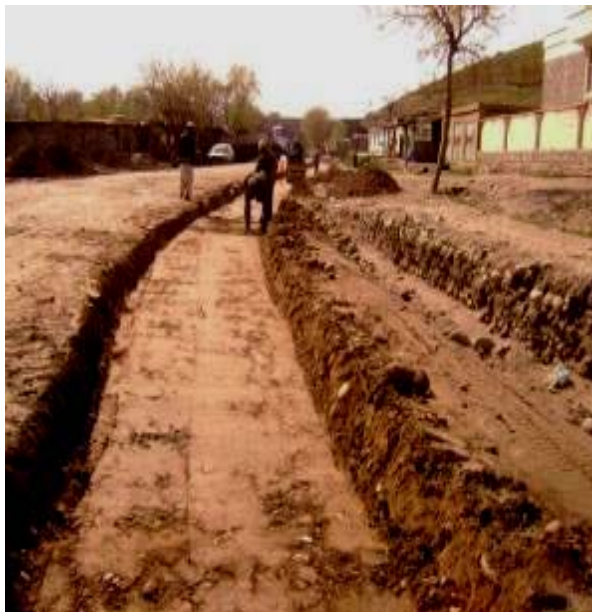
**Site Photo 6:** A view of the exposed and compacted sub-grade soil layer as the road was being cut and widened in Arokhi village section of the road. (Photo provided by Kapisa PRT)

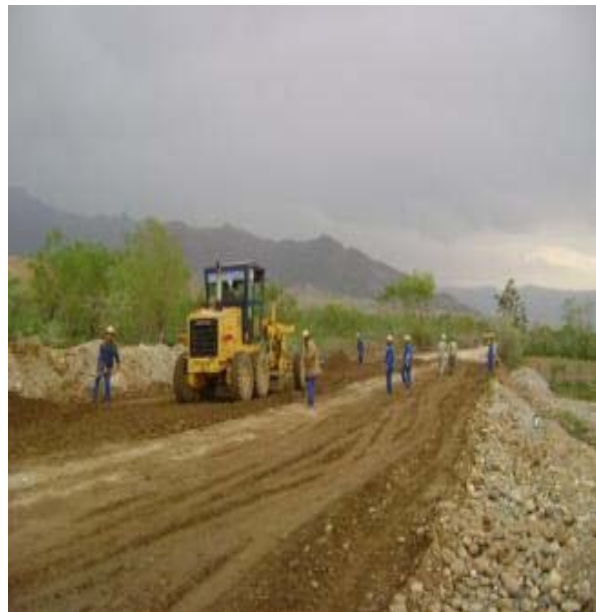
**Site Photo 7:** A view of the road being graded after the ground was filled in order to make the shoulders wider and level. (Photo provided by Kapisa PRT)

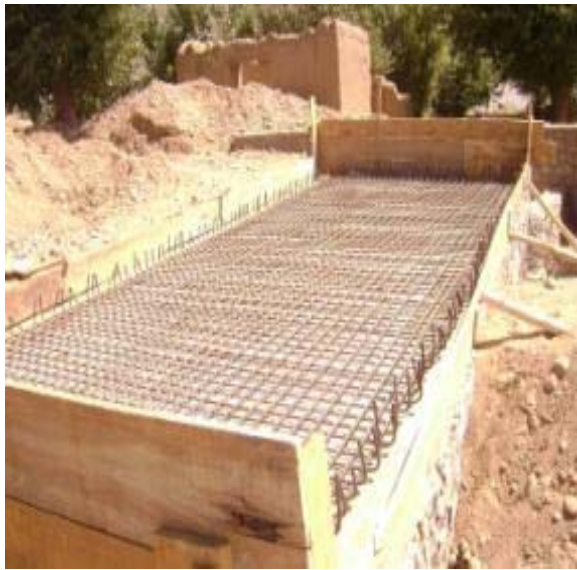
Site Photo 8: A rebar and wood formwork prepared to construct one of the 26 slab culverts required by the design plan. (Photo provided by Kapisa PRT)

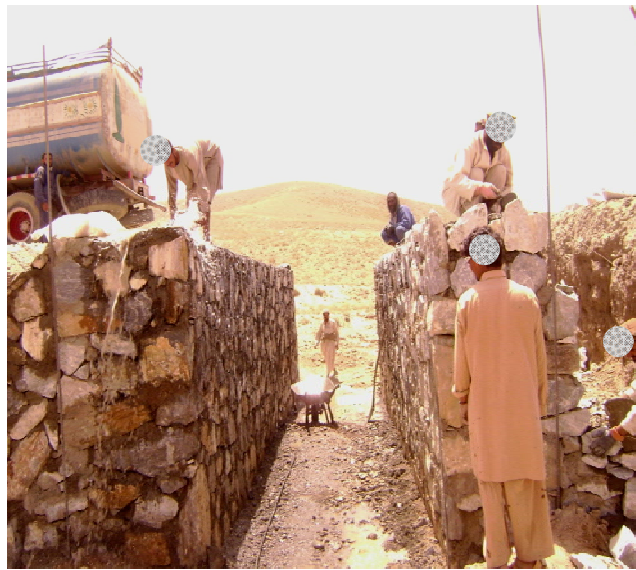
Site Photo 9: The wing walls of a stone masonry foundation for one of the 29 box culverts required by the project design plan. Of note are workers properly curing the cement mortar in the upper left hand corner of the photograph in order to allow it to develop its bonding strength. (Photo provided by Kapisa PRT)

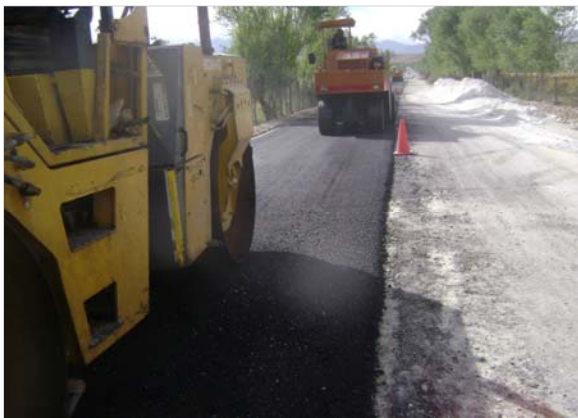
Site Photo 10: The asphalt base course being rolled (compacted) immediately after being placed on the prepared aggregate sub-base course following the application of the prime coat. Of note is the use of 2 types of rollers as specified in the SOW—a pneumatic tire roller (PTR) and a steel roller which together allow the newly surfaced road top to fully compact and bond the various layers together. (Photo provided by Kapisa PRT)

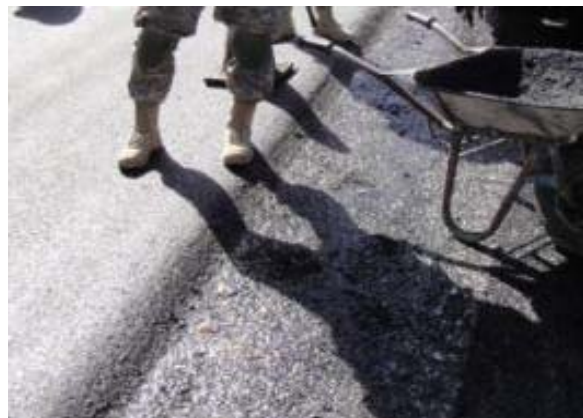
Site Photo 11: During the SIGAR on-site visit to the road, the PRT Quality Assurance Representative discussed an unfinished edge of asphalt as well as the requirement for compaction and placement of gravel shoulders which the contractor still needed to perform. (Photo provided by Kapisa PRT)

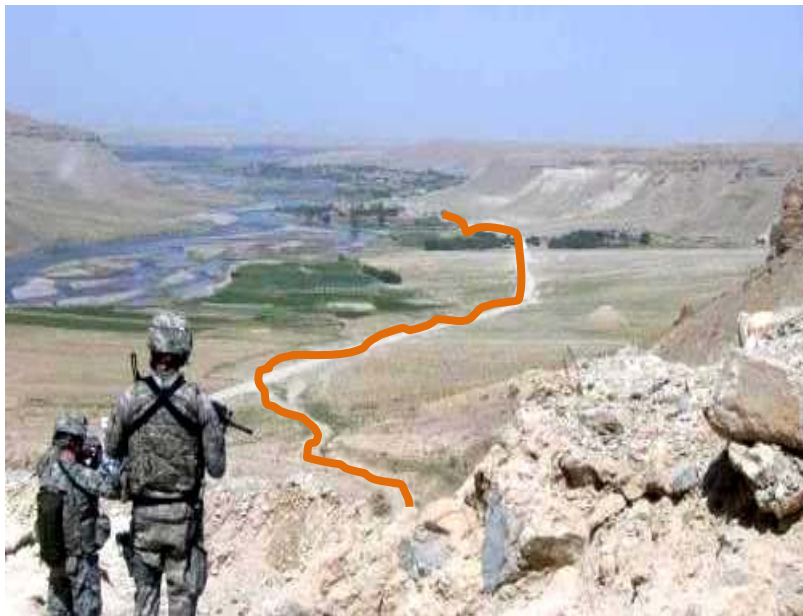
Based on SIGAR's observations, the heavy traffic, including overweight trucks and armored vehicles currently using the road, could seriously reduce the lifetime of the road, expected to be 5 years, unless an effective repair and maintenance program is implemented. Although the local authorities agreed to maintain the road during the development of the project, PRT officials and USFOR-A have concurred that the Kapisa Province Ministry of Public Works does not currently have the capability to effectively maintain this road and will not have the capability for some time. Depending on the deterioration of the road surface from traffic, without effective repairs and maintenance, the U.S. investment of \$6.6 million is at risk. PRT officials acknowledged that these road sustainability requirements were not fully anticipated in the original contract's scope of work.

**Site Photo 12: A view of the Mahmood Raqi to Nijrab Road looking northwest towards Mahmood Raqi from a location near the 18 kilometer mark of the 28 kilometer road taken in early August 2009 with the Panjshir River to the left of the photo. The progress of the project can be seen as the road turns and bends northeast into the Nijrab District as shown by the orange line. (Photo provided by Kapisa PRT)**

SIGAR recommends that USFOR-A continue coordination with the U.S. Agency for International Development (USAID) to include this road in the expanding Management and Operation Program to develop capacity for repairing and maintaining roads at the provincial level. This recommendation includes, but is not limited to, providing information through the Combined Information Data Network Exchange (CIDNE) system to permit USAID visibility of and access to details of this project.

SIGAR further recommends that the Kapisa PRT and other appropriate U.S. authorities, in partnership with the Kapisa Provincial Ministry of Public Works, develop a sustainability plan for providing the level of preventative maintenance and repair needed to sustain the significant investment made by the United States, which may involve the U.S. Agency for International Development (USAID) plans for expanding the road Management and Operation Program to develop capacity for repairing and maintaining roads at the provincial level.
