SIGAR

Office of the Special Inspector General
for Afghanistan Reconstruction

October 20, 2015

USAID’S GEOSPATIAL COORDINATES FOR 12 OF 23 FACILITIES WERE WITHIN ONE KILOMETER OF THE ACTUAL FACILITY LOCATION

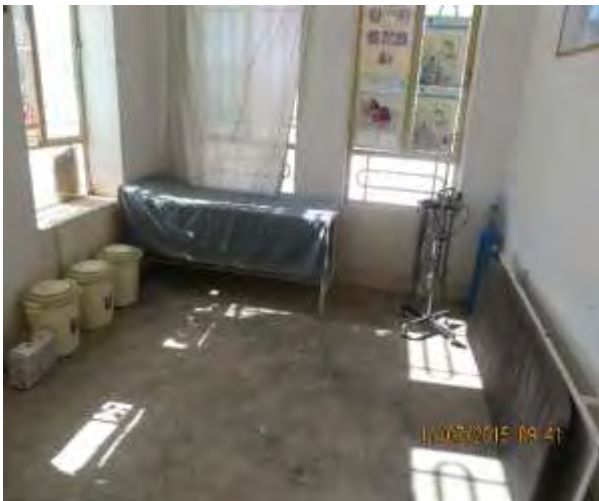
the facilities to be in good working order.¹³ Photos 1 and 2 show the treatment rooms at two of the facilities.¹⁴

Photo 1 - Treatment Room at Facility 2786

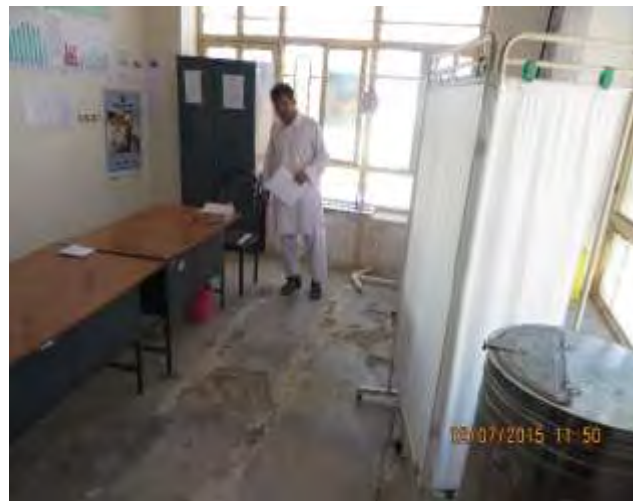
Photo 2 - Treatment Room at Facility 2933

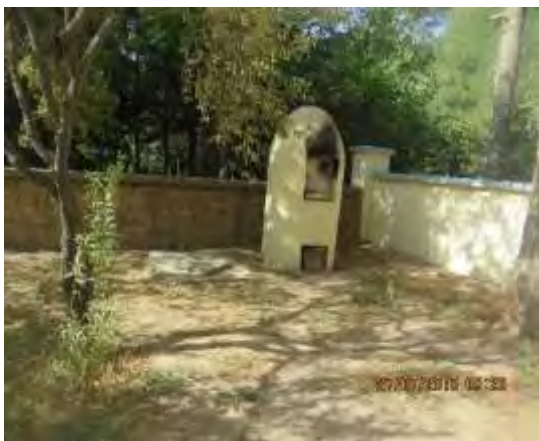
Finally, our site inspections found that at least 16 facilities disposed of medical waste in open-air kilns, some of which were publicly accessible. This method of unsecured disposal does not adhere to best practices and raises the risk that patients seeking treatment—or children we observed playing outside at several facilities—could be accidentally exposed to contaminated waste.¹⁶ Photos 3 and 4 show easily accessible, open-air kilns used to dispose of waste at two facilities.

Photo 3 - Accessible Open-Air Kiln at Facility 1737

Finally, inadequate or sporadic access to electricity, water, or needed pharmaceuticals at several locations raises concerns that USAID is paying for services that the implementing partner is not providing. We encourage USAID to take action to ensure that all of the health facilities it supports in Herat are operating with the utilities and pharmaceutical stores necessary to provide the intended level of health services to the target population.

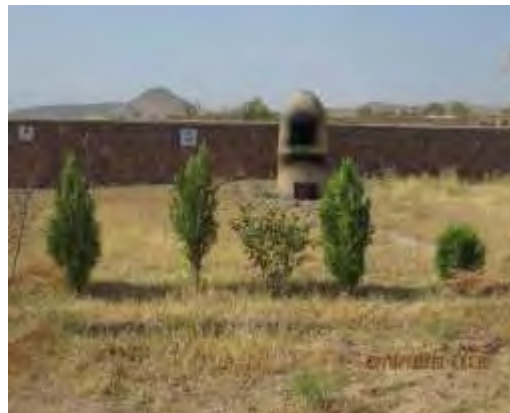
Photo 4 - Accessible Open-Air Kiln at Facility 1595
