**BRIDGES IN KABUL PROVINCE,
AFGHANISTAN: SIX BRIDGES ARE
IN GENERALLY GOOD CONDITION,
BUT AFGHAN GOVERNMENT LACKS
BUDGET FOR SUSTAINED
MAINTENANCE**

DECEMBER 2018

SIGAR 19-08-SP

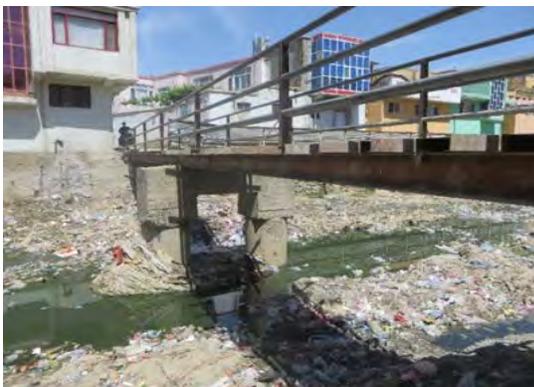
Photo 1 - Bridge Project 1

Bridge 1 is a pedestrian bridge completed in May 2010 at a cost of \$85,000. We found that the bridge is in generally good and usable condition. The steel bridge spans 16 meters across a river, which separates two villages that have close socioeconomic ties. We estimated it serves 300 people a day. We were told that the bridge was built with the strong support of local leaders who described it as “one of the important needs of the village.” One community member interviewed in close proximity to the bridge described how, prior to the bridge’s construction, village residents would travel to another village just to cross the river, making it difficult to access services and facilities. The MOPW representative stated the community relied heavily on the bridge to connect community members with their workplaces, schools, clinics, and the local markets. We were able to locate an Agreement letter from six village elders requesting construction of the bridge and a promise to sustain the bridge. According to an MOPW official, the MOPW has not included maintenance for the bridge in its budget.

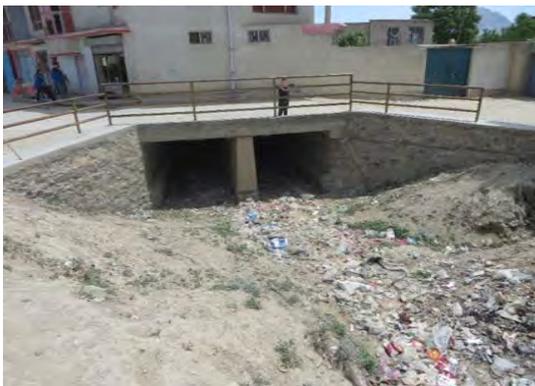
Photo 3 - Bridge Project 2 (Child on Bridge)

Bridge 2 is a vehicle and pedestrian bridge. The 5-meter concrete bridge was constructed at a cost of \$120,715. We found that the bridge is in generally good condition and found no visible damage to its surface or support structure. We estimated that roughly 250 individuals travel on foot or in vehicles daily across this bridge. The MOPW official we interviewed stated that the bridge was heavily relied upon by the community to attend schools, access markets, and perform other daily necessities as it connects two villages. A community member described the bridge as “somewhat useful”, noting that it was used predominately during seasons when water flowed beneath it. The community member further noted that prior to the bridge’s construction villagers could not cross to the other side when the river was flowing. An undated Memorandum of Agreement between the U.S. Department of the Army and Afghan Government estimated that recurring maintenance costs are \$1,000; however, according to an MOPW official, the Afghan government has not included maintenance for this bridge in its budget.

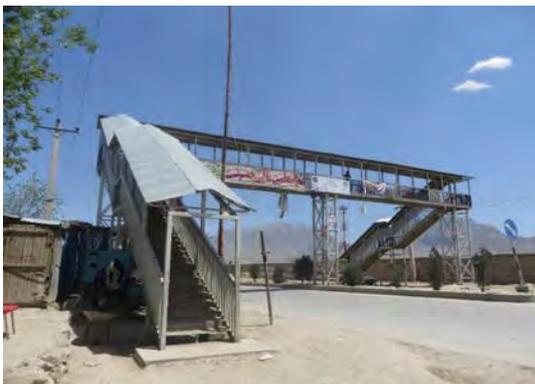
Photo 5 - Bridge Project 3 (Street View)

Bridge 3 was completed in November 2012 at a cost of \$80,000. It is a pedestrian overpass 16 meters long and 1.2 meters wide. We found that the bridge is in usable condition. The MOPW official noted that the community was “moderately” reliant on the bridge and believed it had led to a decrease in traffic accidents since it provided a safer crossing for children going to school. However a community member stated that he believed the overpass was “not so useful” and estimated that only 3 to 5 people use the bridge each day. An April 2012 Memorandum of Agreement between MOPW and U.S. Department of the Army estimated that the recurring operations and maintenance costs for the overpass to be \$400. According to an MOPW official, the Afghan government has not included maintenance for this overpass in its budget.

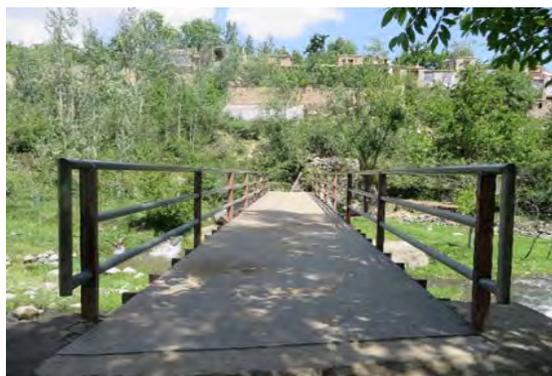
Photo 7 - Bridge Project 4, (Pedestrian Bridge)

Bridge 4 was completed in March 2010 at a cost of \$99,500. It is a pedestrian bridge, comprised of steel plates, measuring 1.6 meters wide by 18 meters long. We found that the bridge is active and in usable condition. We estimated that the bridge was being used by 300 people each day. The MOPW official we interviewed stated that the local community was heavily reliant on the bridge. The community member we interviewed responded that the bridge was “very useful.” Both noted the bridge was used for connecting villages throughout the district and for access to schools and work. We were able to locate a letter from the local police department requesting construction of the bridge stating that the local police department and elders in the area would be responsible for the maintenance and care of the bridge. According to an MOPW official, the Afghan government has not included maintenance for the bridge in its budget.

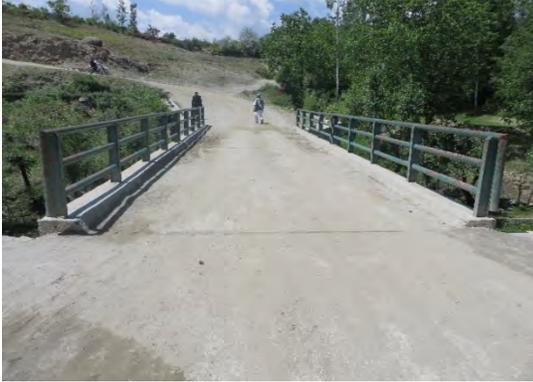
Photo 9 - Bridge Project 5 Used by Pedestrians

Bridge 5 was constructed in July 2010 at a total cost of \$170,000. We estimated the bridge to be 5 meters wide by 15 meters long and that about 200 people and 25 vehicles cross the bridge daily. We found that the bridge is usable and in generally good condition.

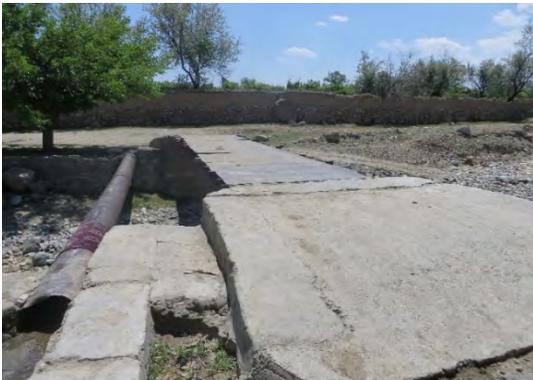
Photo 11 - Bridge Project 6 over Dry River Bed

Bridge 6 was completed in June 2011 at a cost of \$54,704. It is a pedestrian foot bridge, which measures approximately two meters wide by ten meters long. The MOPW official and the local citizen we interviewed noted that the bridge spans a riverbed that is dry during much of the year. Therefore, the bridge is used more extensively during the spring flooding season.

During our site visit we noted a lack of safety rails and slight structural damage to the bridge, specifically, notable bending of the metal plates that compose the surface area of the bridge. The community member we interviewed noted that the bridge was used by vehicles. A Memorandum of Agreement between the MOPW and the Department of the Army (undated) stipulates that the MOPW agreed to provide \$200 for recurring operation and maintenance once the bridge was completed. However, according to an MOPW official, the Afghan government has not included maintenance for this overpass in its budget.
