## USAID SUPPORTED HEALTH FACILITIES IN BAMYAN PROVINCE, AFGHANISTAN: OBSERVATIONS FROM 44 SITE VISITS

April 2019

SIGAR 19-34-SP

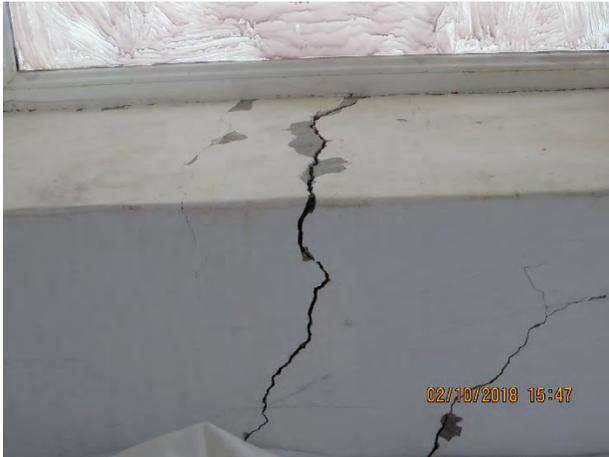
Photo 1 shows severe cracks in a wall of facility 2549; Photo 2 shows an apparently abandoned health facility construction project near facility 2358; Photo 3 shows roof damage caused by rocks falling from a nearby hillside according to staff at facility 1571; and Photo 4 shows a potential health concern in the restroom of facility 801.

**Photo 1 - Wall Cracks at Health Facility 2549**

To help ensure that USAID has accurate location data for the health clinics it supports, we recommend that USAID update its geospatial coordinates and share this review with the MOPH so they can update their records and so that the structural and other deficiencies we identified can be brought to the attention of those responsible for addressing them.

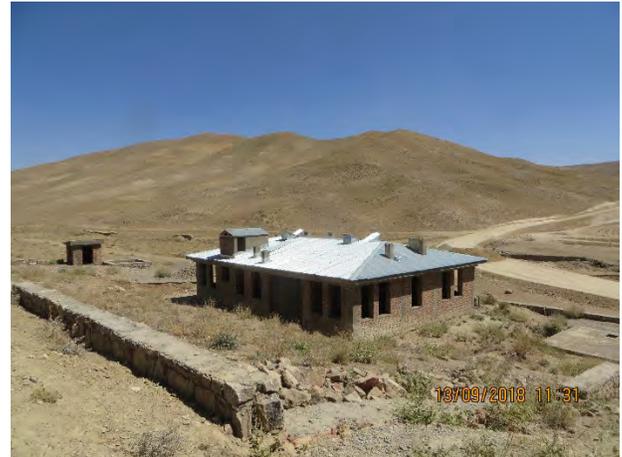
Although most facilities were in good condition, we observed instances of cracked walls, leaking roofs, and other non-structural defects that did not appear to negatively affect operations. We also observed that facility 2358 was a two room building and construction of another clinic 2 kilometers away from this facility was never completed. Finally, at some locations, we observed potential health or safety hazards at facilities that may be cause for concern.

**Photo 2 - A partially constructed but abandoned health facility near Health Facility 2358**

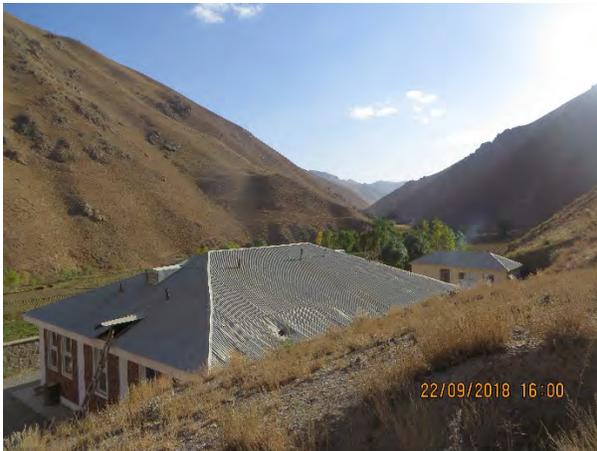
**Photo 3 - Damaged Roof at Facility 1571**

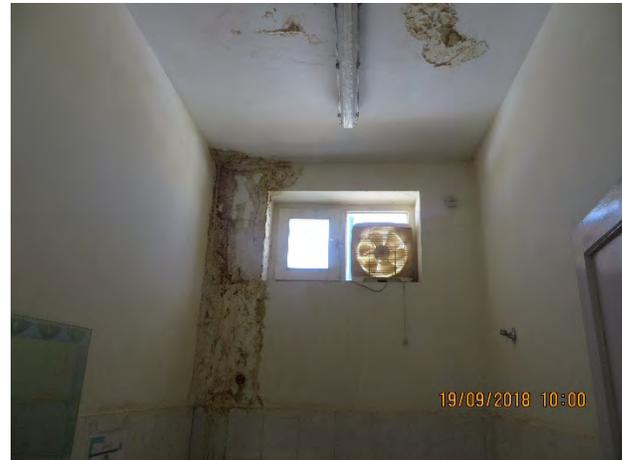
**Photo 4 - Potential Mold in restroom of facility 801**

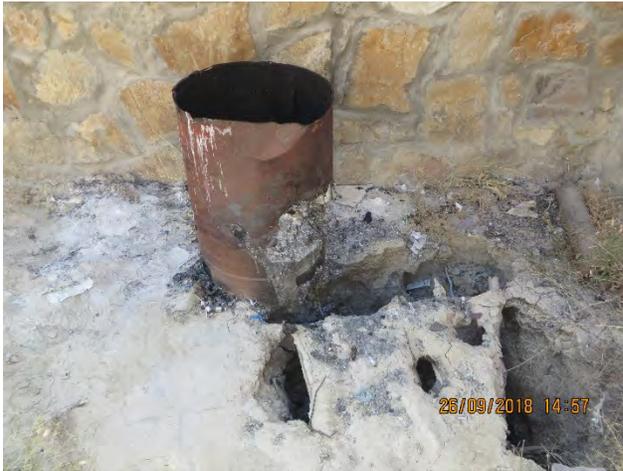
We also observed that many of the inspected facilities possessed medical waste incinerators that conformed to best practices.<sup>8</sup> For instance, one fourth were clearly marked, more than half were well-constructed, and more than two thirds were isolated and well-situated containers for medical waste disposal. However, we observed that roughly one fifth of facilities possessed incinerators may pose a hazard to staff and facility visitors due to either their condition or their location. Photos 5 and 6 display two such examples. Photo 5 shows a damaged drum incinerator and burial pit at facility 2321 and Photo 6 shows an unmarked, poorly positioned and substandard incinerator at facility 496.

Photo 5 - Substandard Medical Waste Disposal at Facility 2321

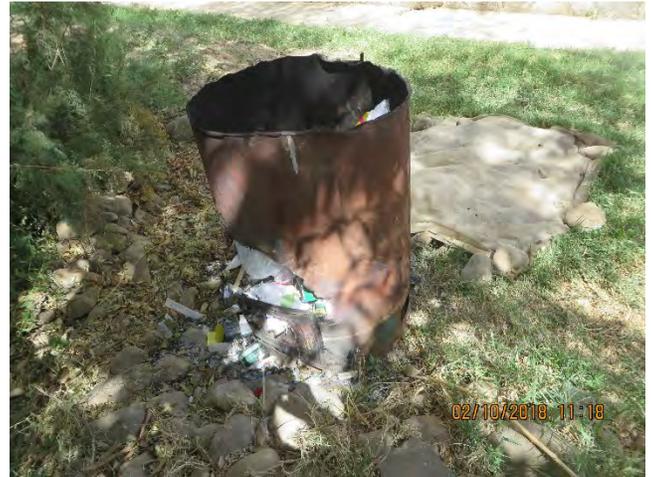
Photo 6 - Unmarked, un-cordoned substandard incinerator at facility 496
